ICLR Friday Forum  
November 17, 2017

# Hurricane Irma Damage Assessment:

Investigating the performance of Florida's homes during  
Hurricane Irma

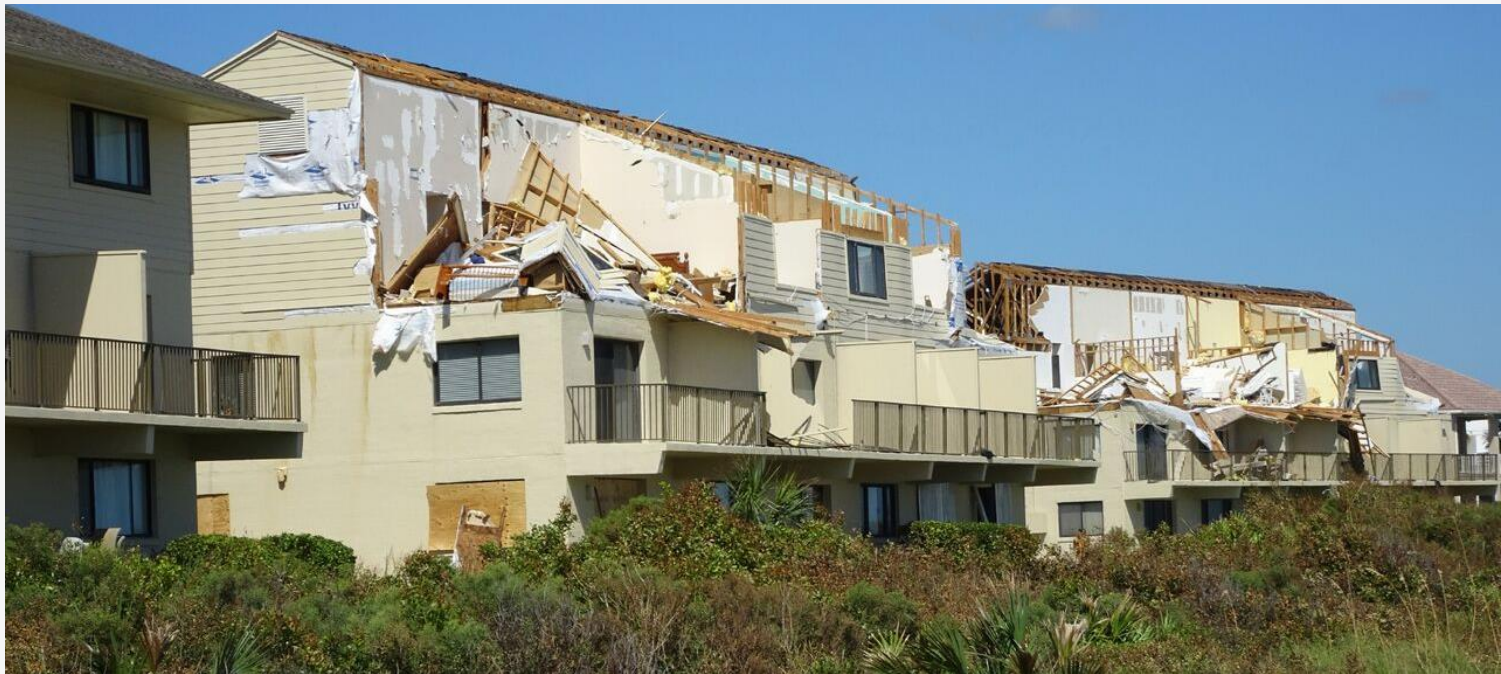
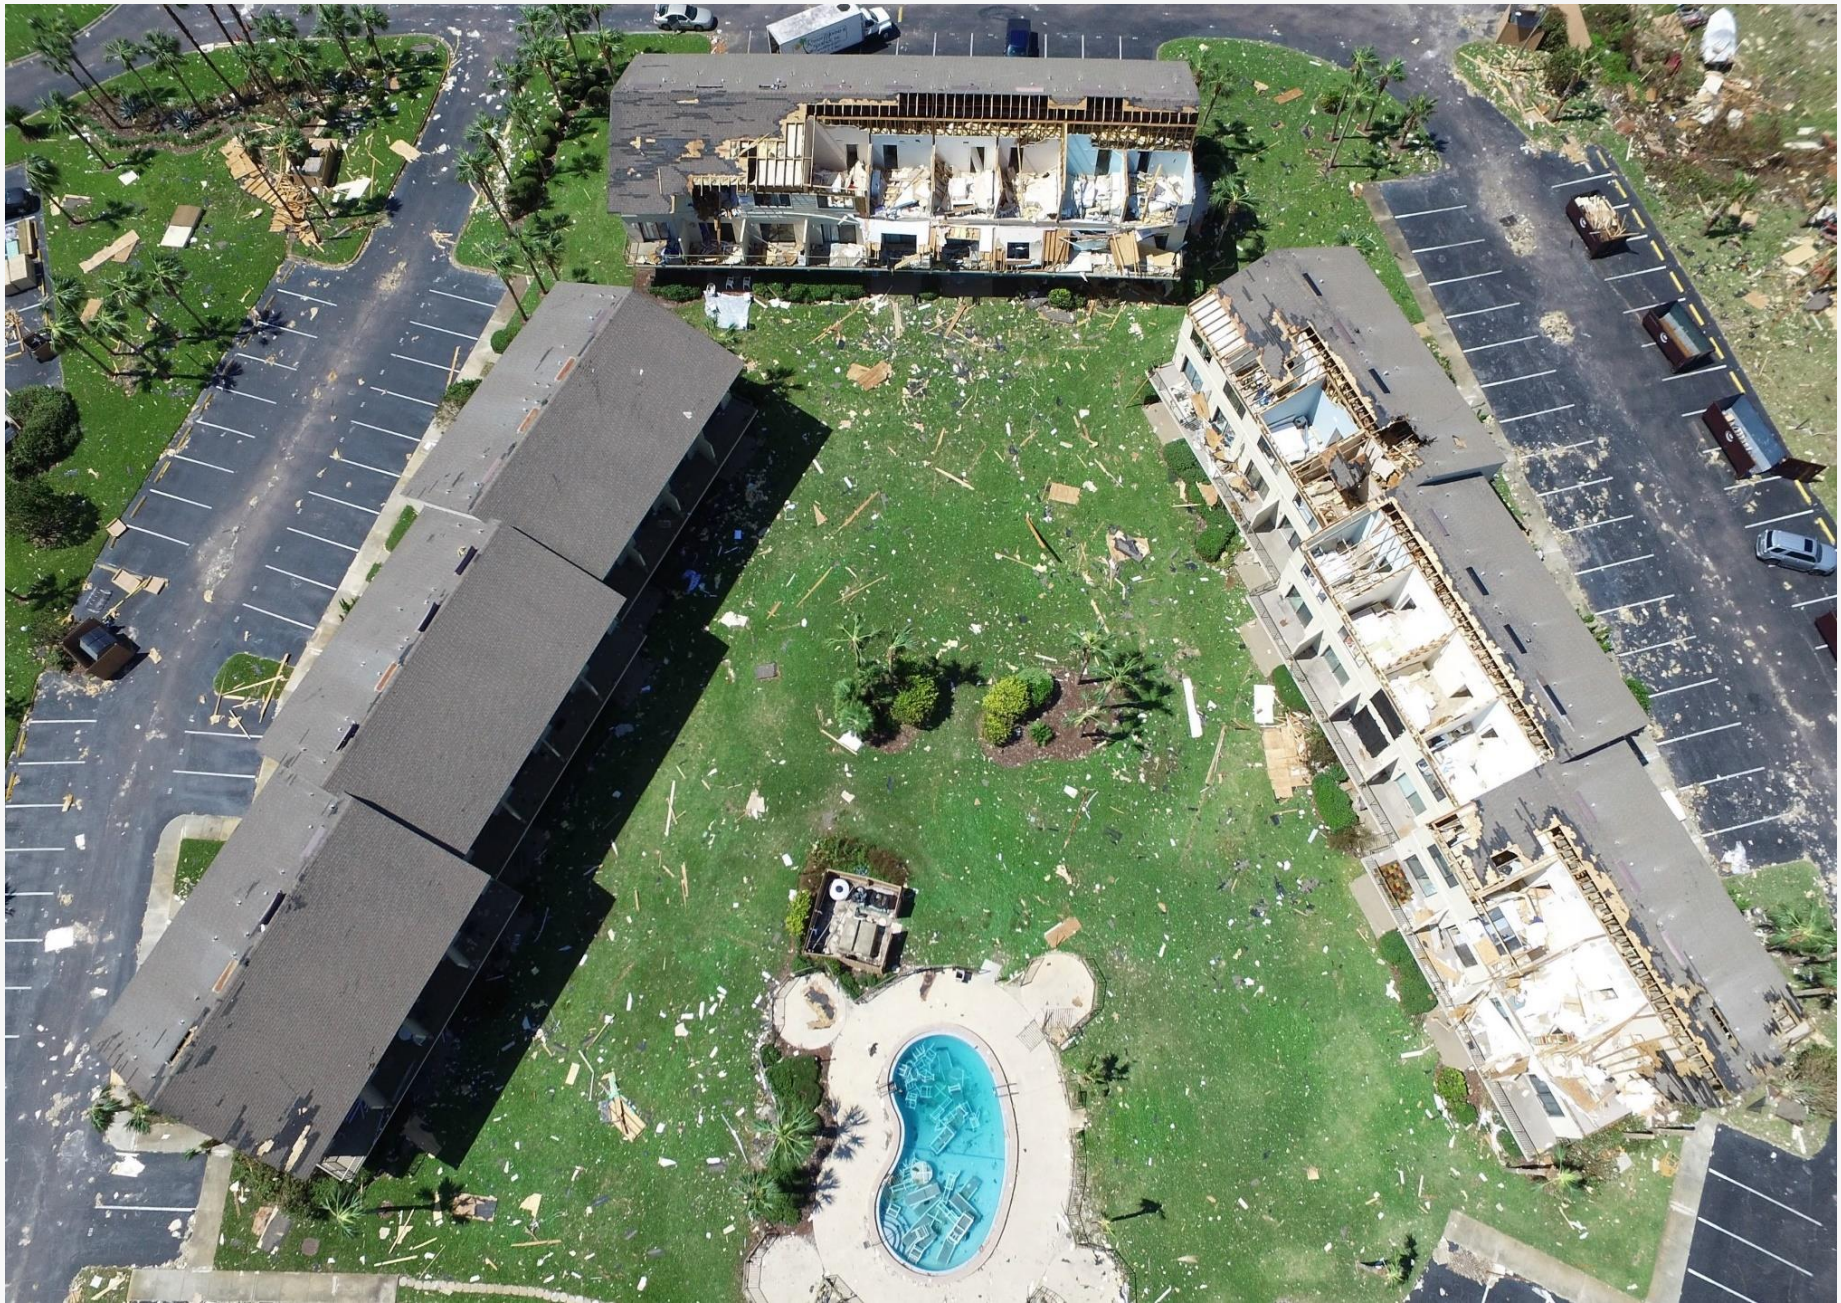
- Crescent Beach, FL
- Vacation townhome rentals, oldest buildings constructed in 1982 – some had been rebuilt in the 2000's following a previous tornado

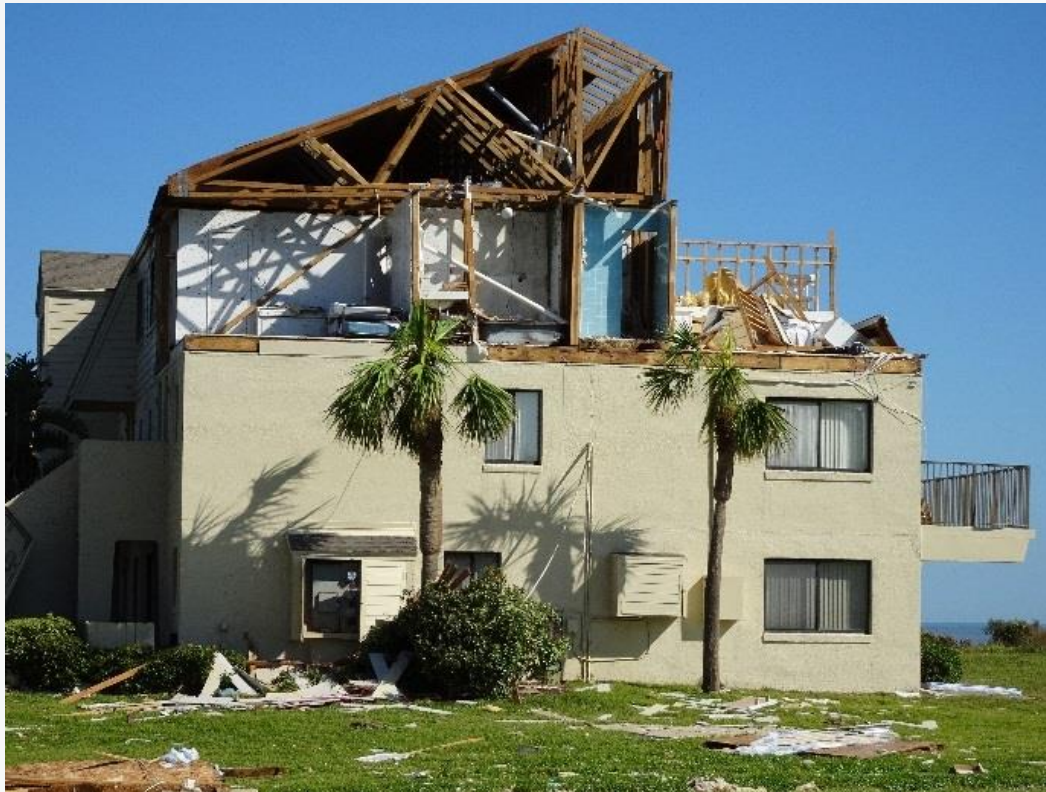
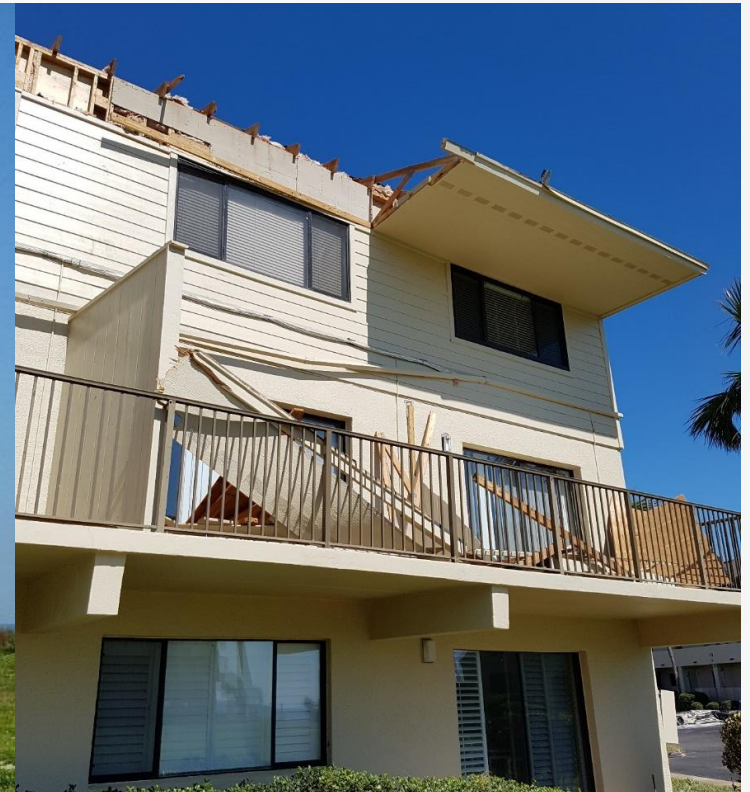
- Estimated wind speed: 130 mph
- Design wind speed: 132 mph
  - Previous design wind speed (2005): 121 mph

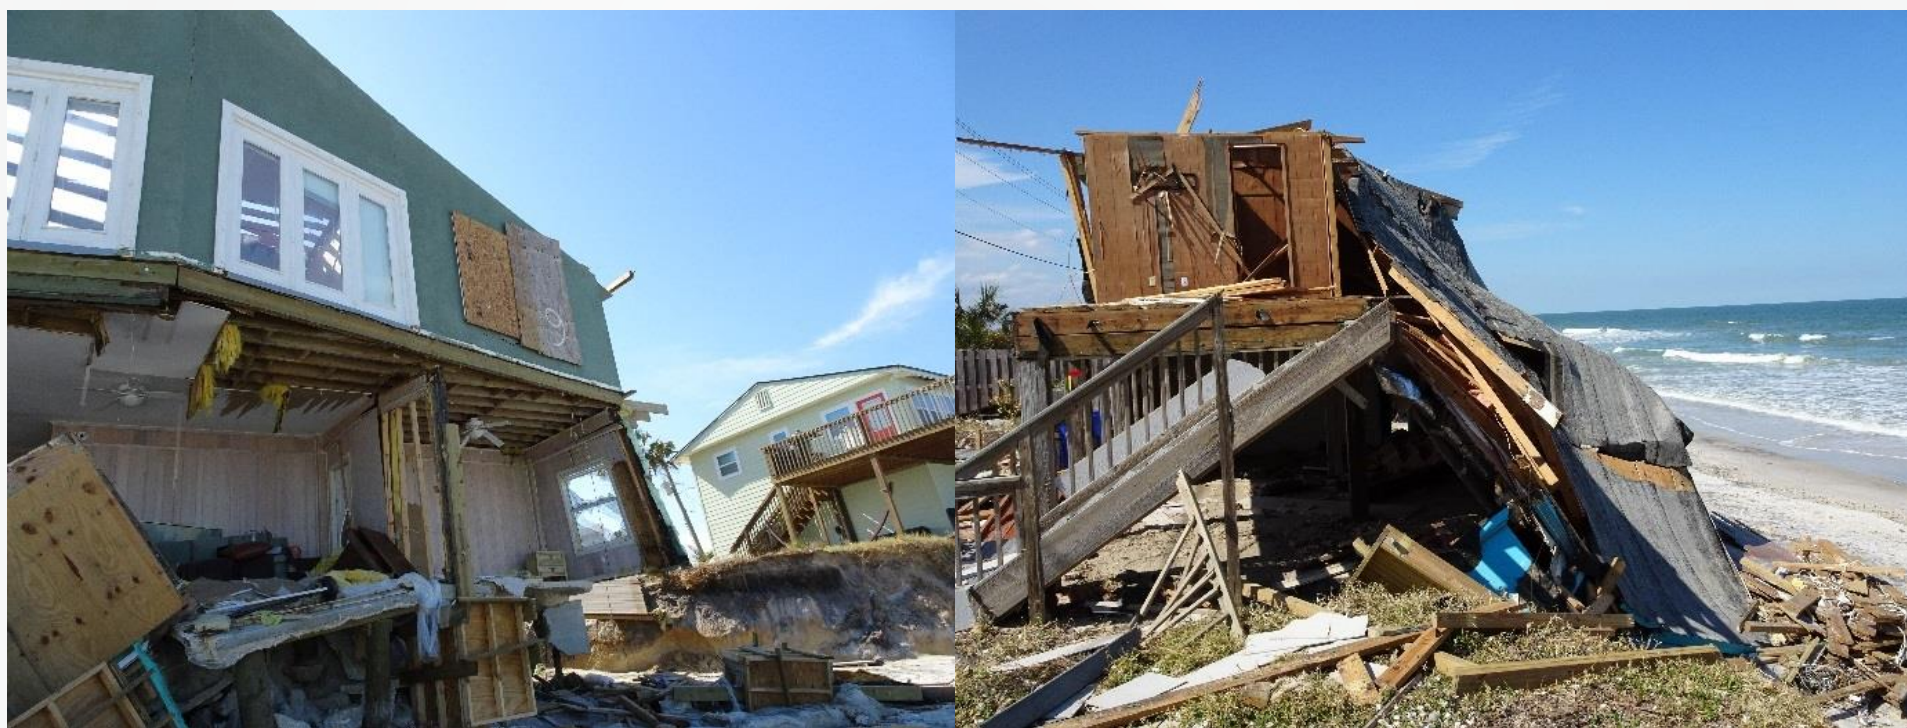
- Vilano Beach, FL
- Storm surge height up to 6 feet measured nearby (USGS data)

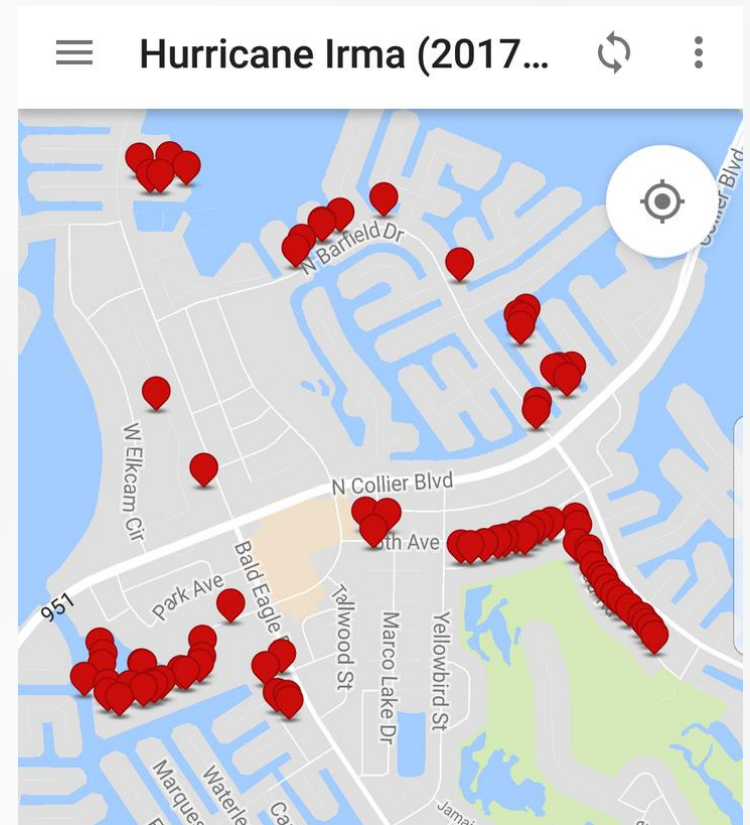
- Consistent, minor damage observed over large residential areas
  - 215 Structures Surveyed
  - Minor damage to clay tile and asphalt roofing was common

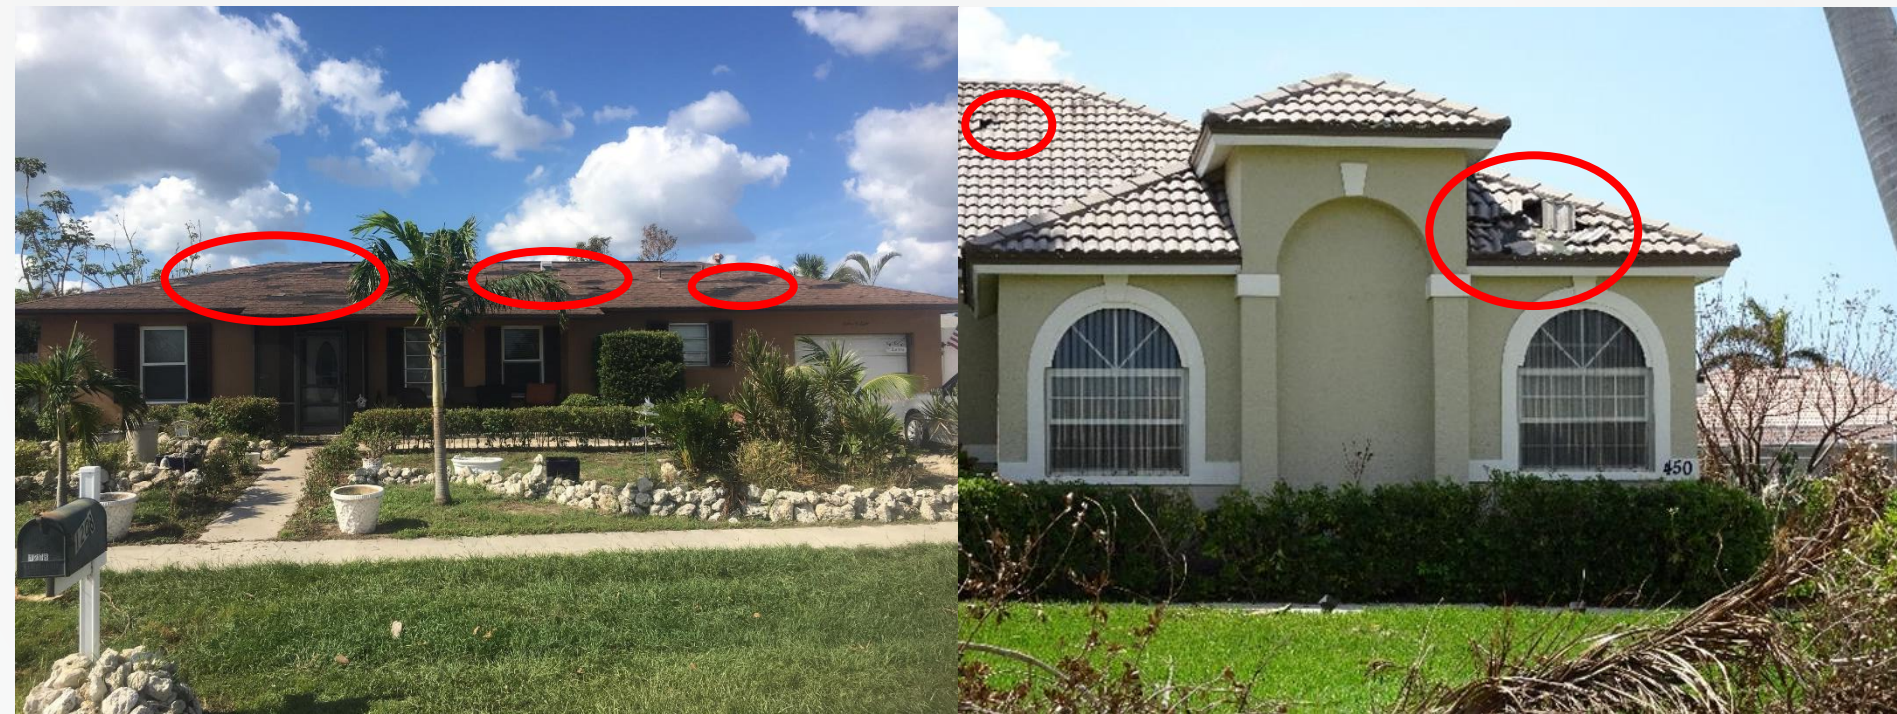
- Estimated wind speed: 108 mph
- Design wind speed: 170 mph
  - Previous design wind speed (2005): 137 mph

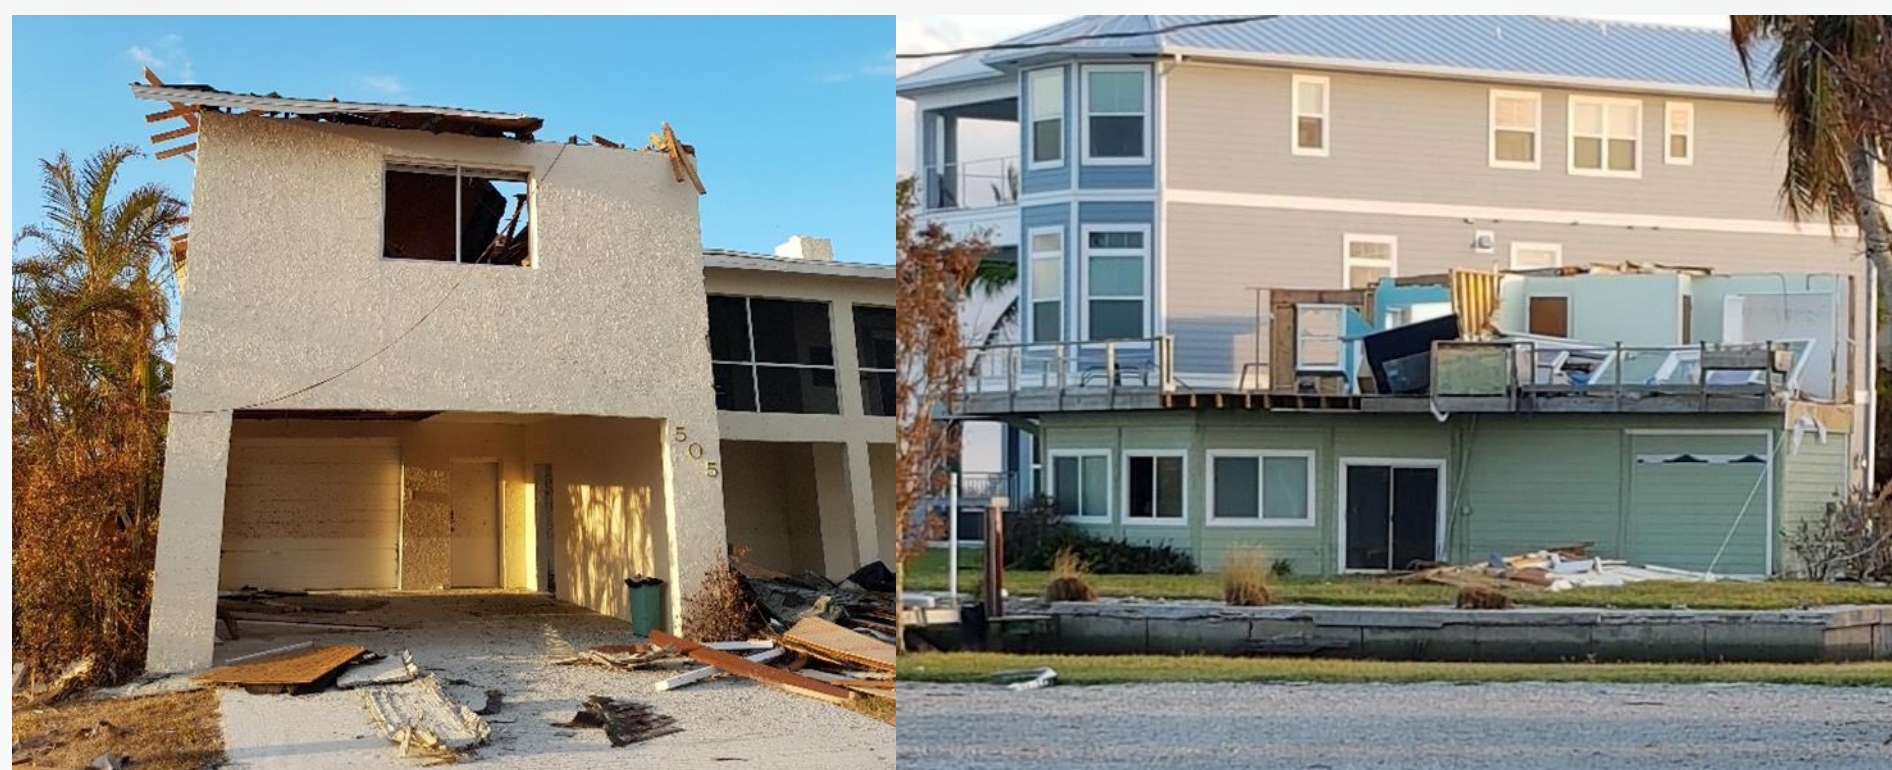
- Estimated wind speed: 108 mph
- Design wind speed: 170 mph
  - Previous design wind speed (2005): 137 mph

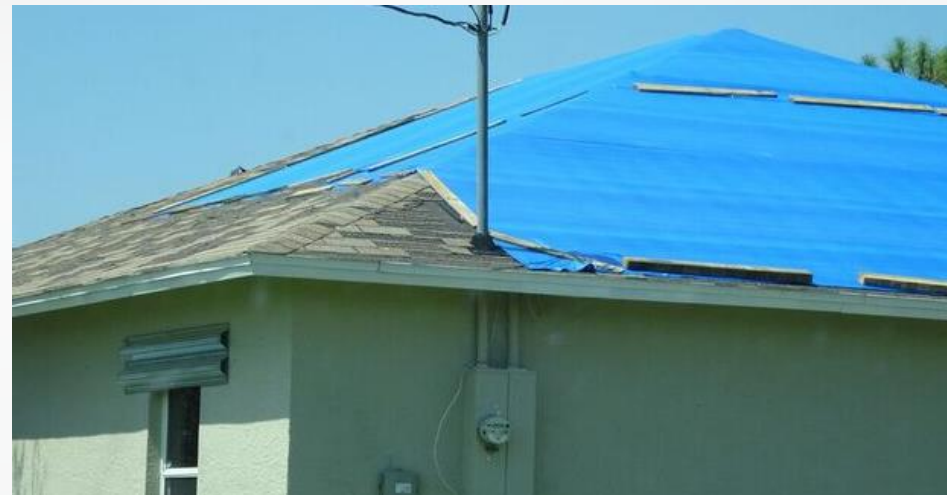
- Insurance Institute for Business and Home Safety (IBHS) FORTIFIED Homes™
  - <https://disastersafety.org/fortified/fortified-home/>
  - Inspected and compared to neighboring homes to assess relative performance
- Minor roof cover damage
  - Comparable levels of damage in FORTIFIED and other nearby homes

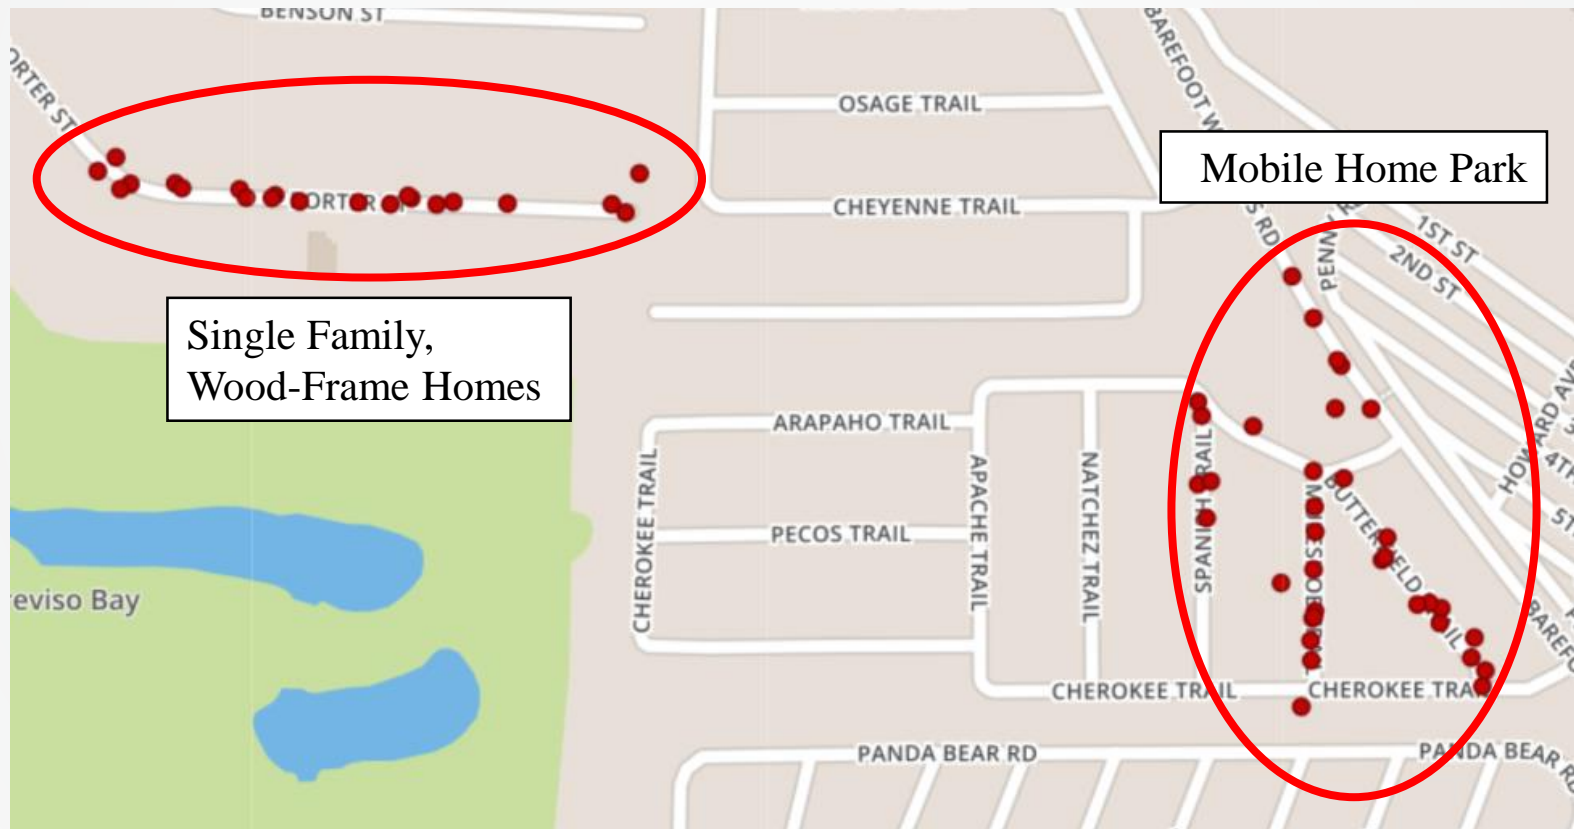
- Estimated wind speed: 100 mph
- Design wind speed: 166 mph

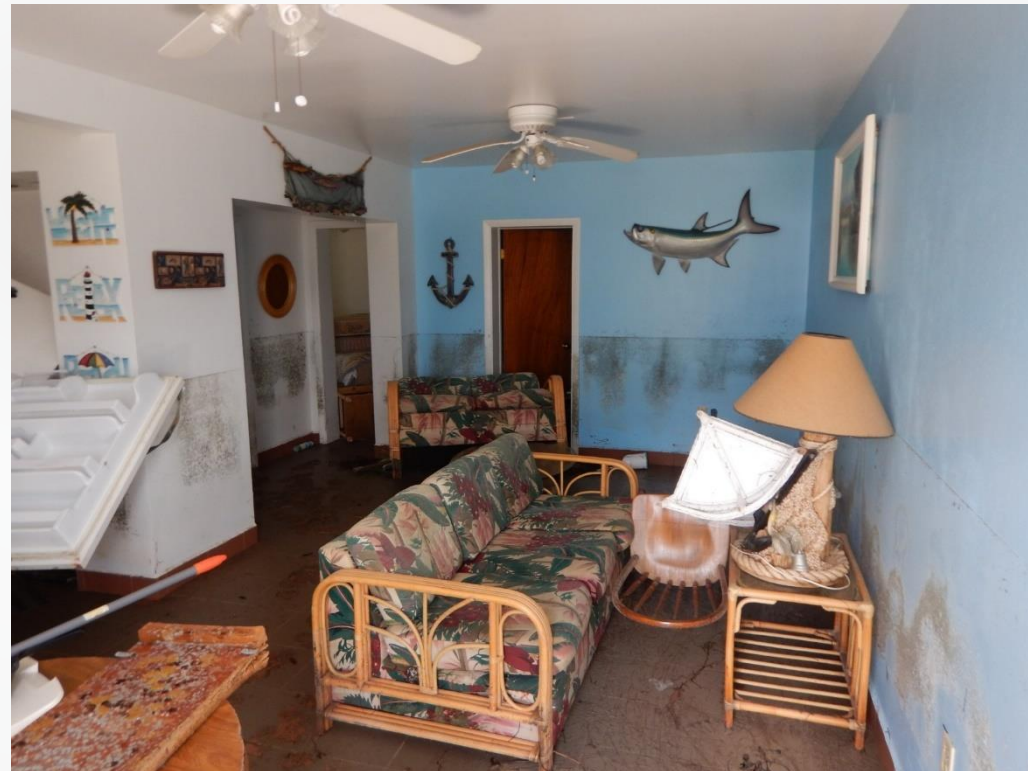
- Storm surge damage caused significant losses
  - Newer, elevated homes performed well
- Extent of interior damage was not generally assessed, unless homeowner was present
