Damage Observations from the Vaughan Tornadoes of August 20, 2009

Gregory Kopp

Faculty of Engineering, University of Western Ontario

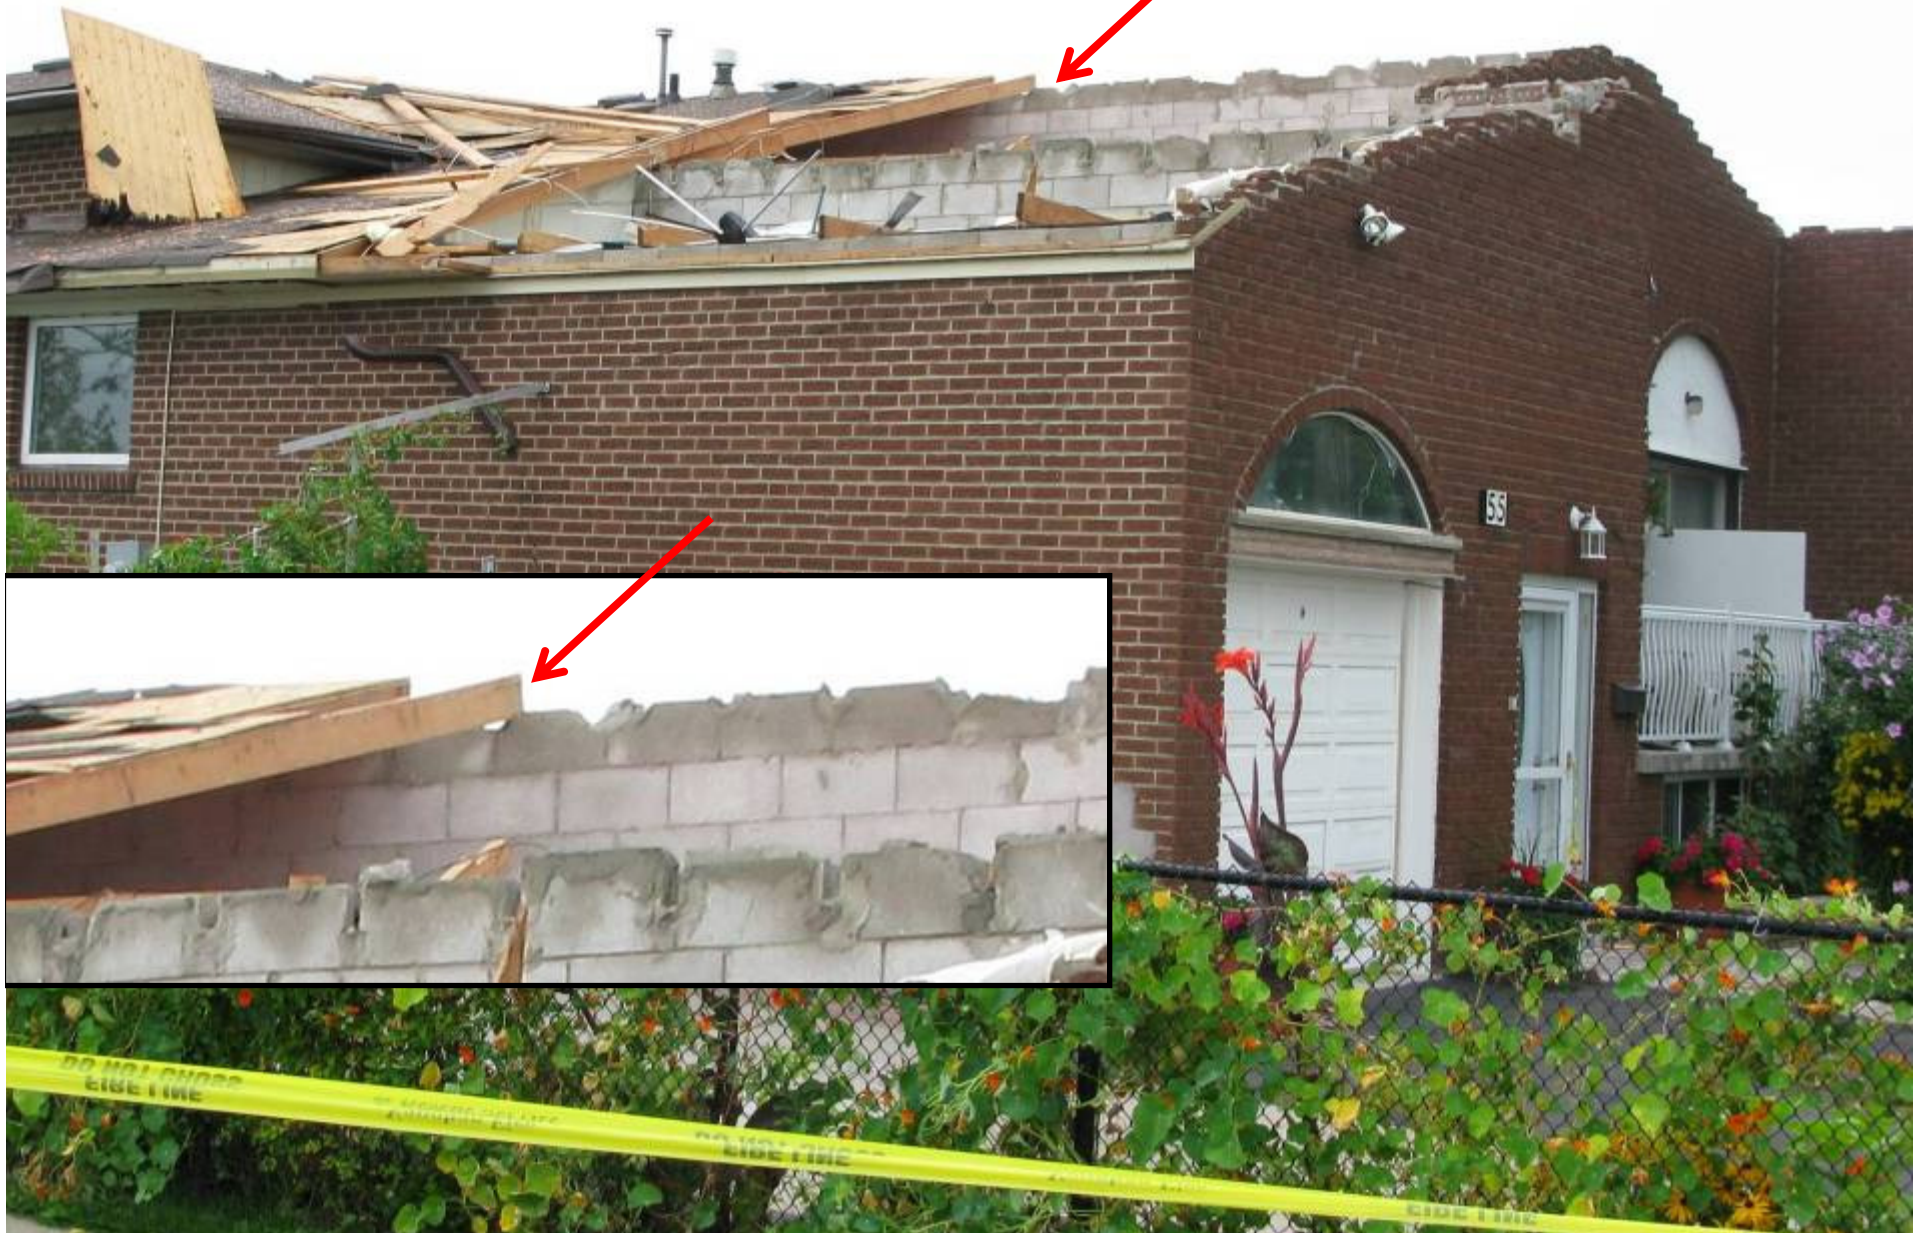
Missing roof-to-wall connections.

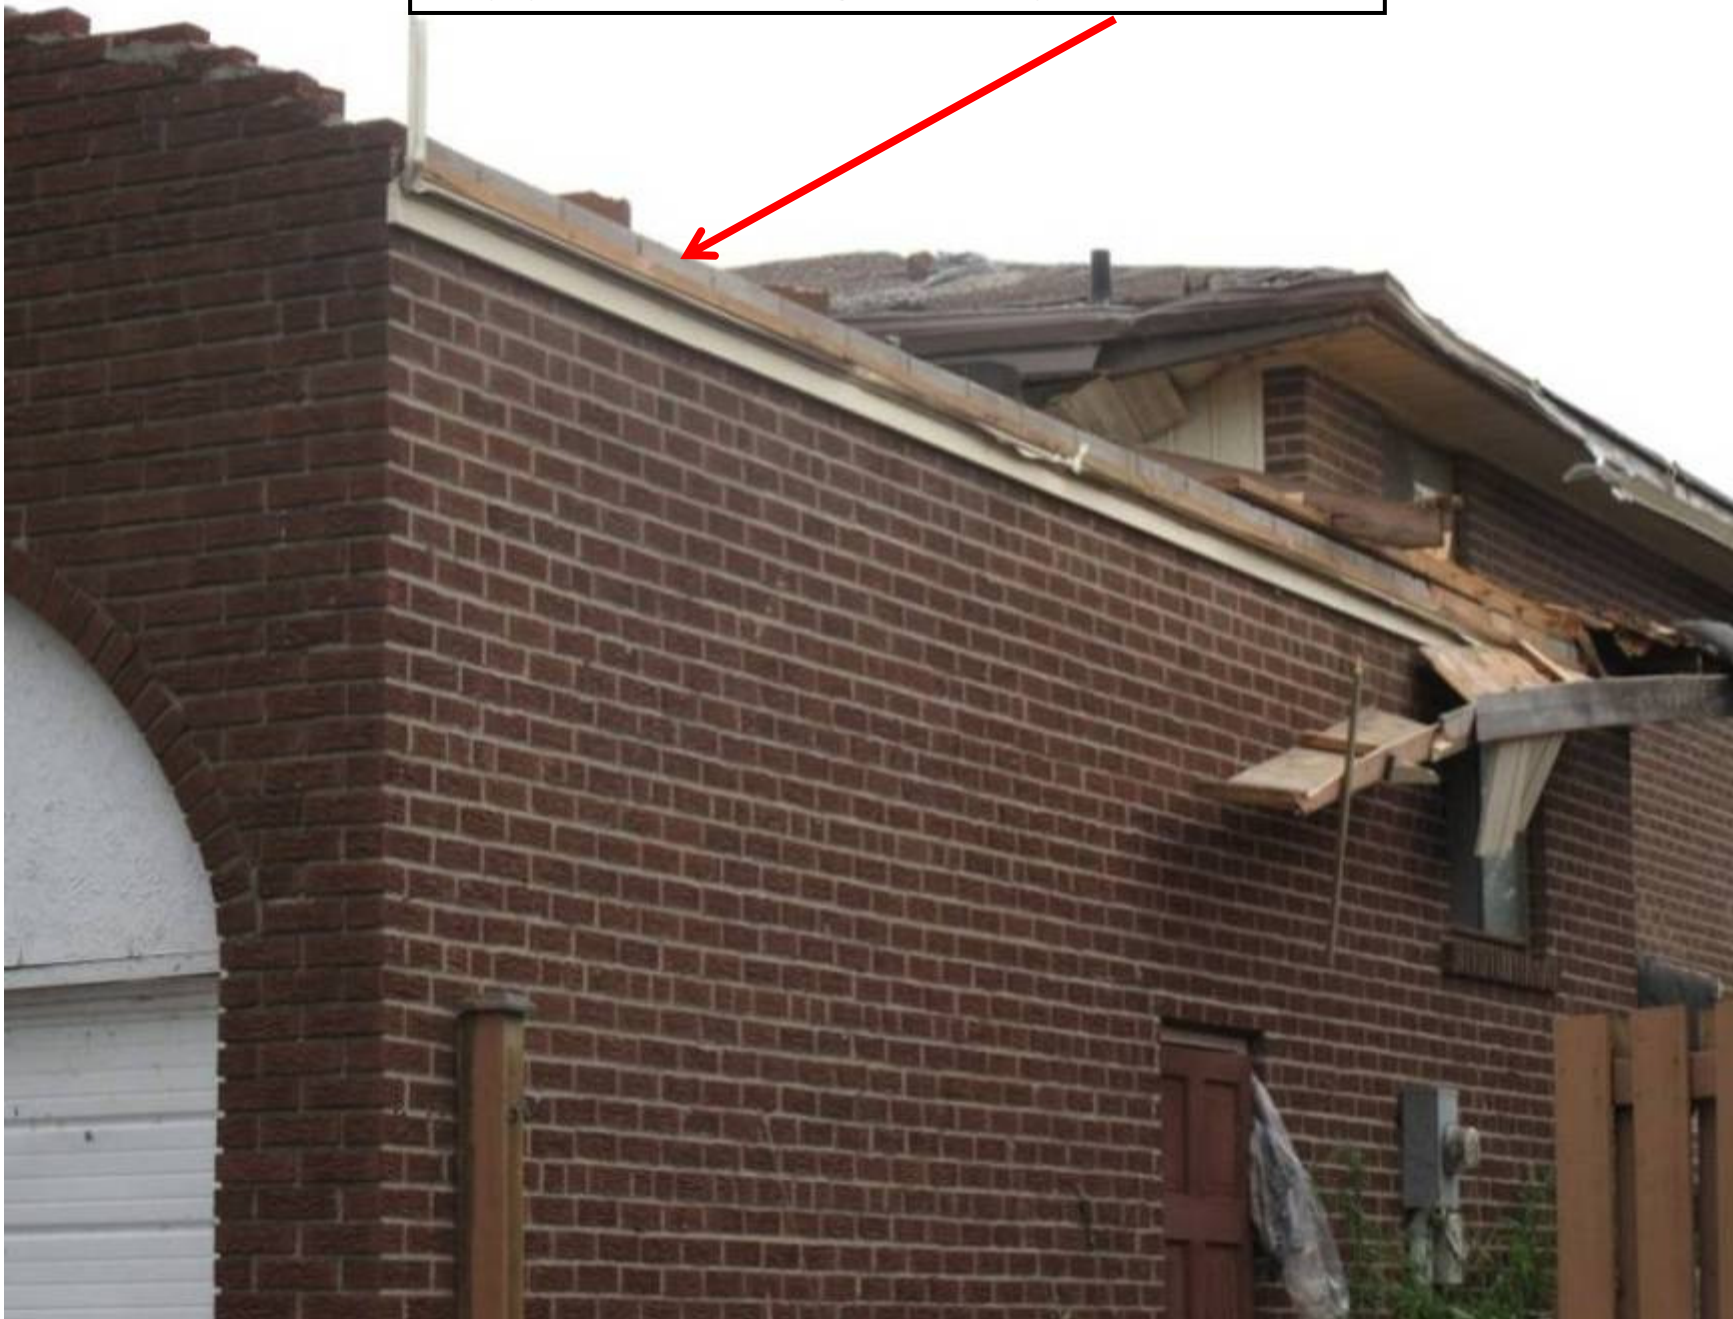
Top plate is missing from top row of blocks

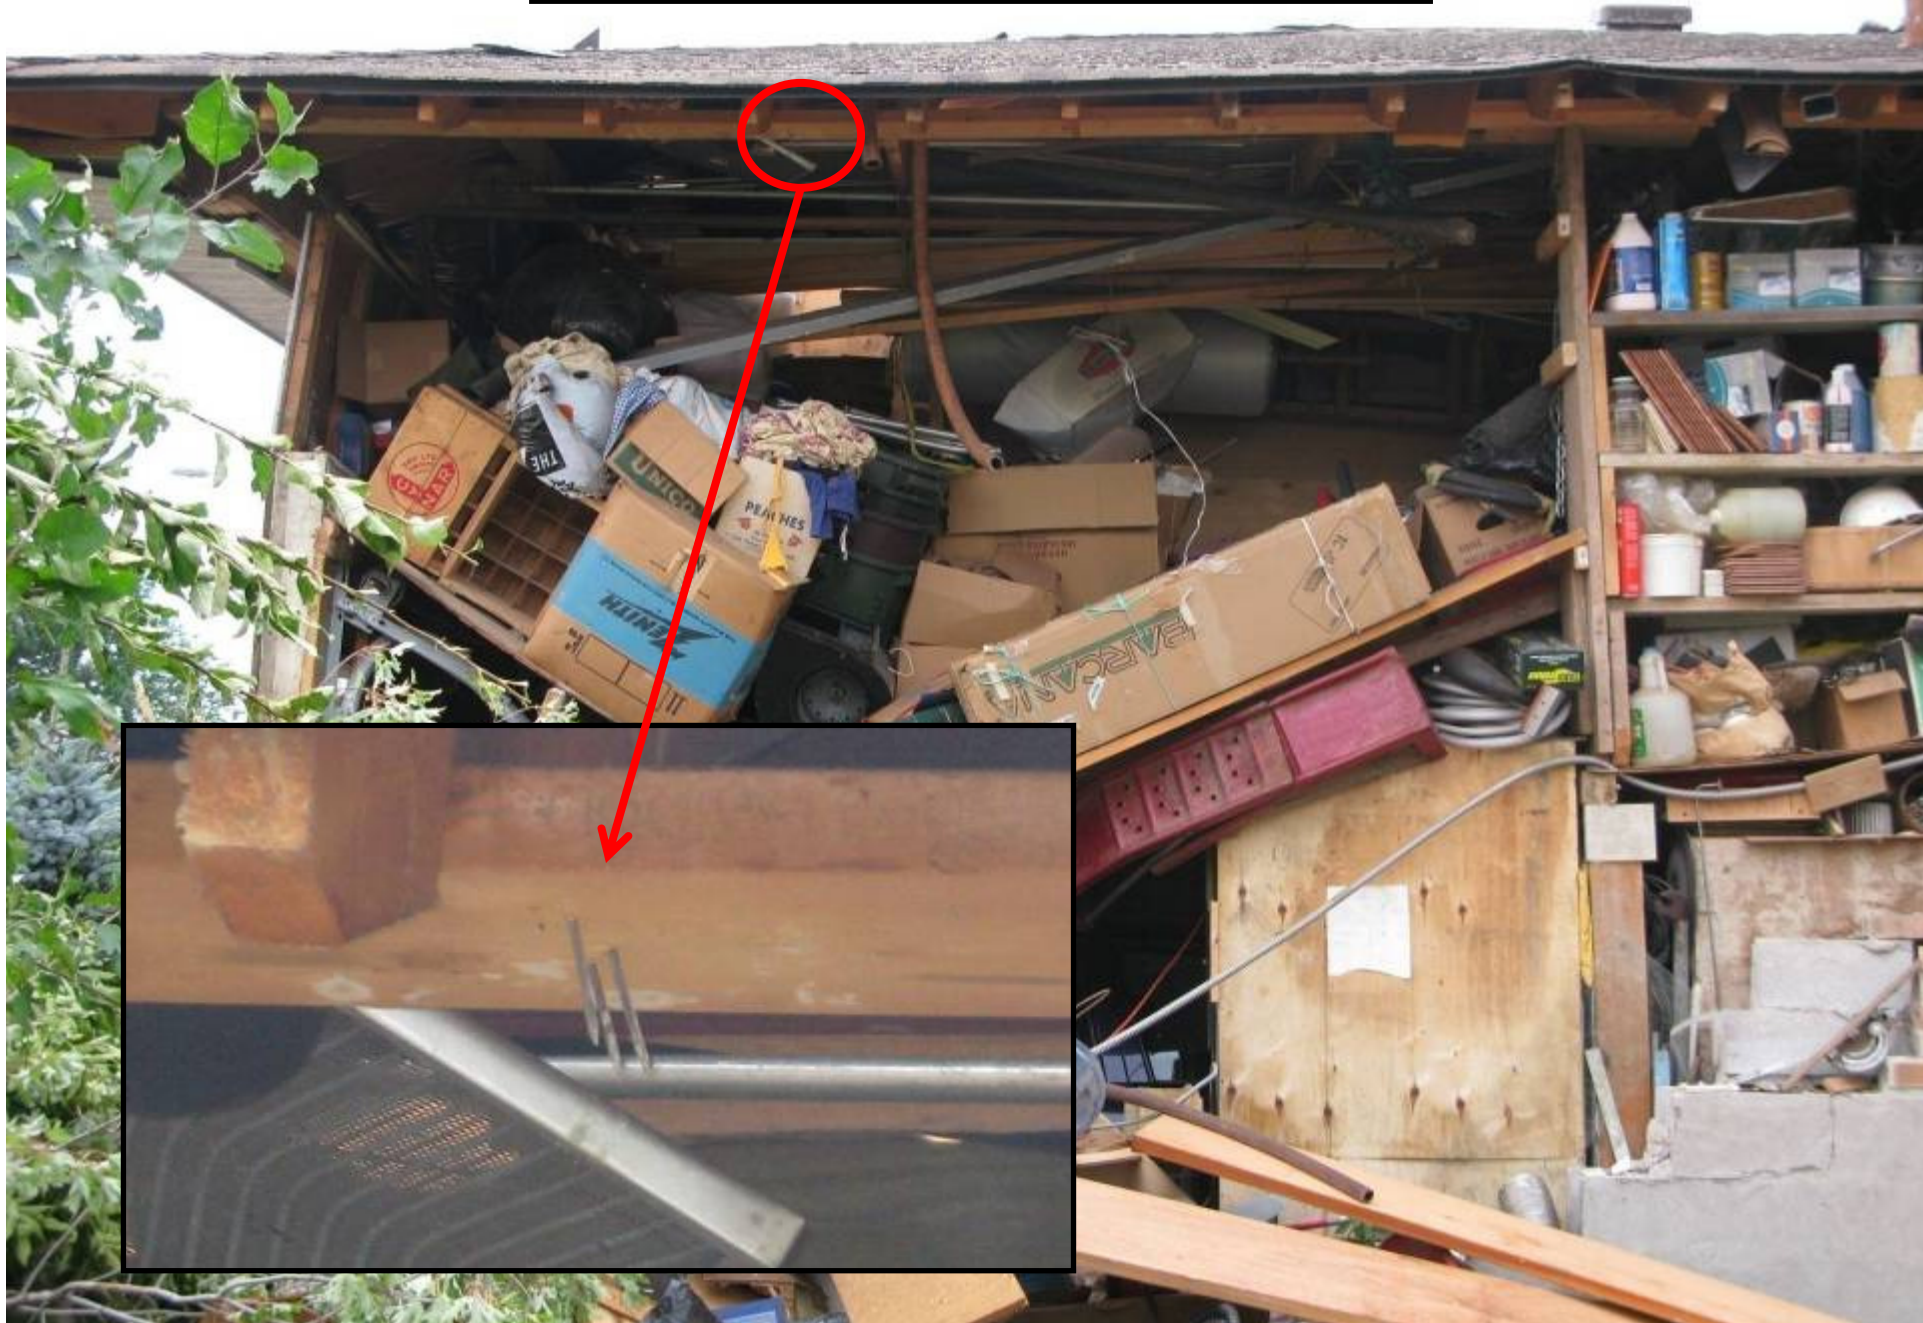
Roof likely lifted and wall fell outwards

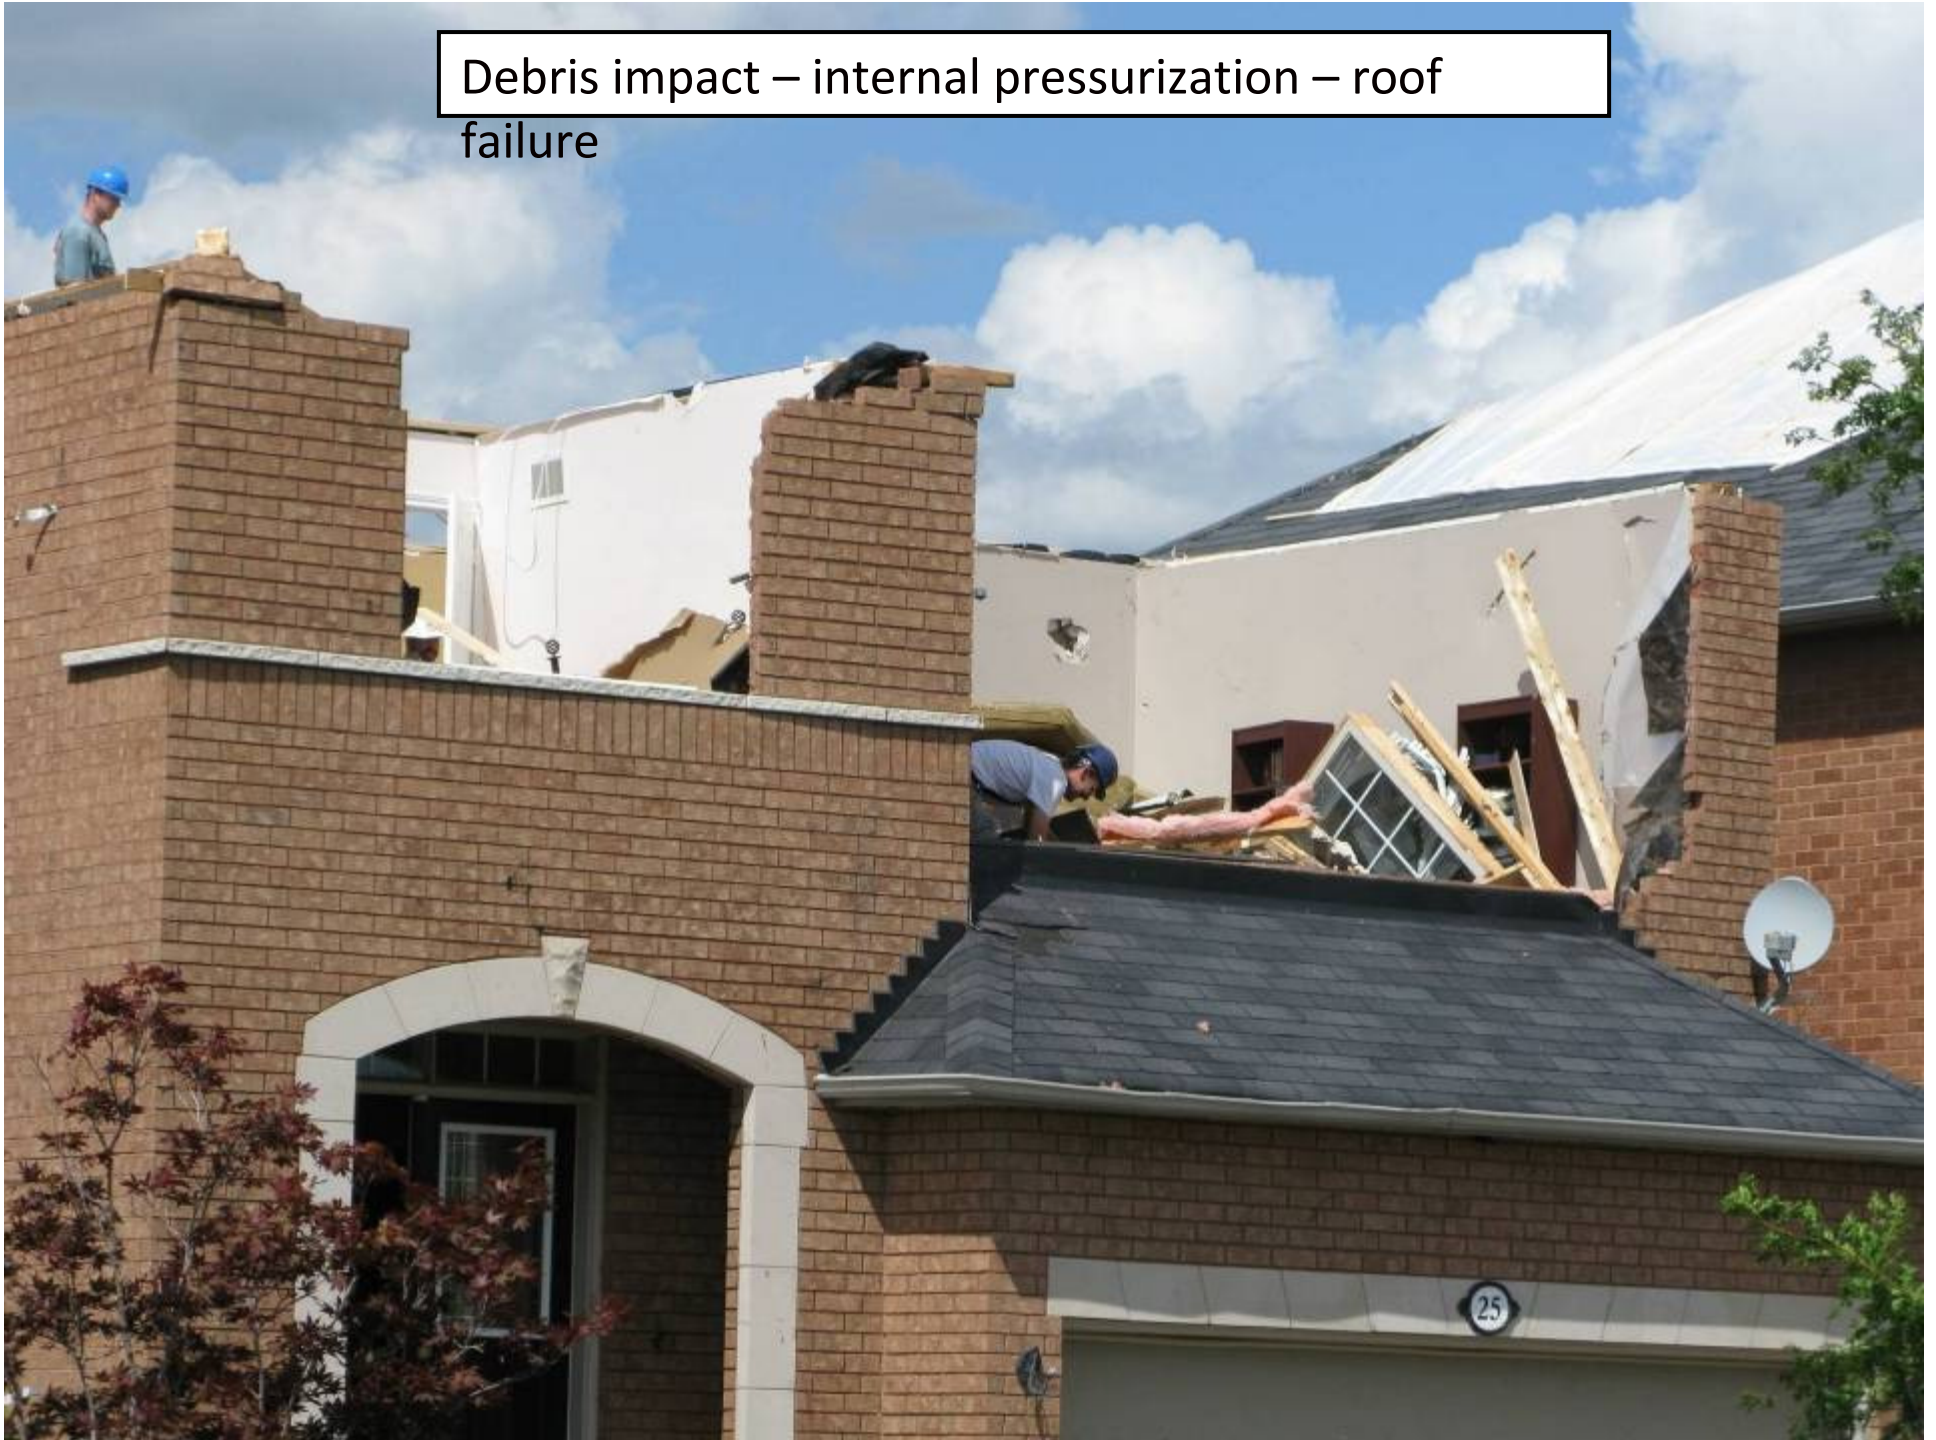
Debris impact – internal pressurization – roof failure

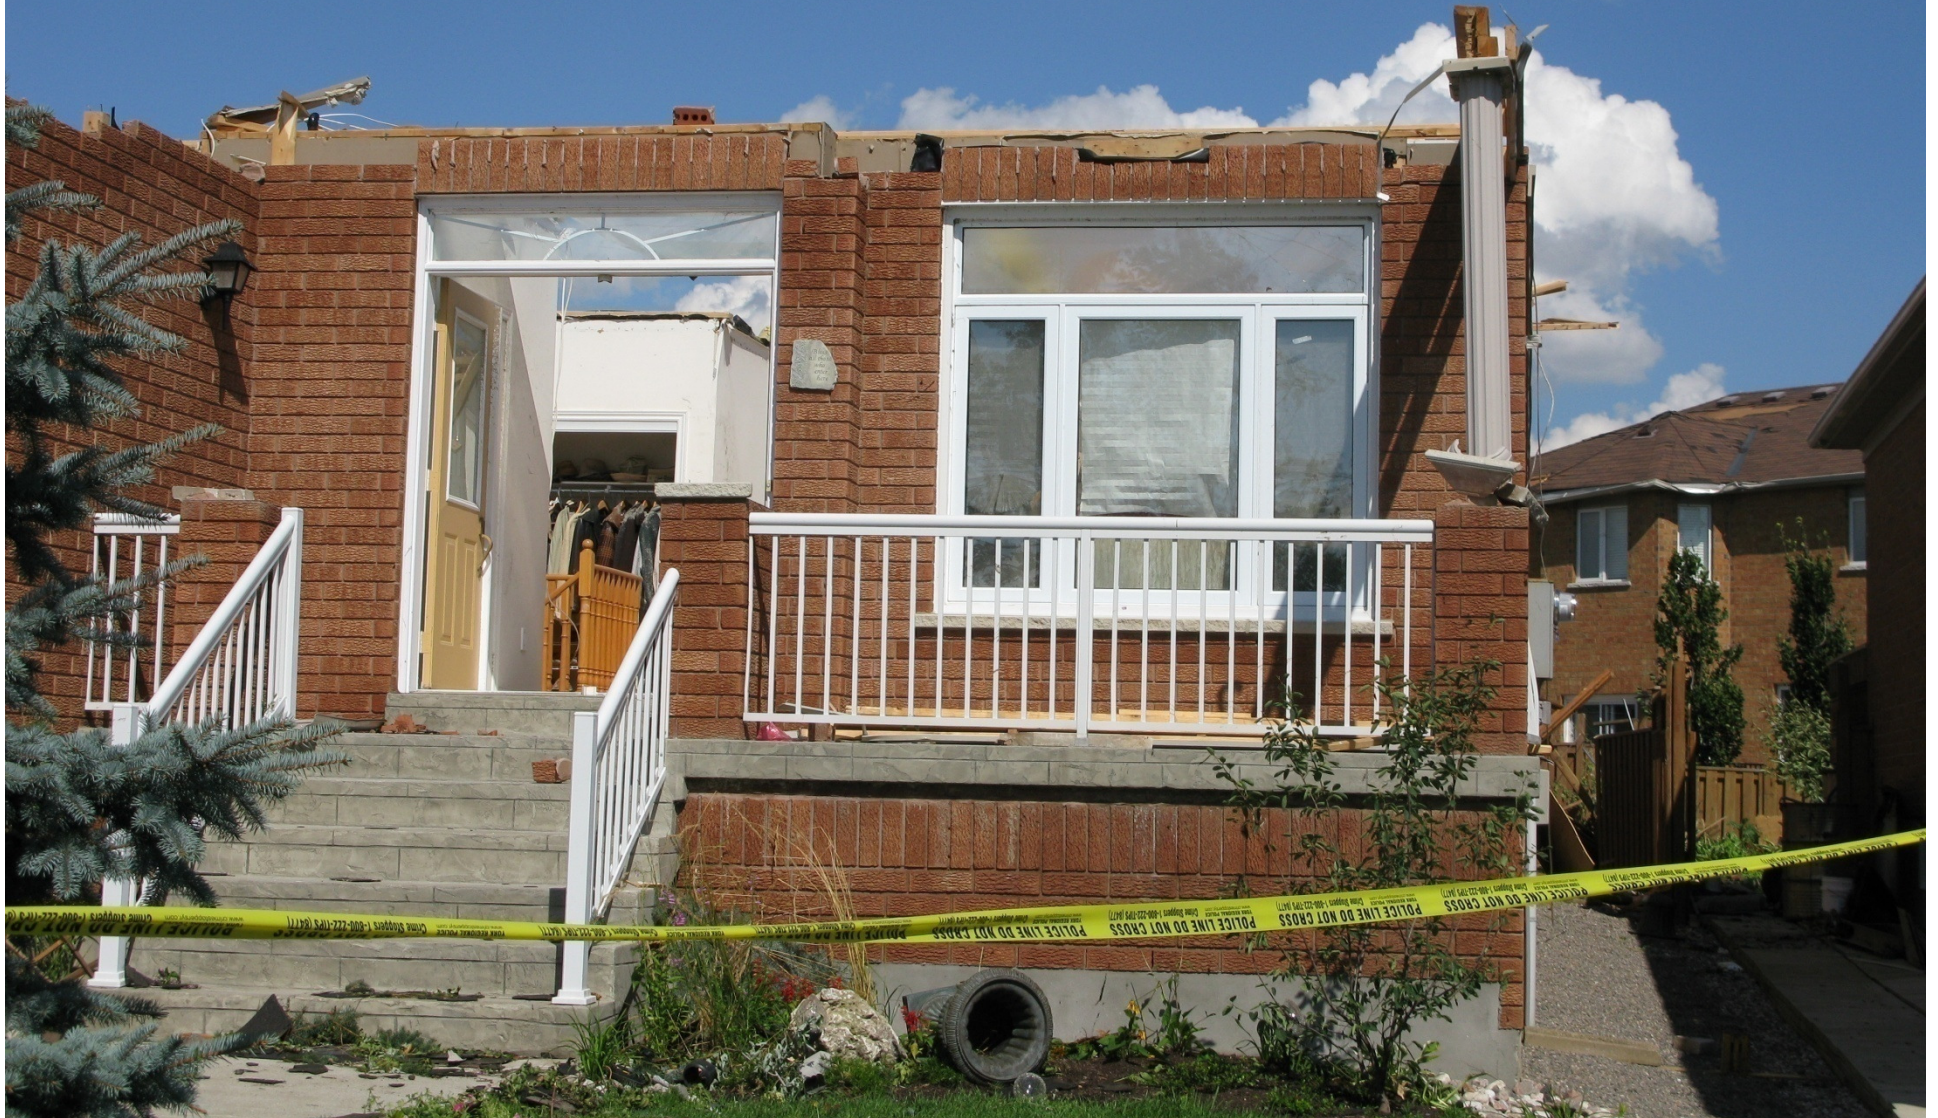
Debris impact – internal pressurization – roof failure ??
This one, we are not sure about - it could have been that the double doors blew in...

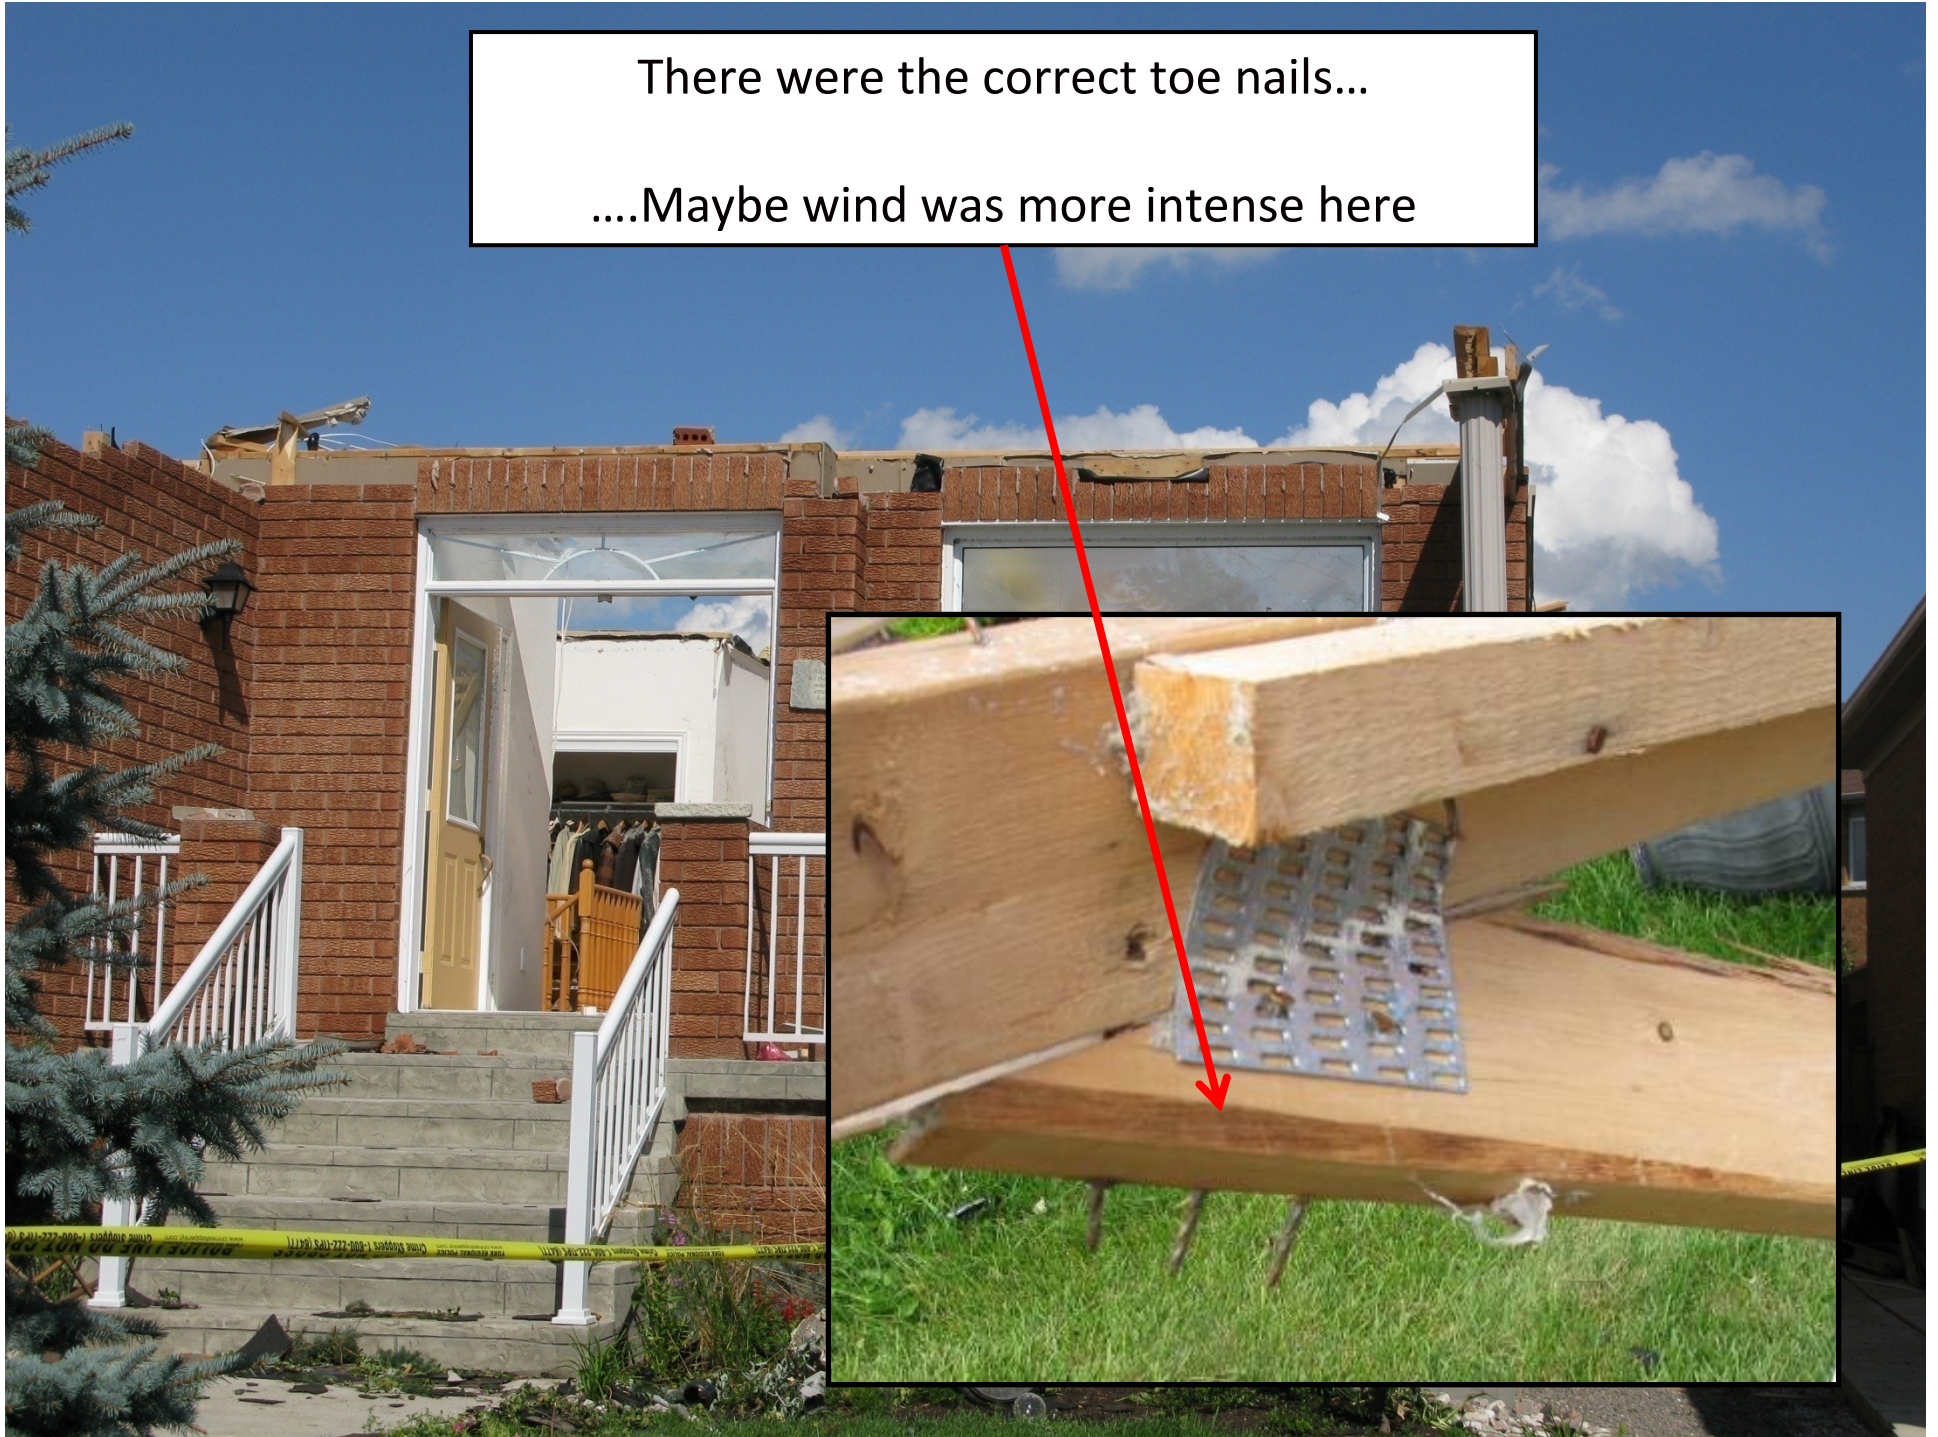
There were the correct toe nails...
...Maybe wind was more intense here

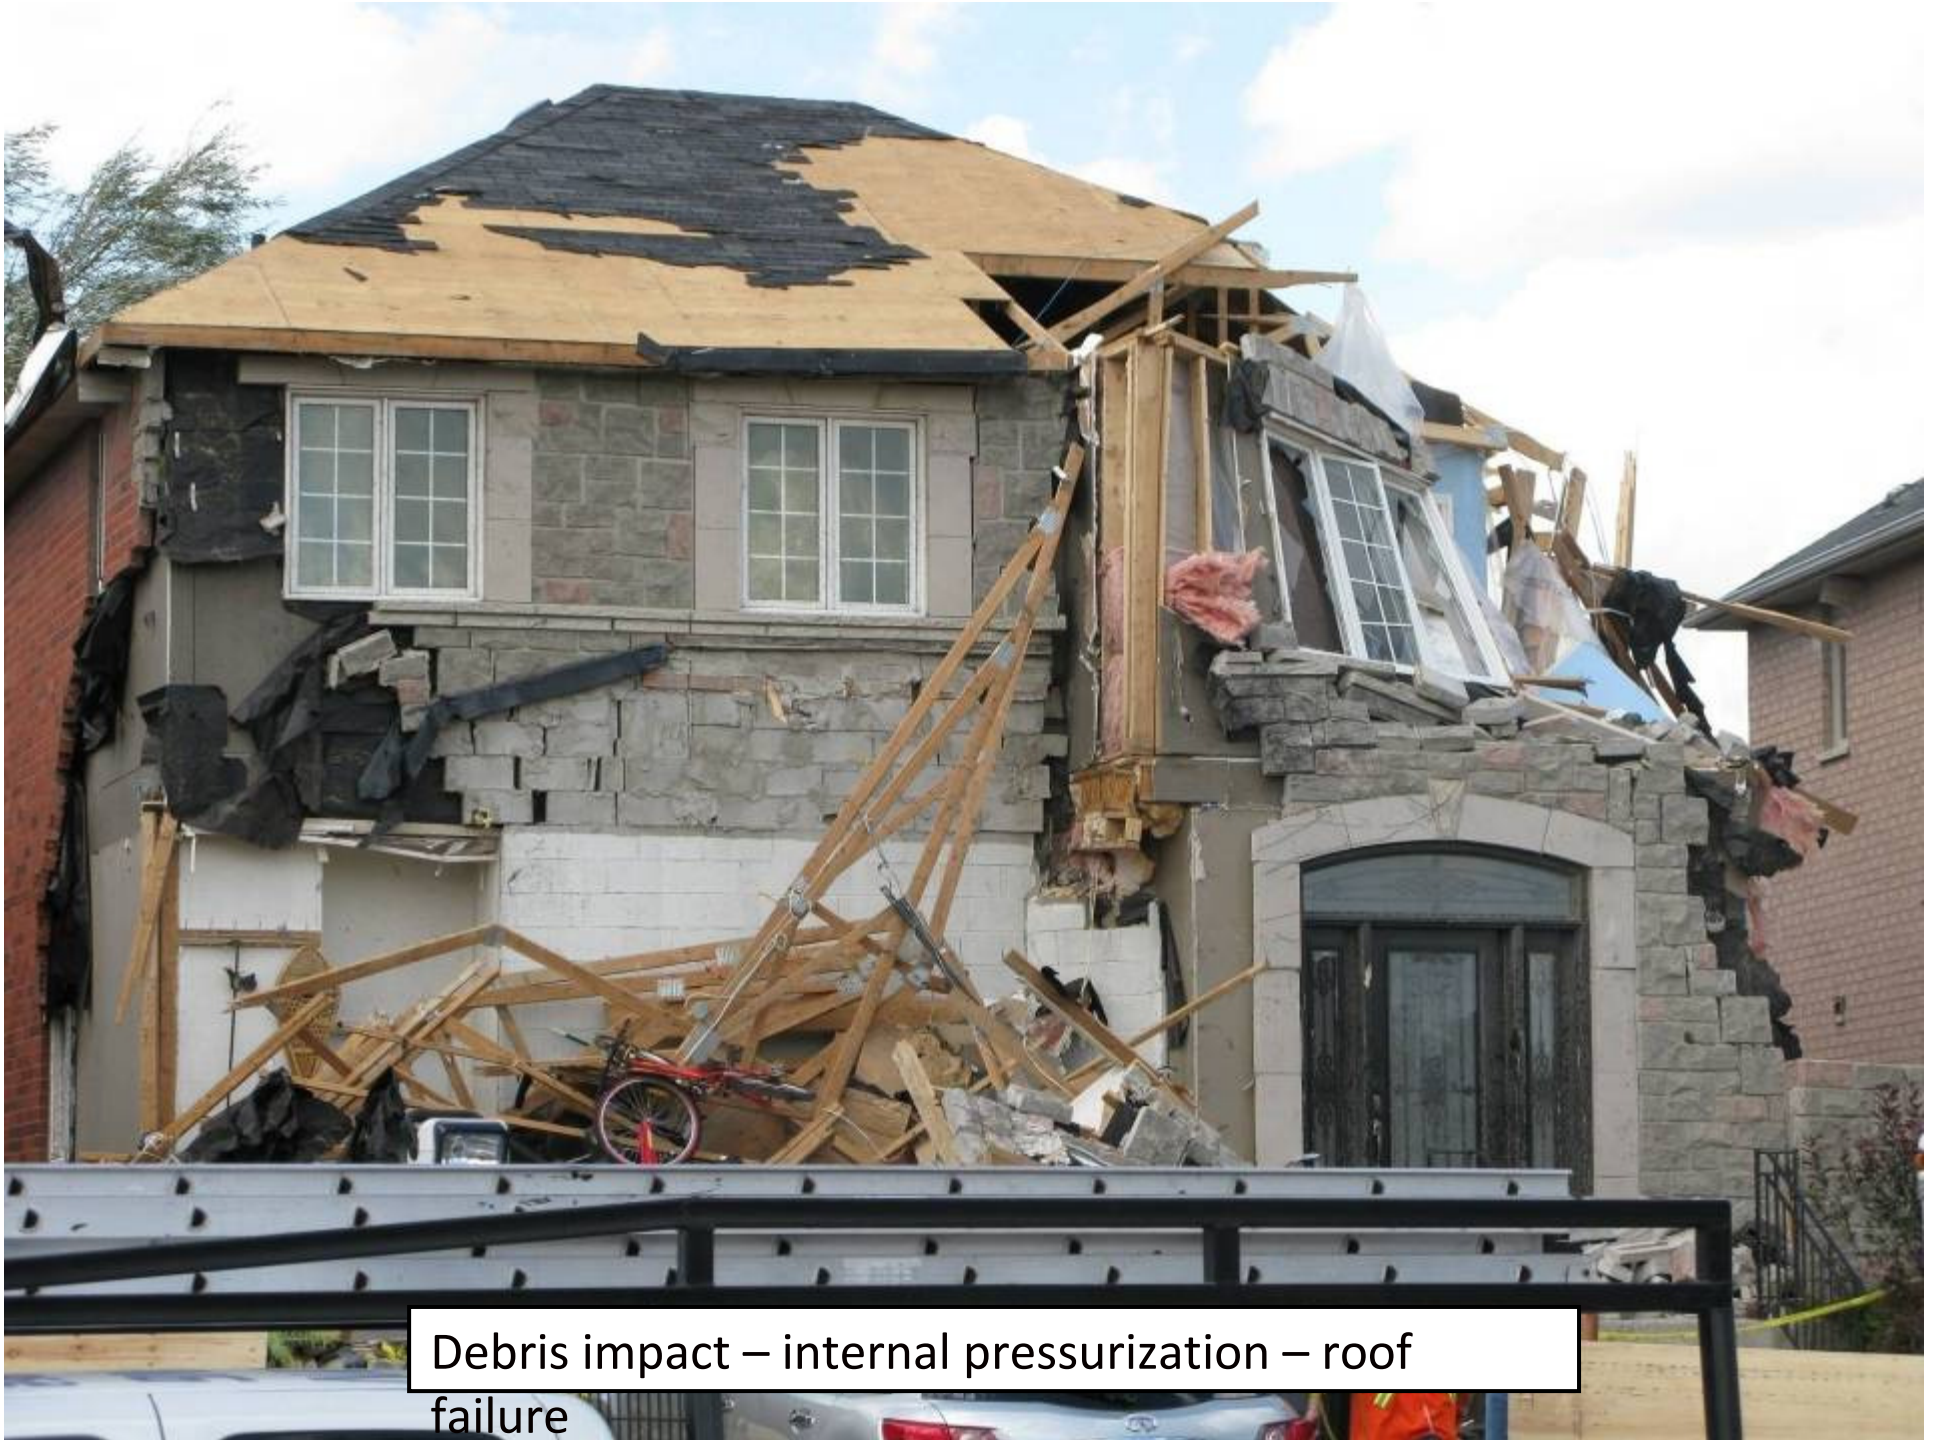
Debris impact – internal pressurization – roof failure

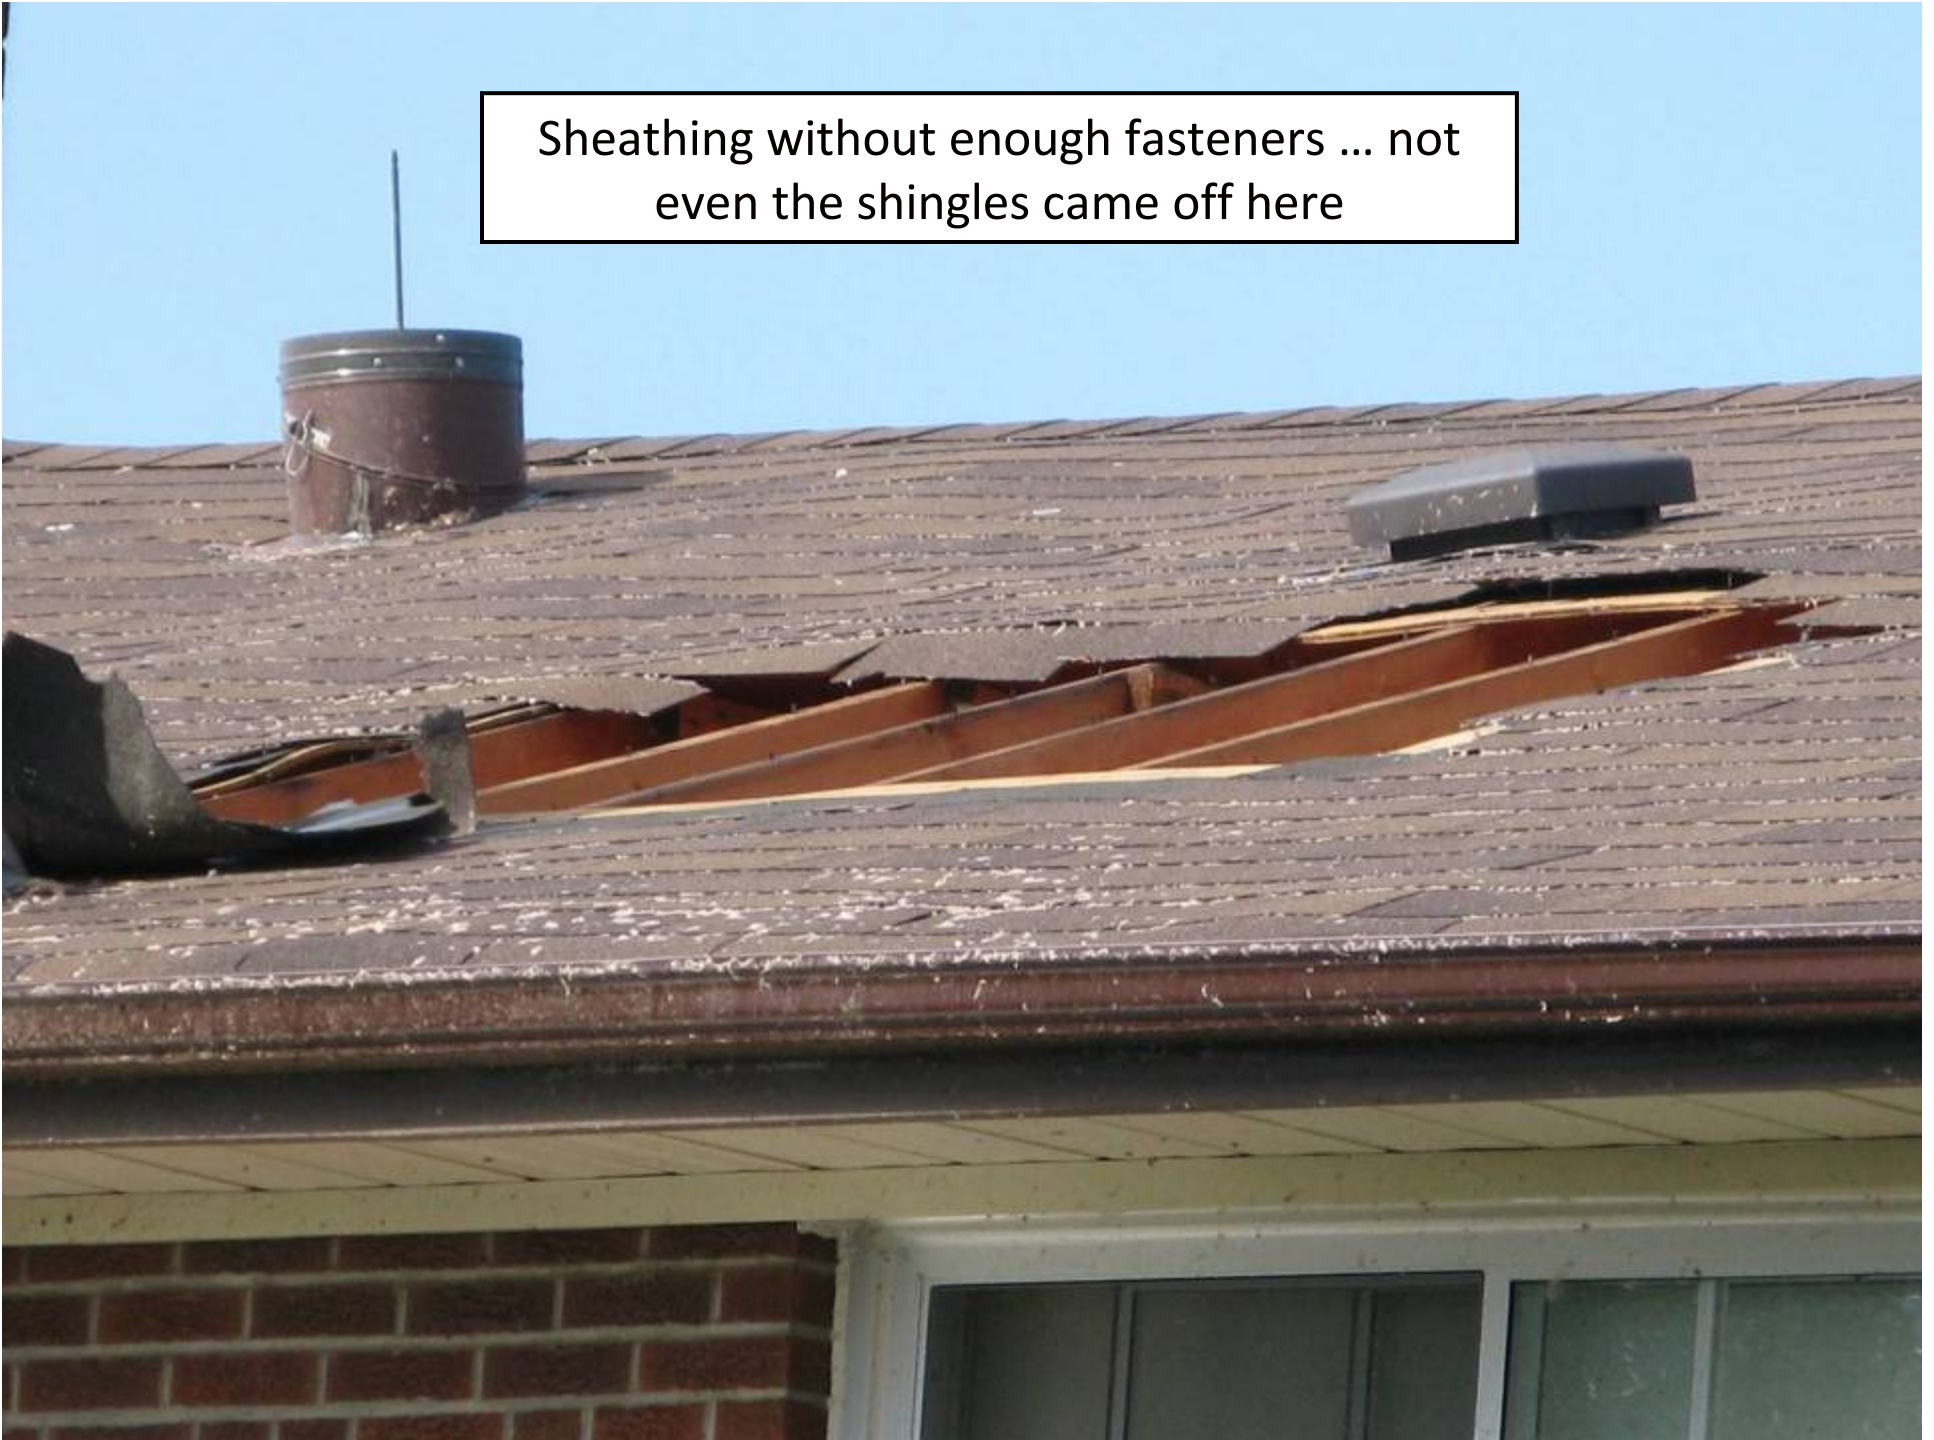
Sheathing without enough fasteners ... not even the shingles came off here
