Damage Observations from the Vaughan Tornadoes of August 20, 2009

Gregory Kopp

Faculty of Engineering, University of Western Ontario

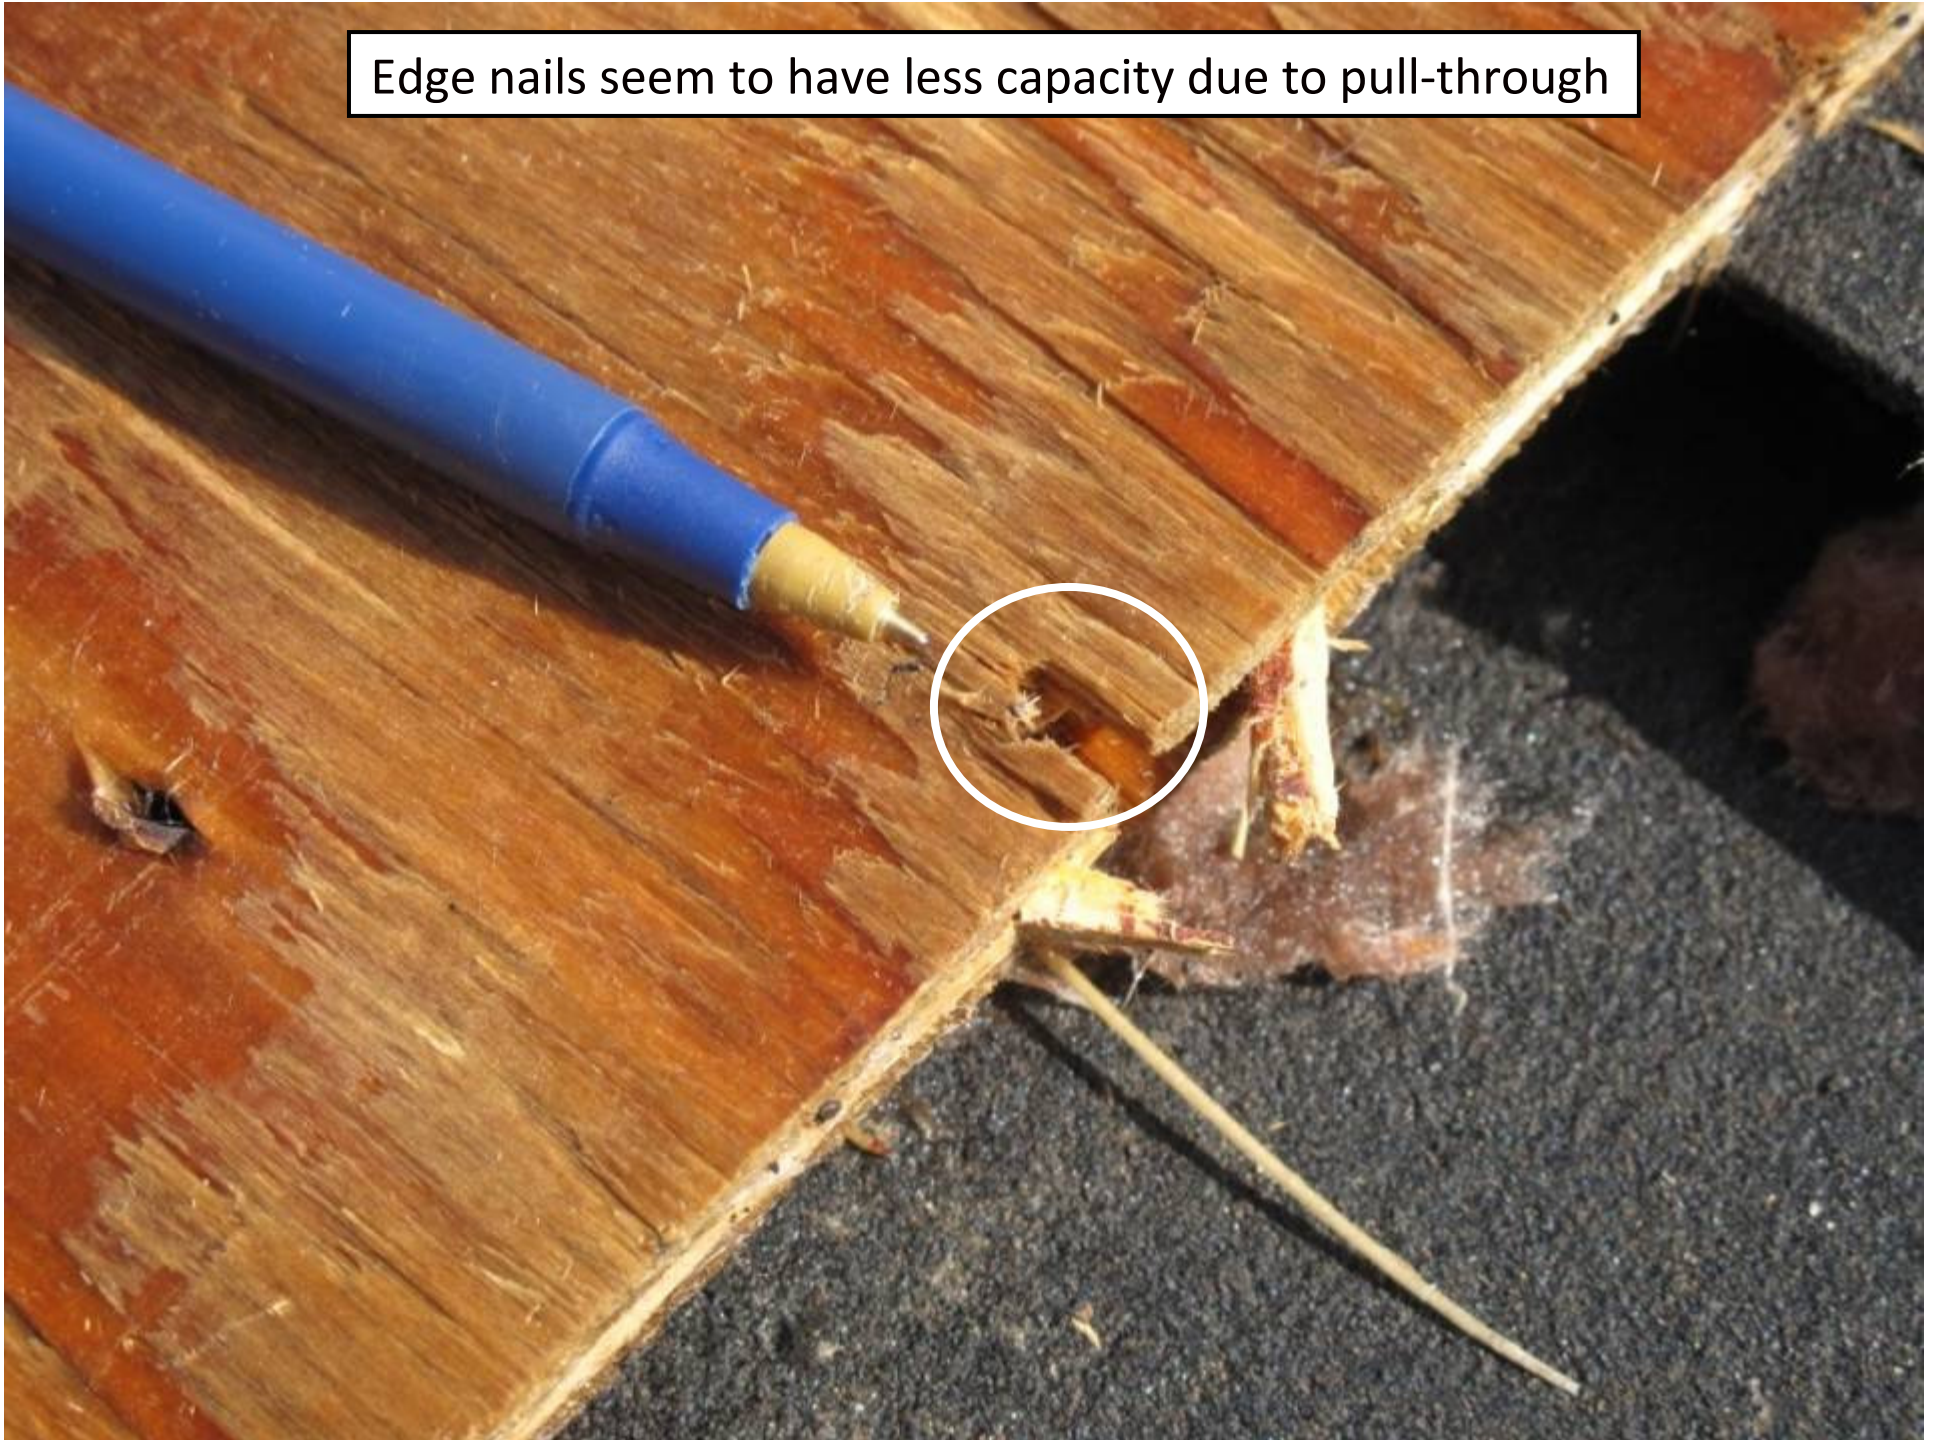
Edge nails seem to have less capacity due to pull-through

Sheathing remains a problem...a new observation is that the end nails may have lower capacity. This needs further examination.

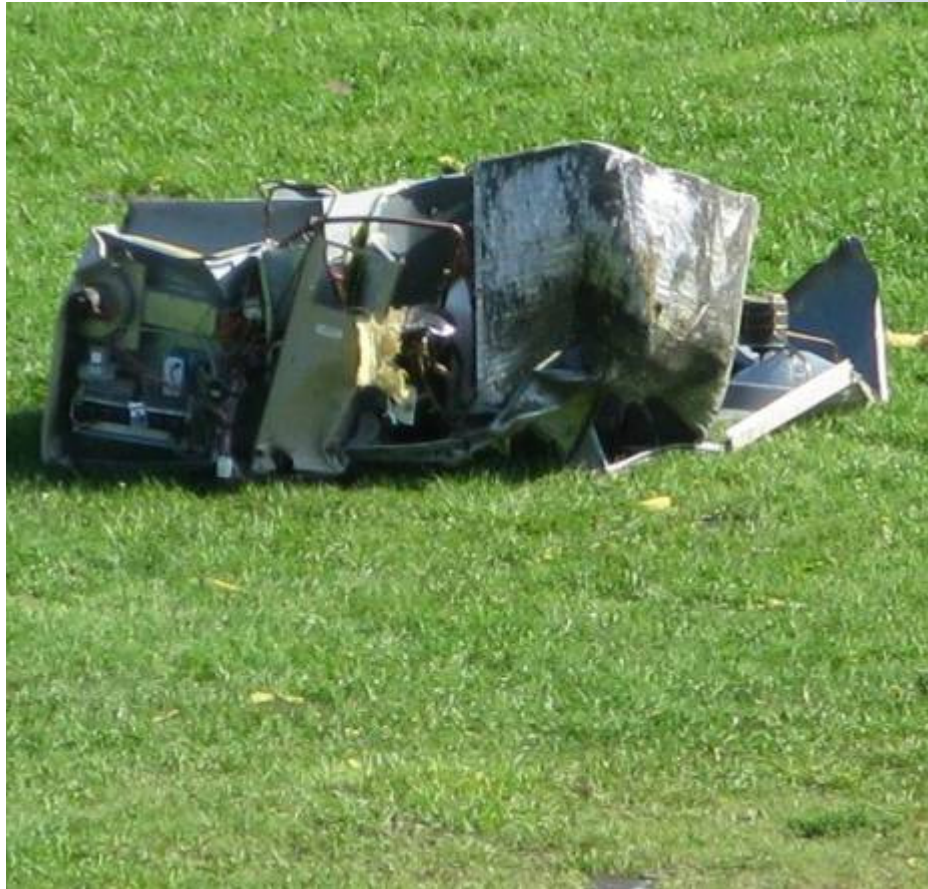
This air conditioner unit travelled 70m

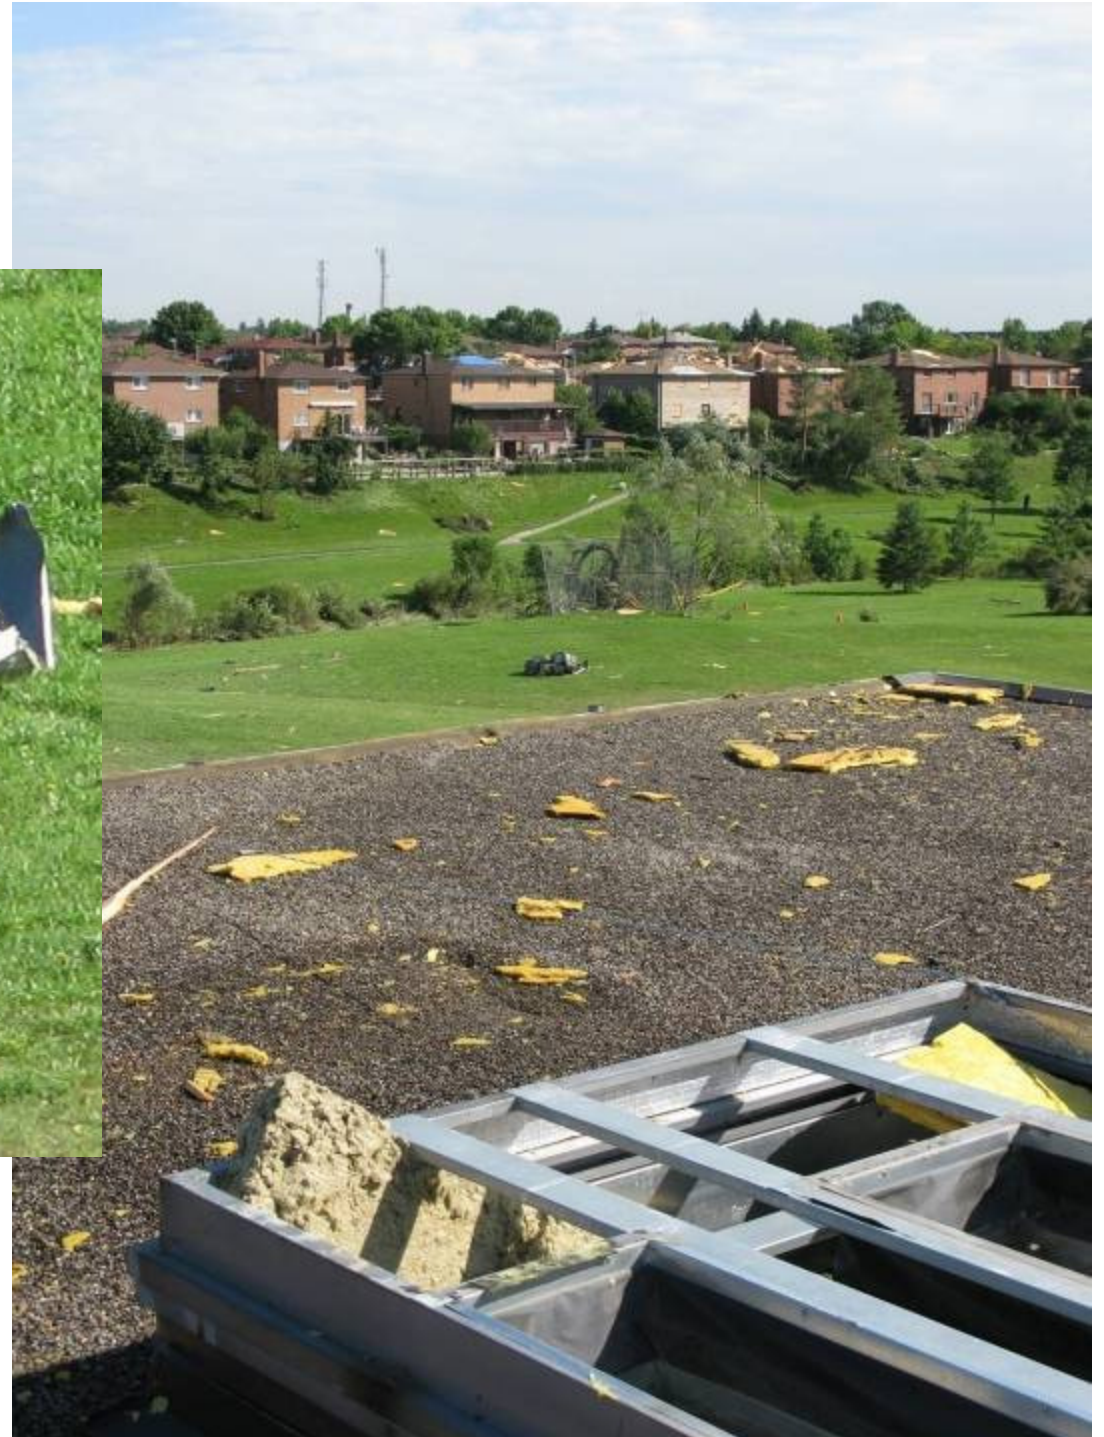
Nothing was holding them down... except their own weight
