Some Observations from Recent Chile Earthquake

H. P. Hong
Dept. of Civil & Environmental Eng.
University of Western Ontario
London, Ontario, Canada
Hongh@eng.uwo.ca

The Event: Chile earthquake

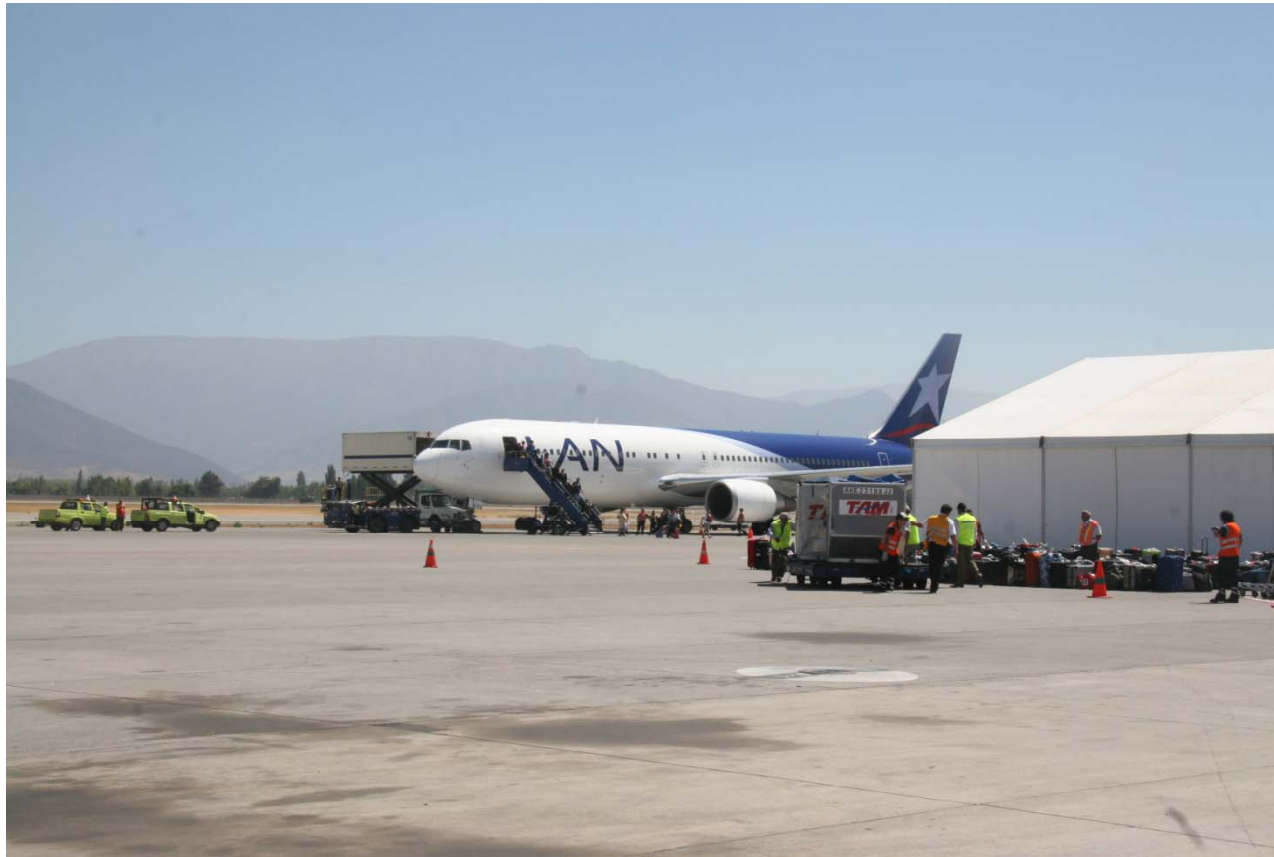
The first impression is that things are not extremely bad, at least, airport is open although the terminals are closed and a temporary tent and laptops are used by officers (March 8, 2010). Certainly, there is business interruption cost associated with it.

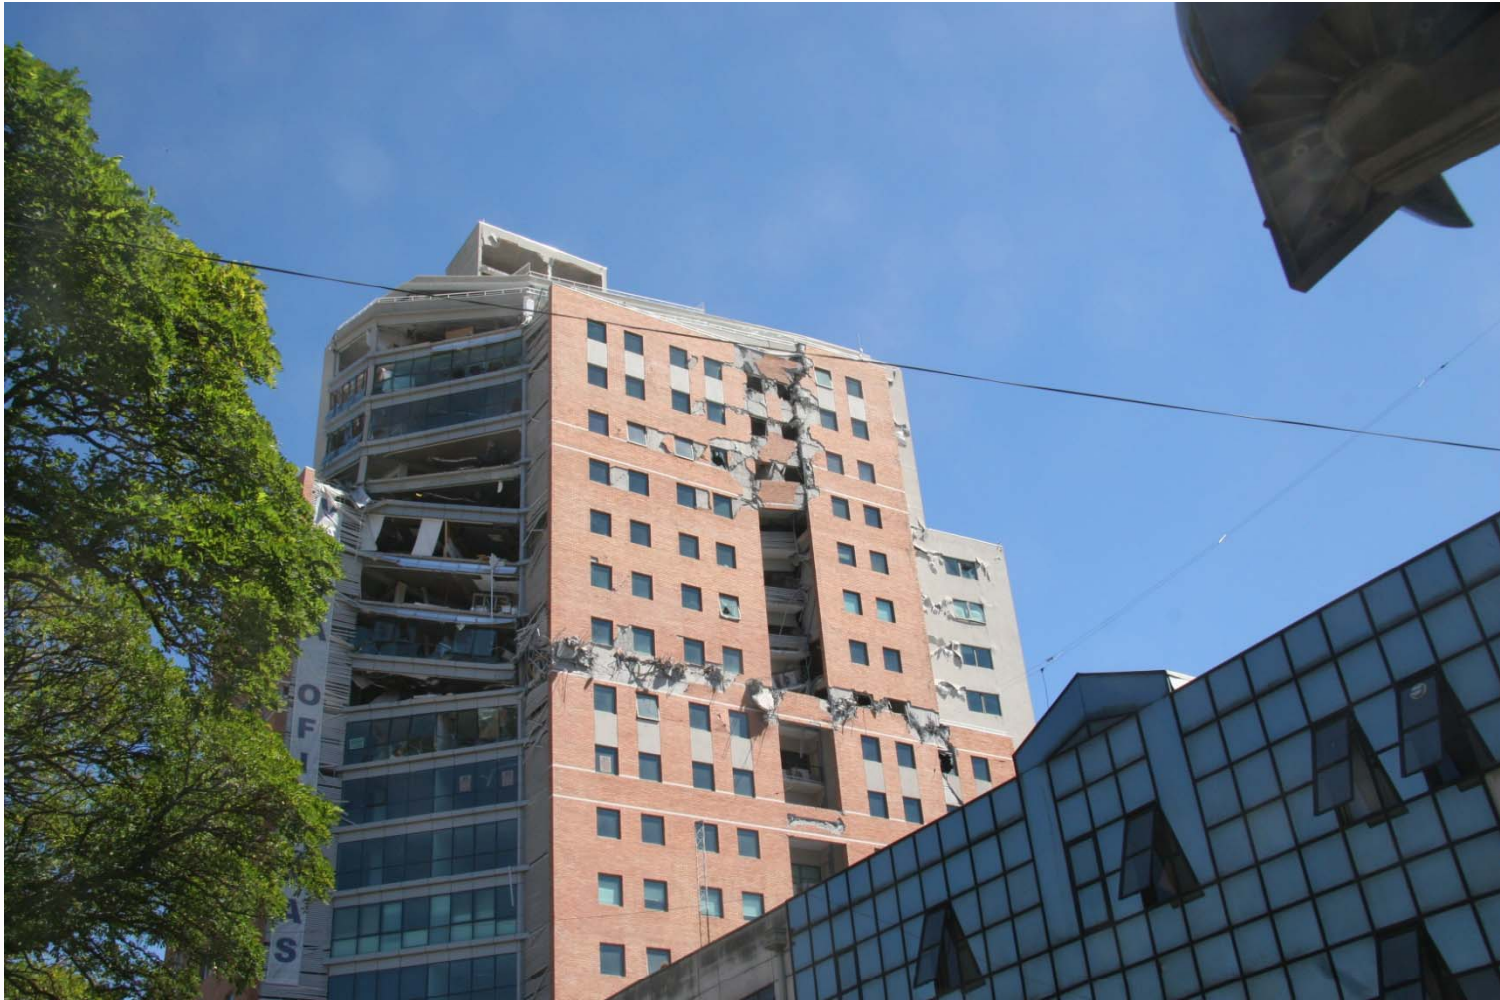
A building in Concepcion: Interstory collapse and will be demolished.

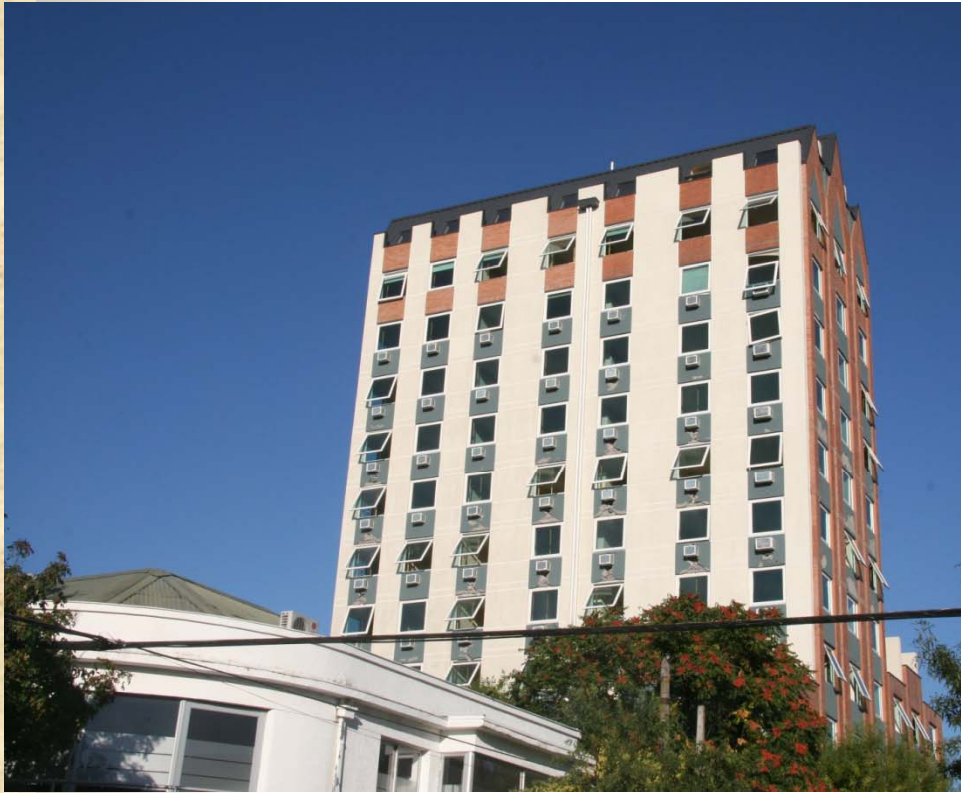
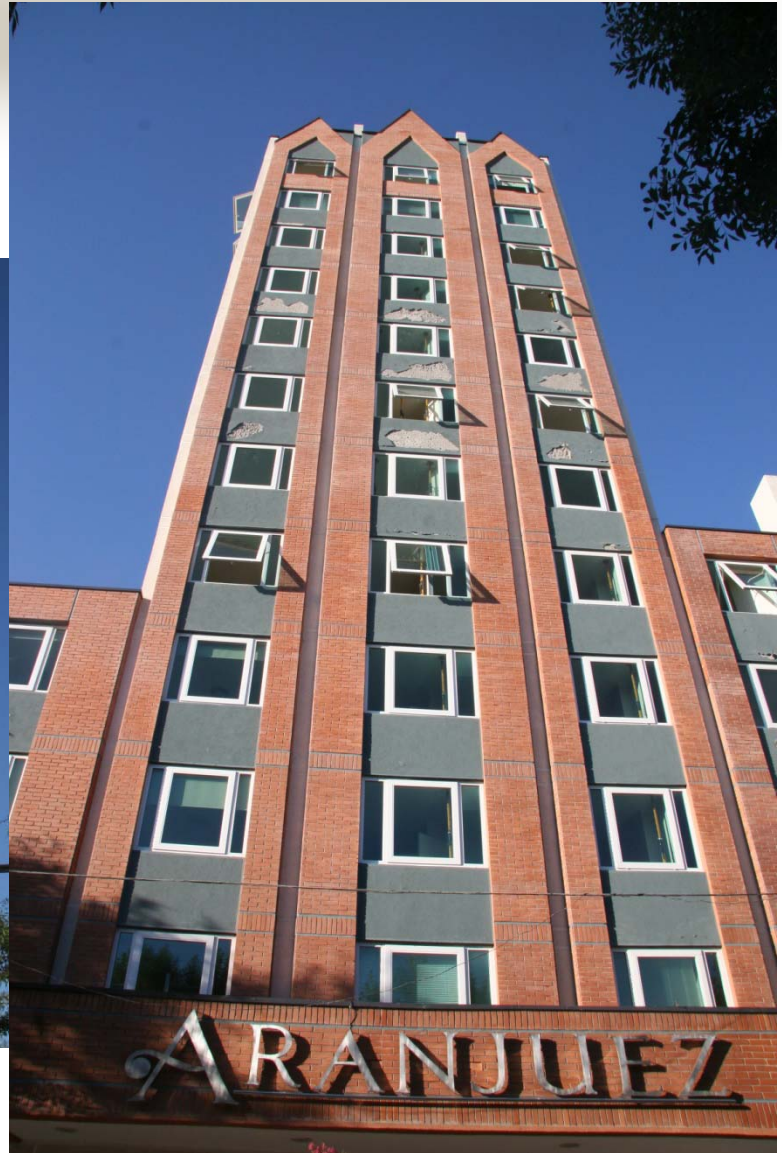
Partial damage. Possible consequences

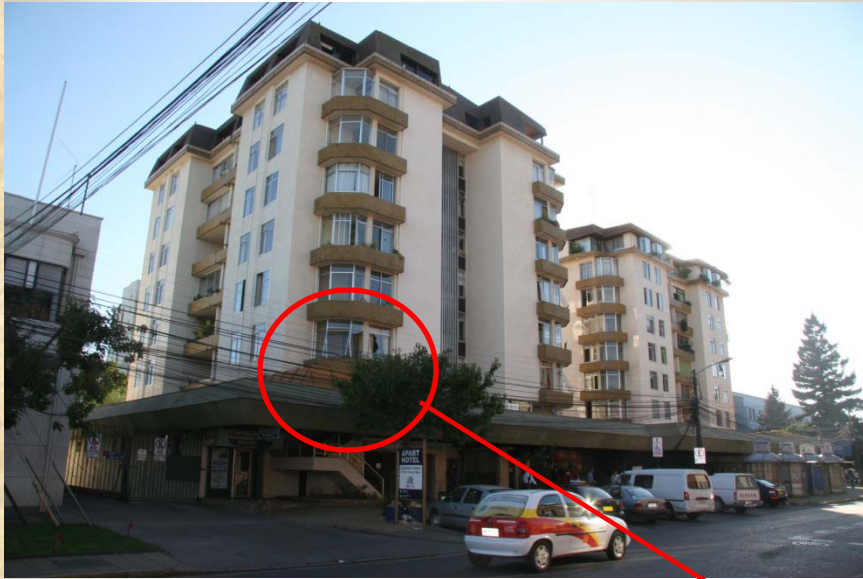
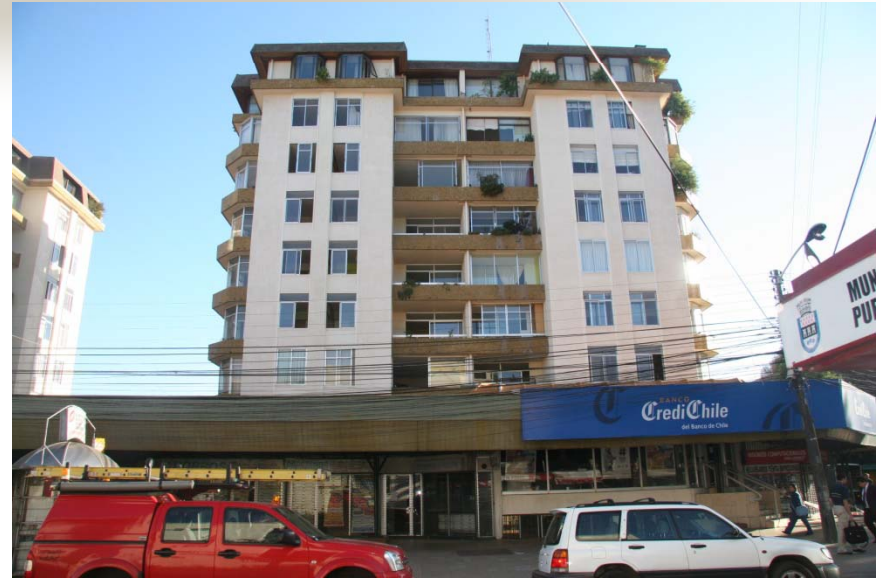
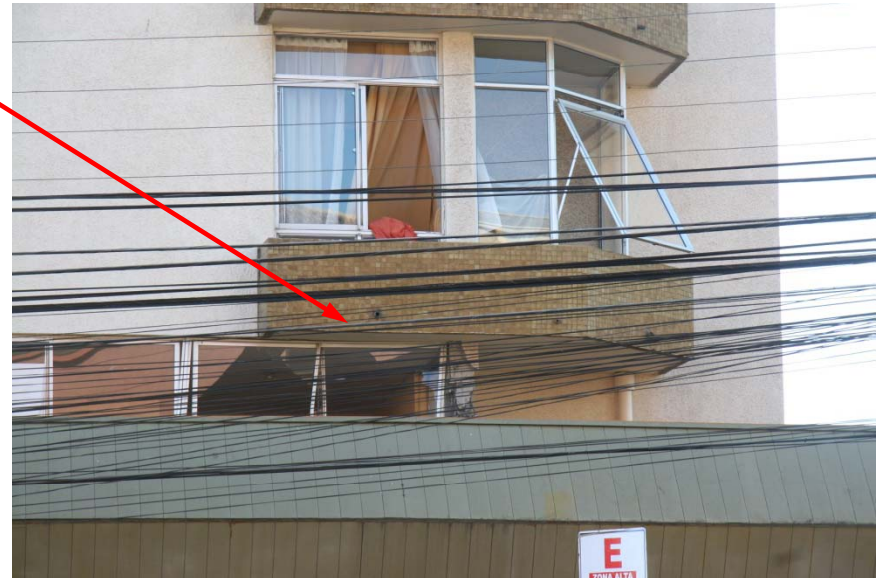
A damaged building in Chillan

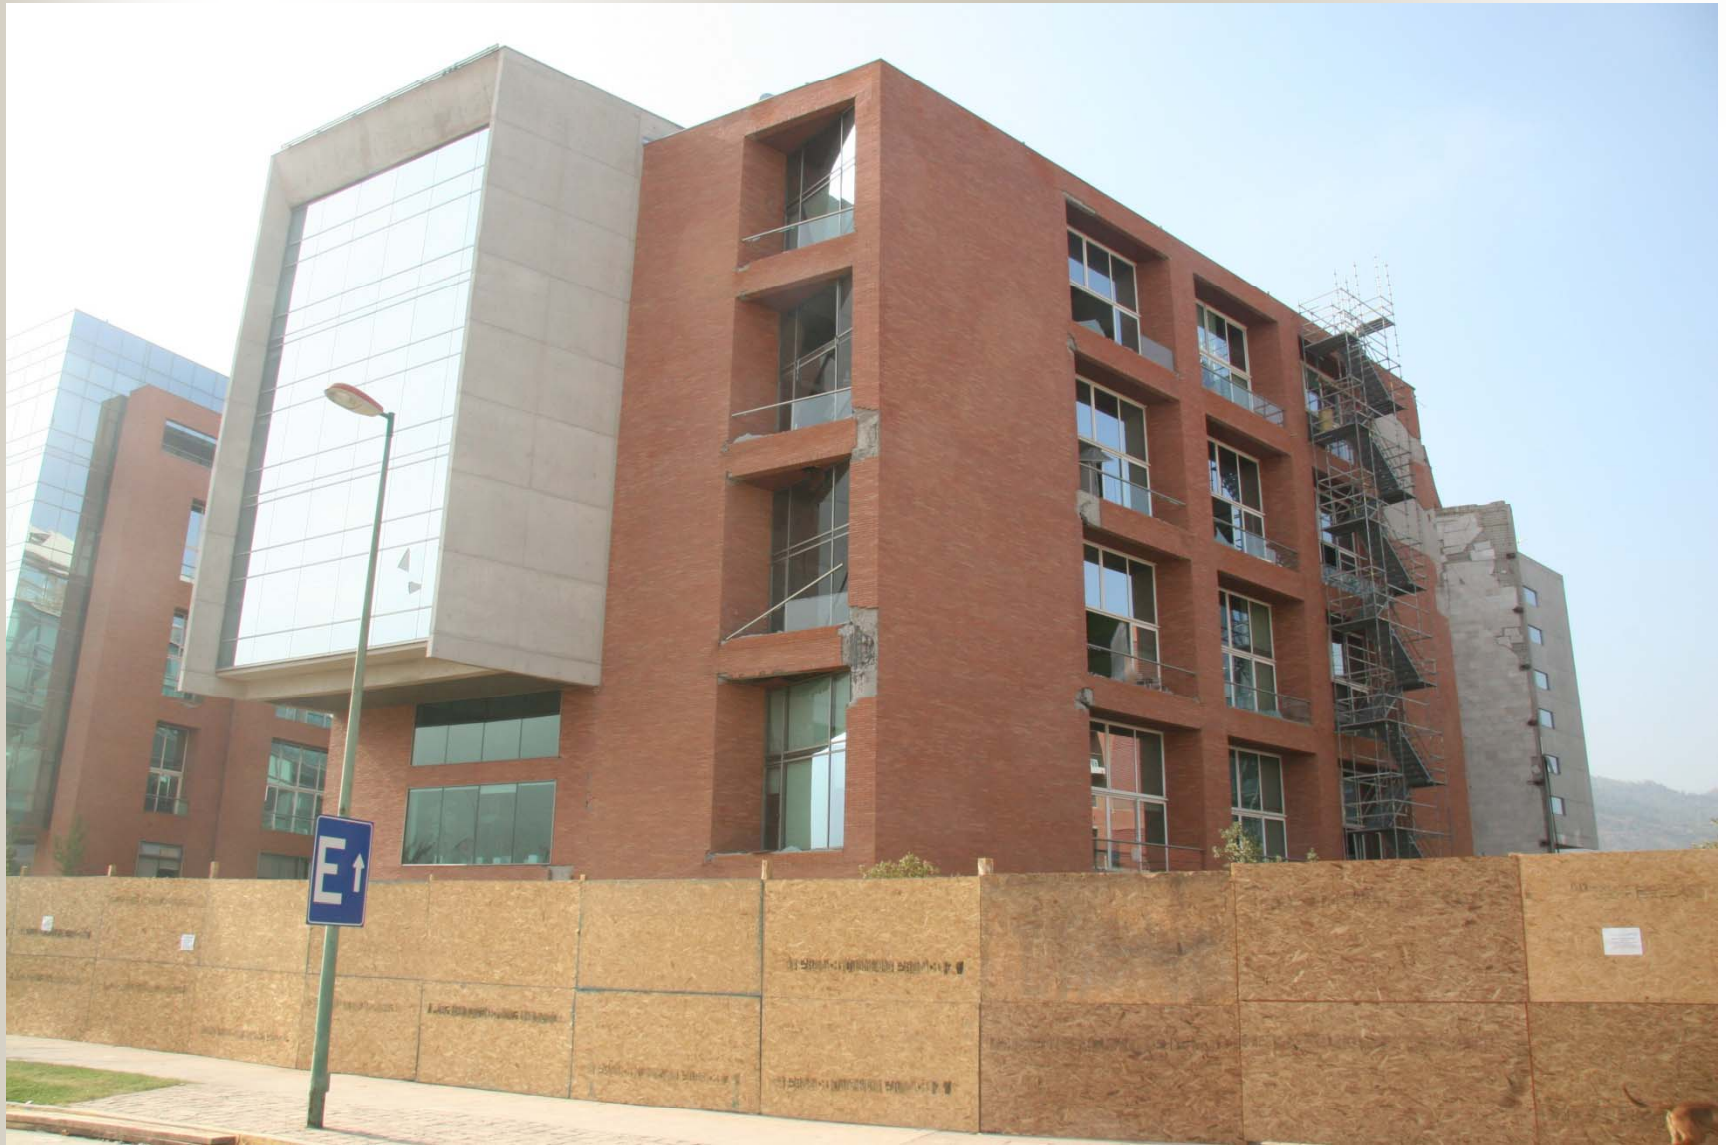
Twin buildings: the damage in one is more significant than the other (Chillan)

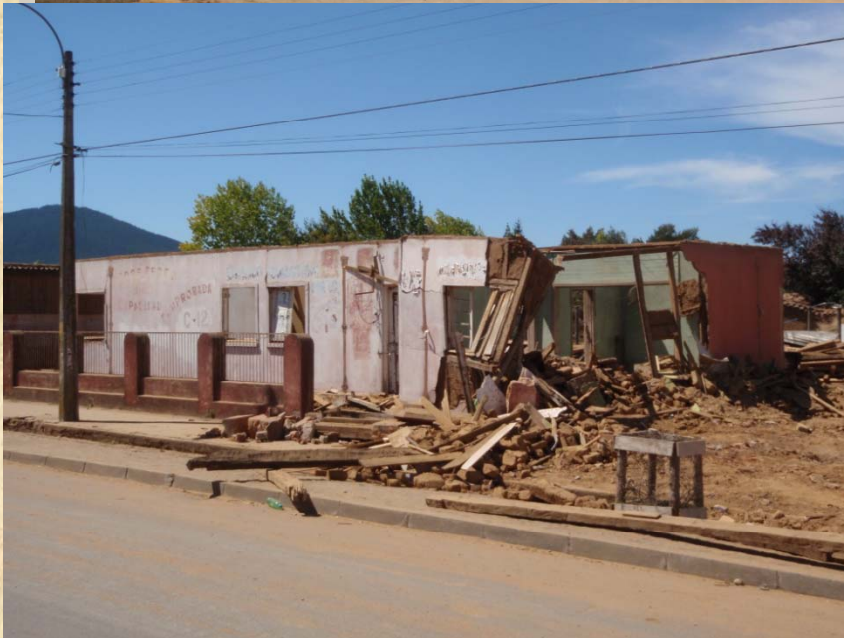
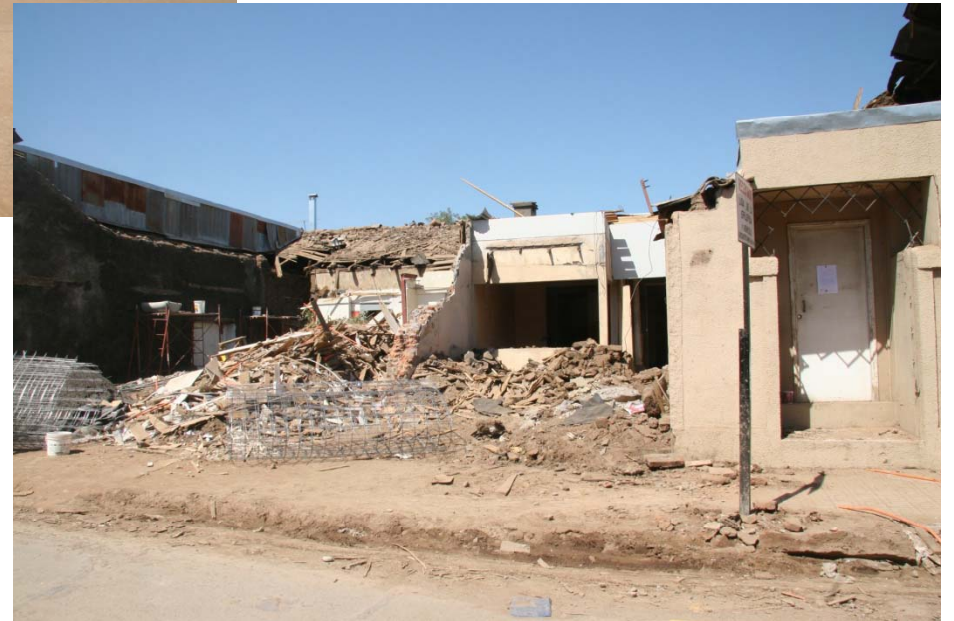
Adobe constructions

- **Unreinforced adobe houses should not be used or strengthened in the seismic region to minimize the seismic vulnerability.**
- **Old and new structures can be vulnerable during an earthquake**
- **Emergency education and practice for natural disasters contributes to the safety of locals, but is not effective for visitors or tourists.**
- **The rush to non-engineered repair/retrofit should be highly discouraged, even though there is a need to restore normal life.**

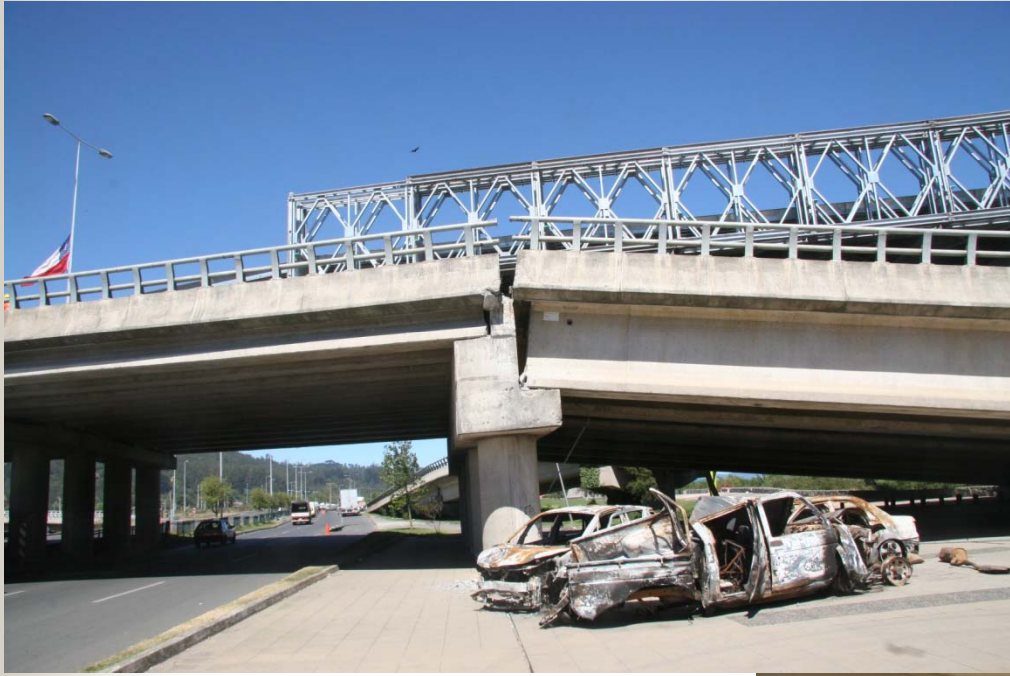
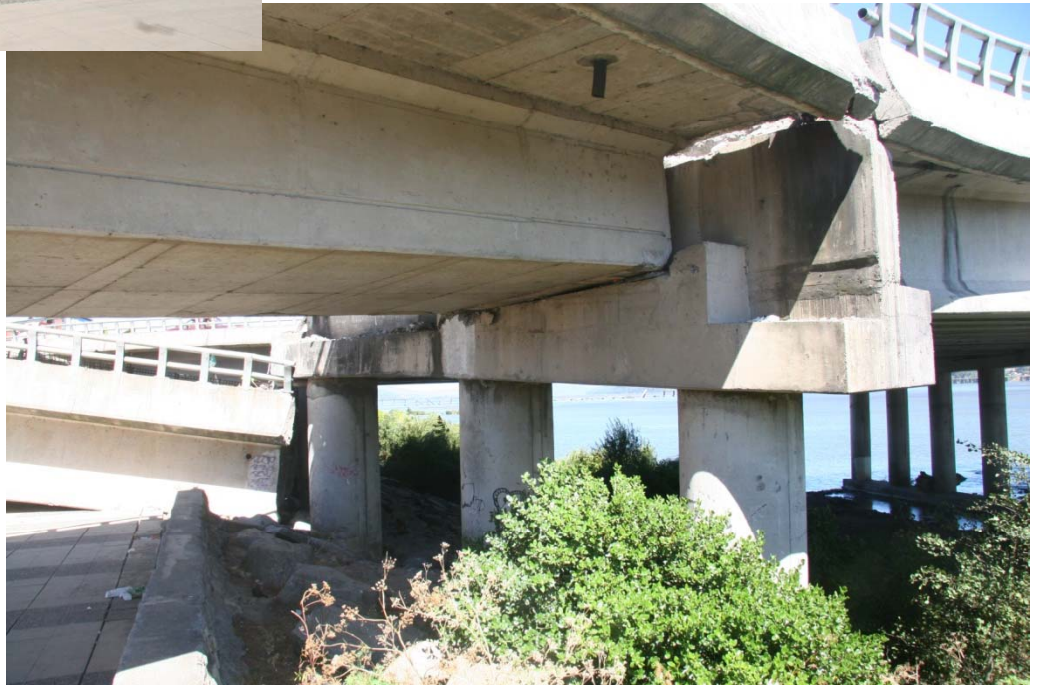
Deck unseating at Llacolén bridge

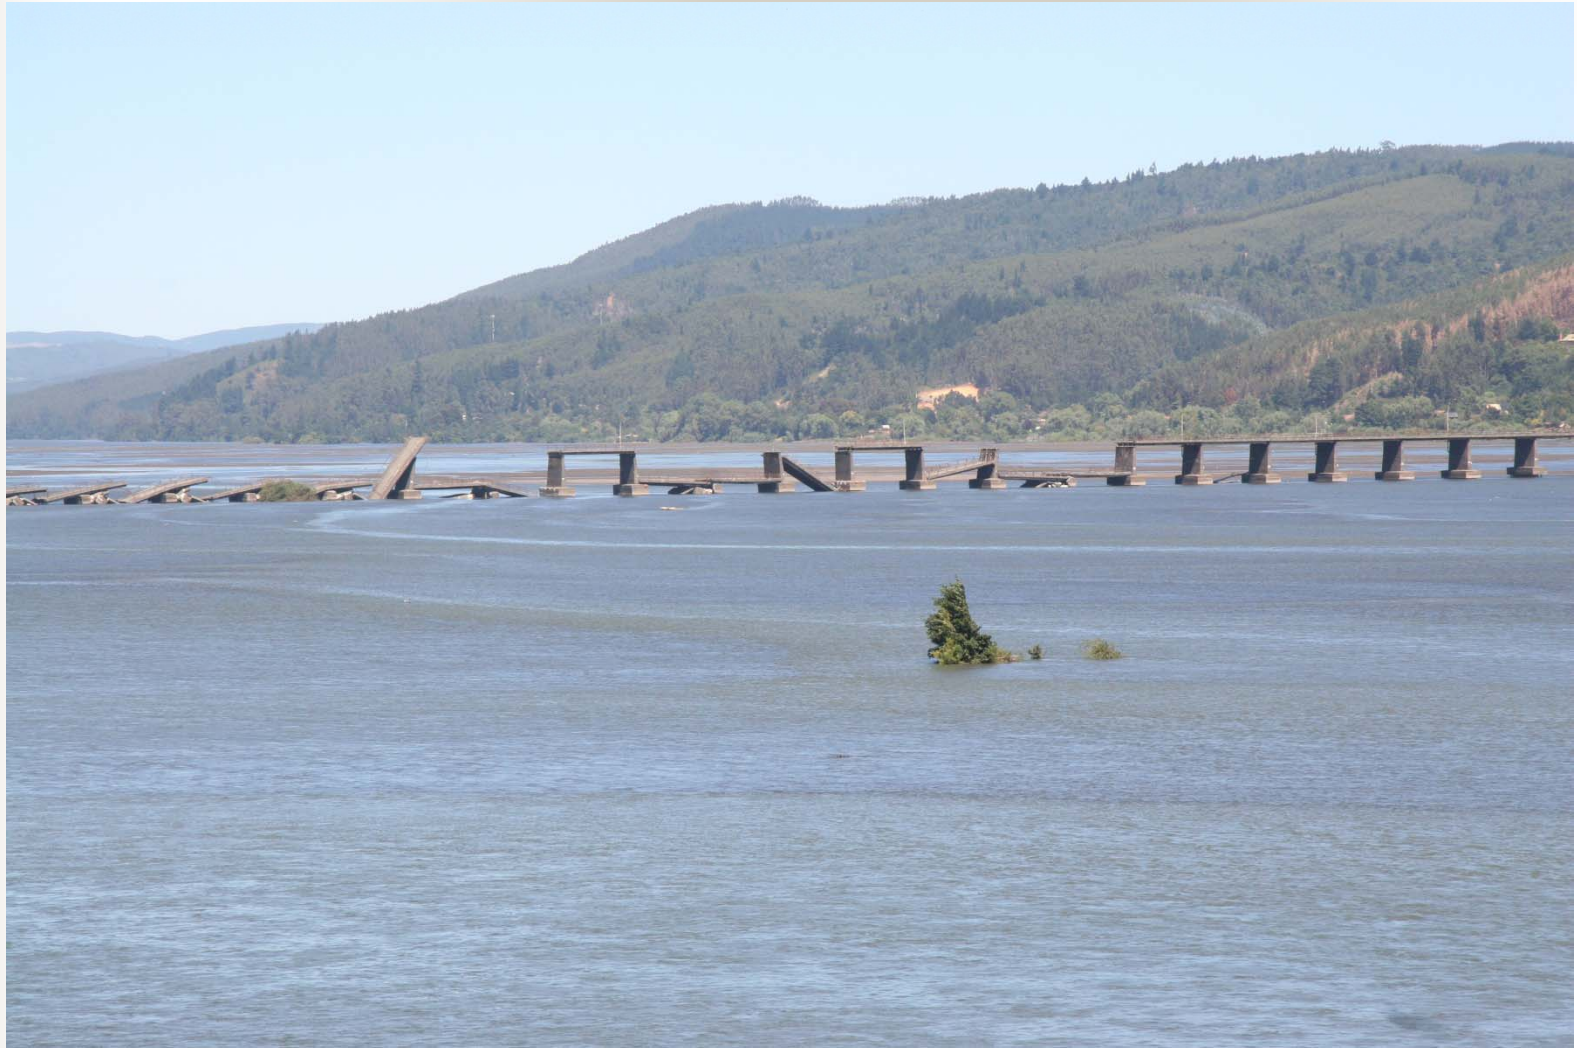
This is a old bridge and it was not in service for several years.

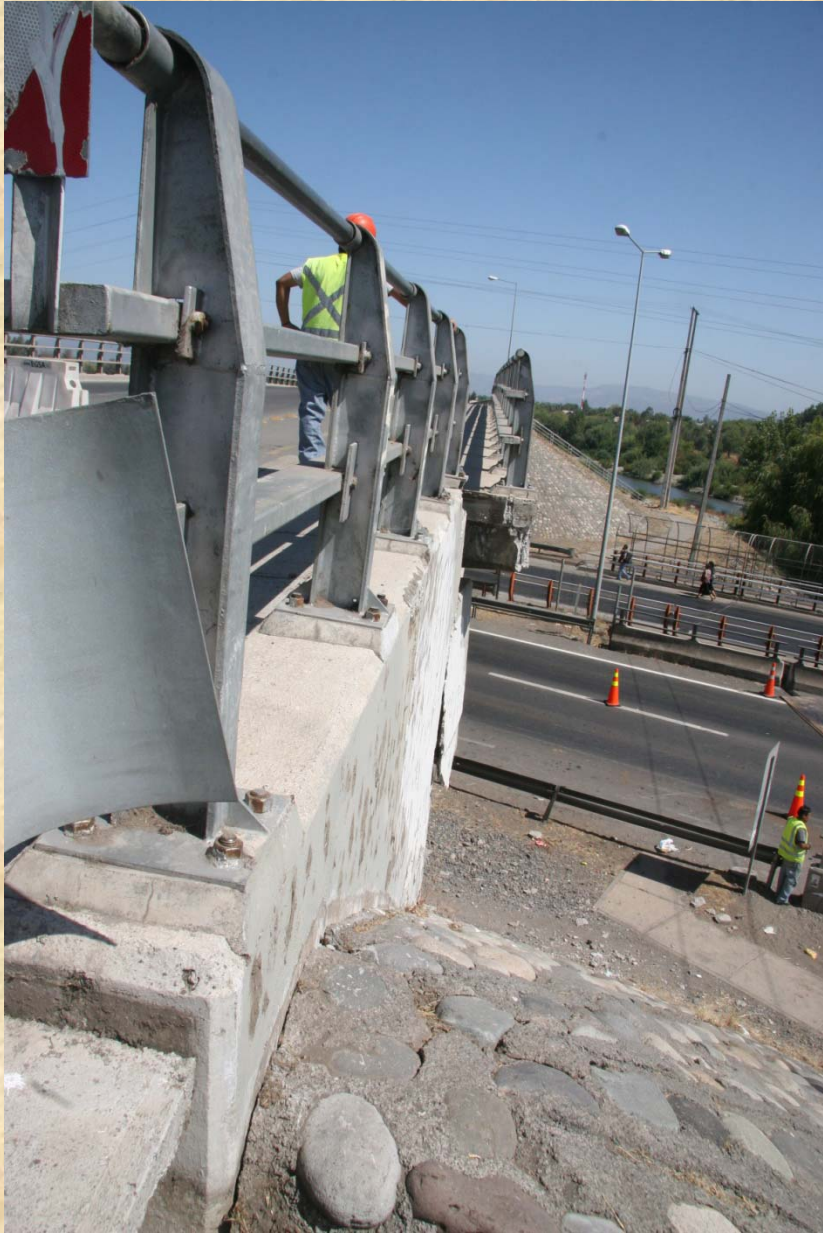
A damaged highway bridge

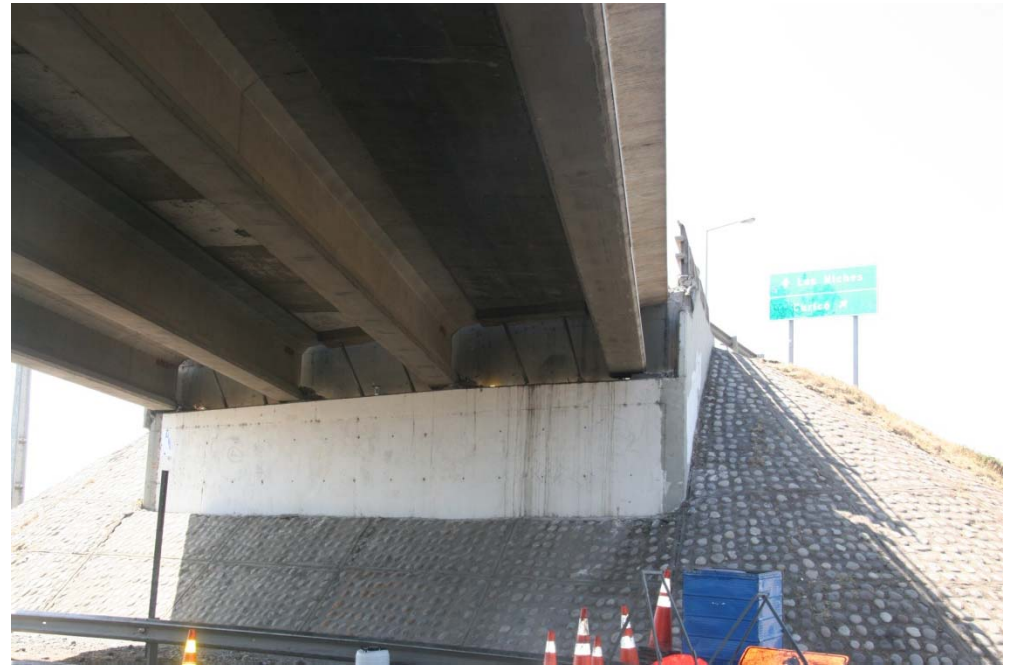
A damaged highway overpass

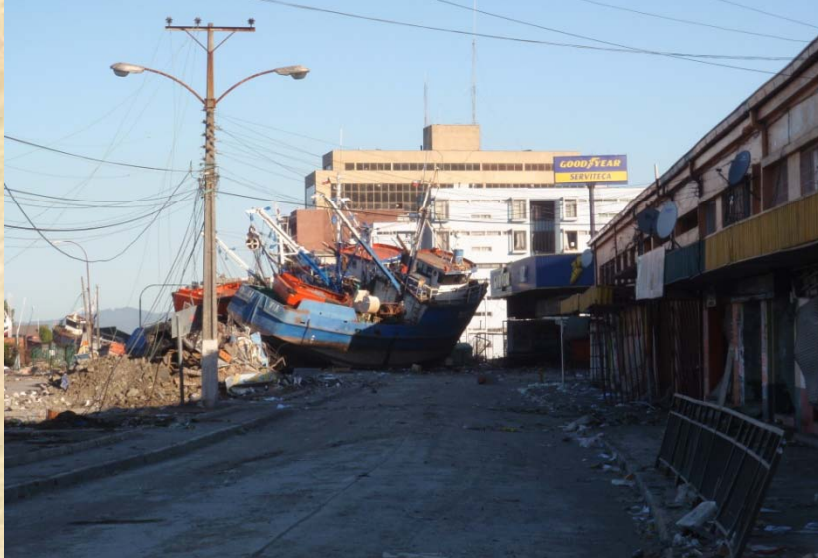
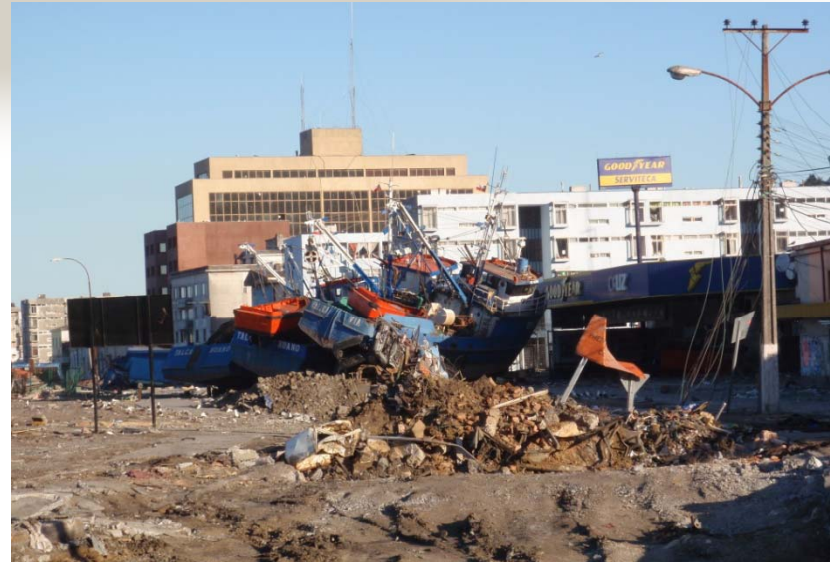
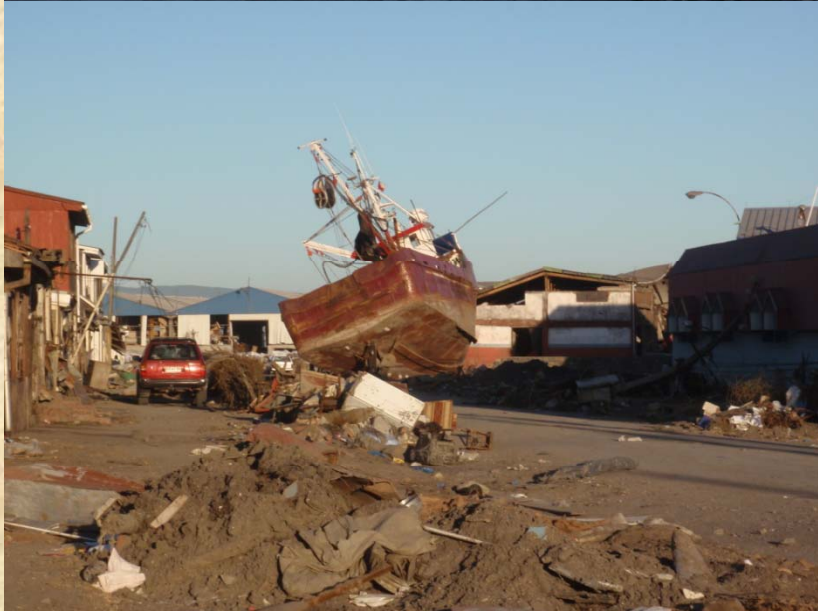
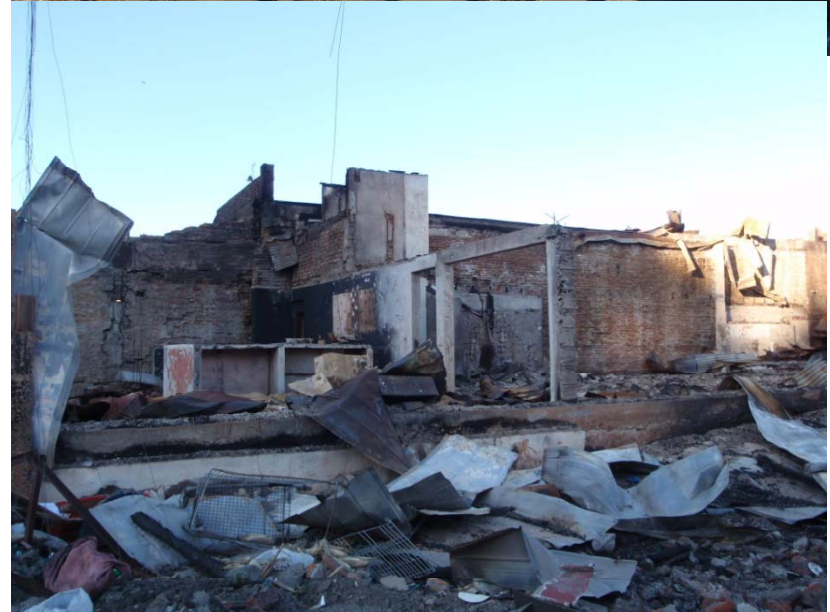
in Talcahuano

Effect of tsunami

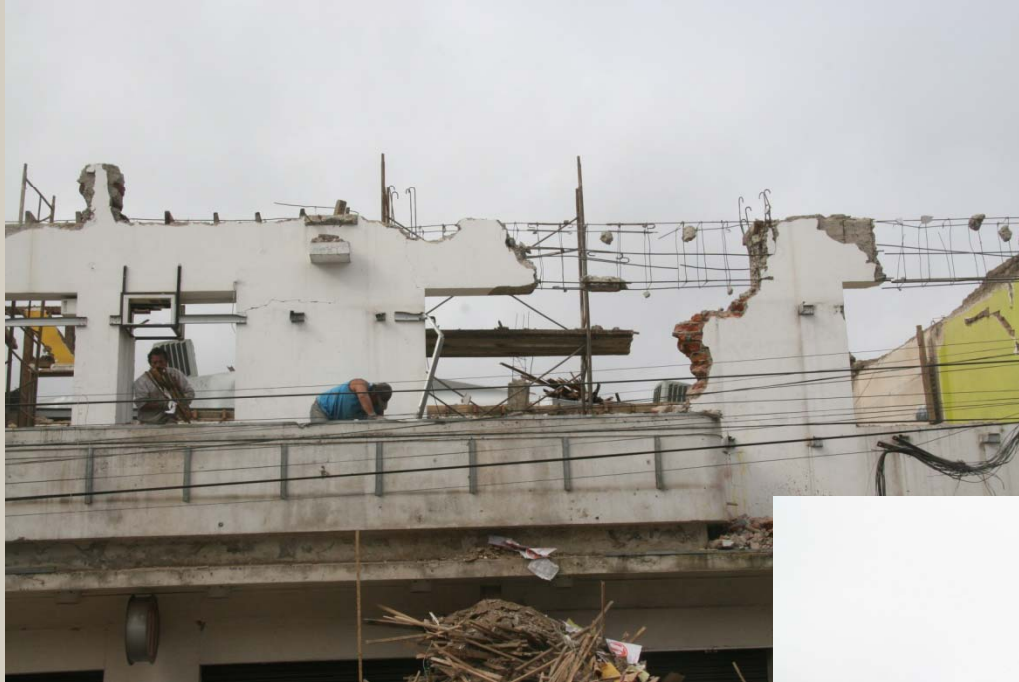
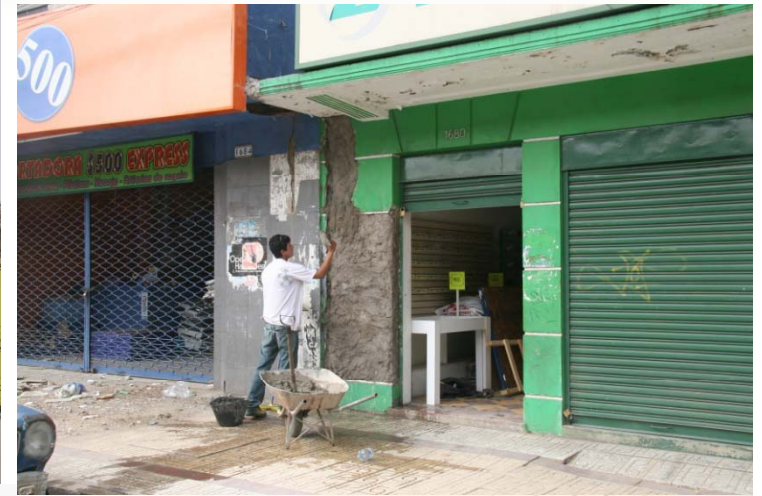
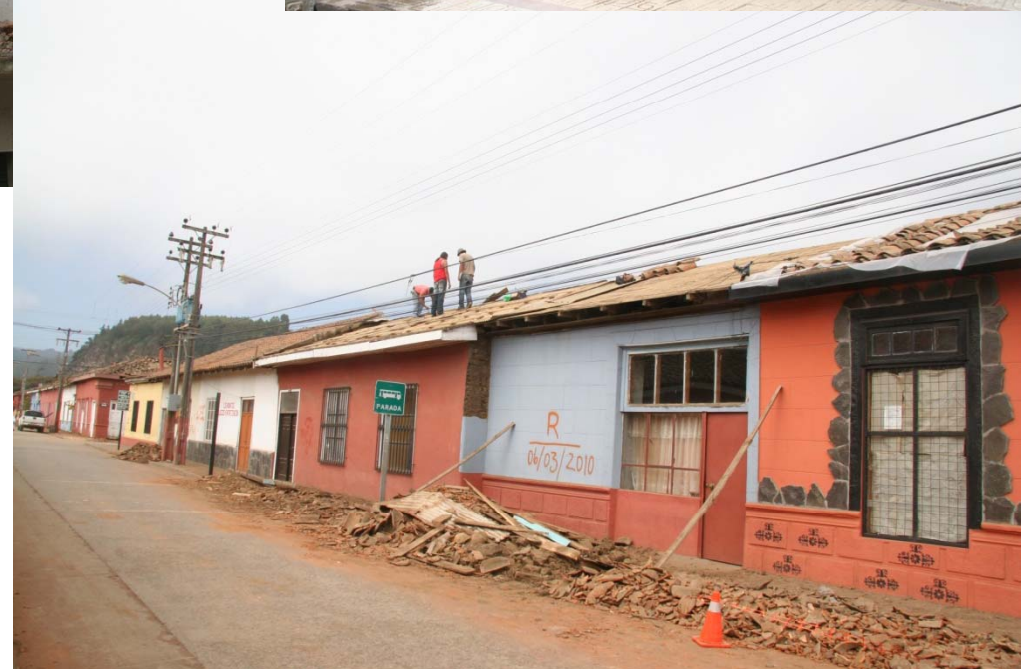
Some observed non-engineered repair
