Taming the Big Bad Wolf

Gregory A. Kopp
Professor,
Canada Research Chair
in Wind Engineering,
Faculty of Engineering,
University of Western
Ontario

An eyewitness account of the damage tornadoes did recently in the Vaughan area of Ontario, just north of Toronto, suggests roof nails are still missing the mark.

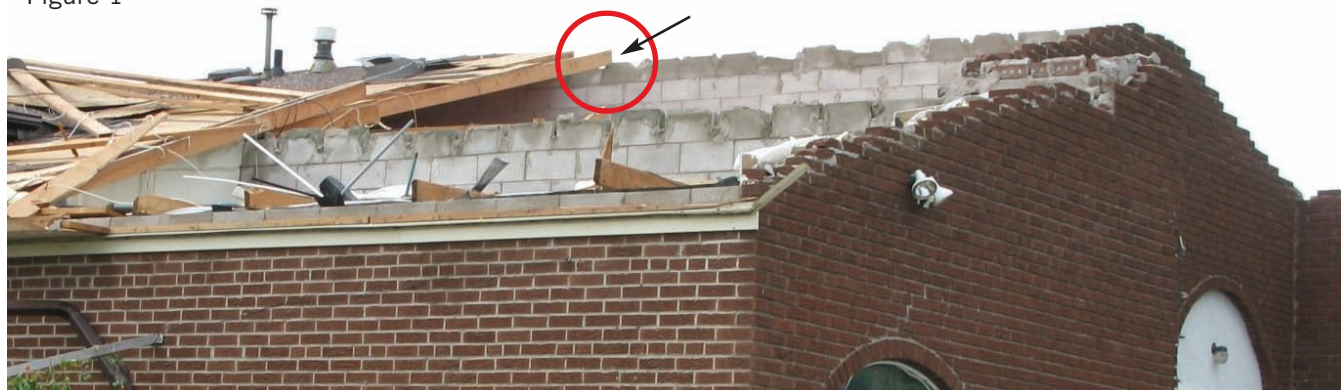
Figure 1

The photograph below (See Figure 1) shows one example of a failure because the roof was not connected to the walls; rather, in this pitched roof construction, the structural members of the roof were placed in slots in the blocks. The red arrow points to where one of the connections should be, but, in fact, there is nothing holding the lumber to the interior wall. In Vaughan, we also saw many roofs that had been properly connected,

in these F2 tornadoes, is actually rather inexpensive — hurricane straps. These are readily available, easy to install in new construction, less prone to errors in installation and, best of all, inexpensive. At most, they would add a few hundred dollars to the cost of a new house. As part of the ‘3 Little Pigs’ project at our Insurance Research Lab for Better Homes (IRLBH) at the University of Western Ontario, we are currently testing such technology in order to find optimal solutions that minimize costs and maximize safety for both new homes and

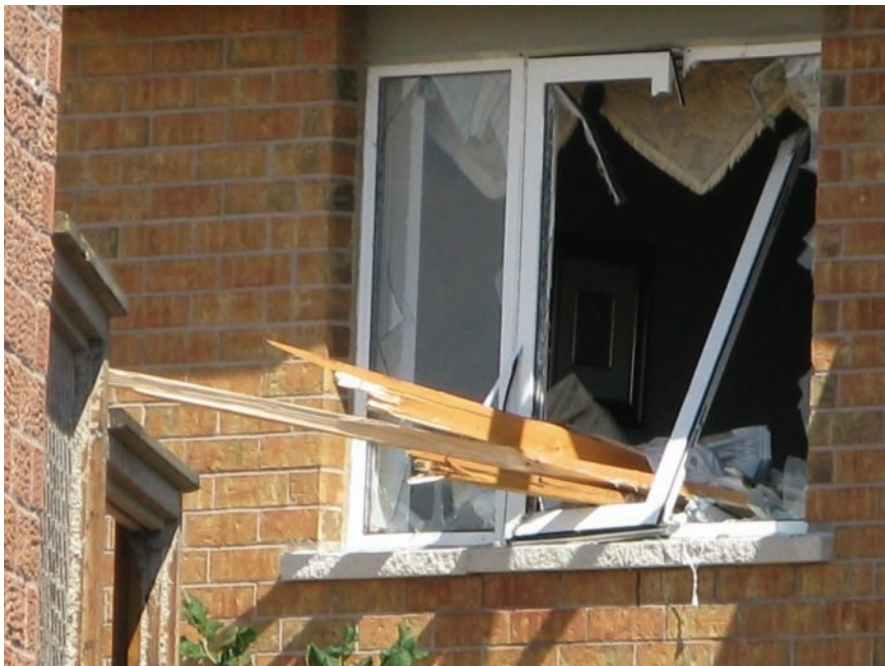
We saw a lot of evidence of debris impact in both neighbourhoods. Many windows and garage doors were broken by debris. We saw many 2x6 and 2x8 pieces of wood penetrate roofs and windows like spears. (See Figure 2 on Page 70.) This is why you are always advised to stay away from windows in tornadoes and head for the basement.

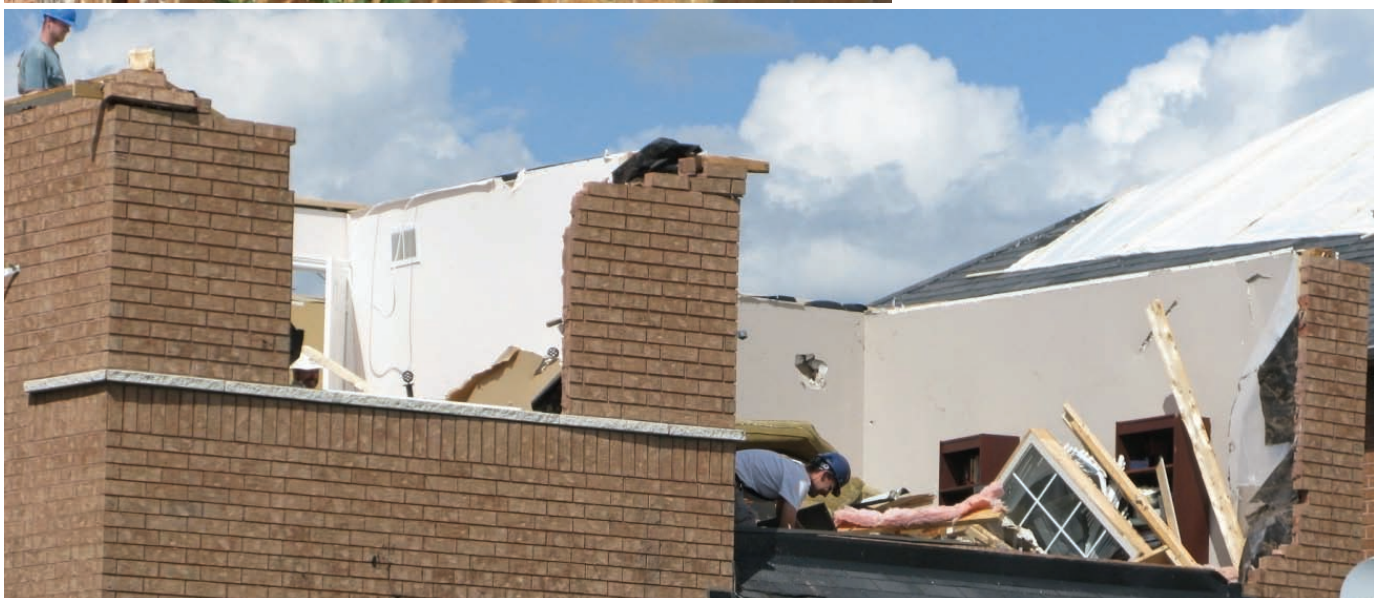
Figure 3 on Page 70 shows an example of the type of roof failure induced by wind-borne debris. Here, the second

floor windows were broken, leading to severe internal pressurization, causing the subsequent failure of the roof. Thus, when failures occur in one house, it can lead to failures in neighbouring houses because of the wind-borne debris. In Maple, debris caused a lot of damage. It broke many second floor windows and garage doors. The garage door failures led to garage roofs coming off in several instances, while window failures led to roof failures.
