# Observations from the Angus Tornado, 2014 June 17

**Gregory A. Kopp**

Boundary Layer Wind Tunnel Laboratory,  
Faculty of Engineering, Western

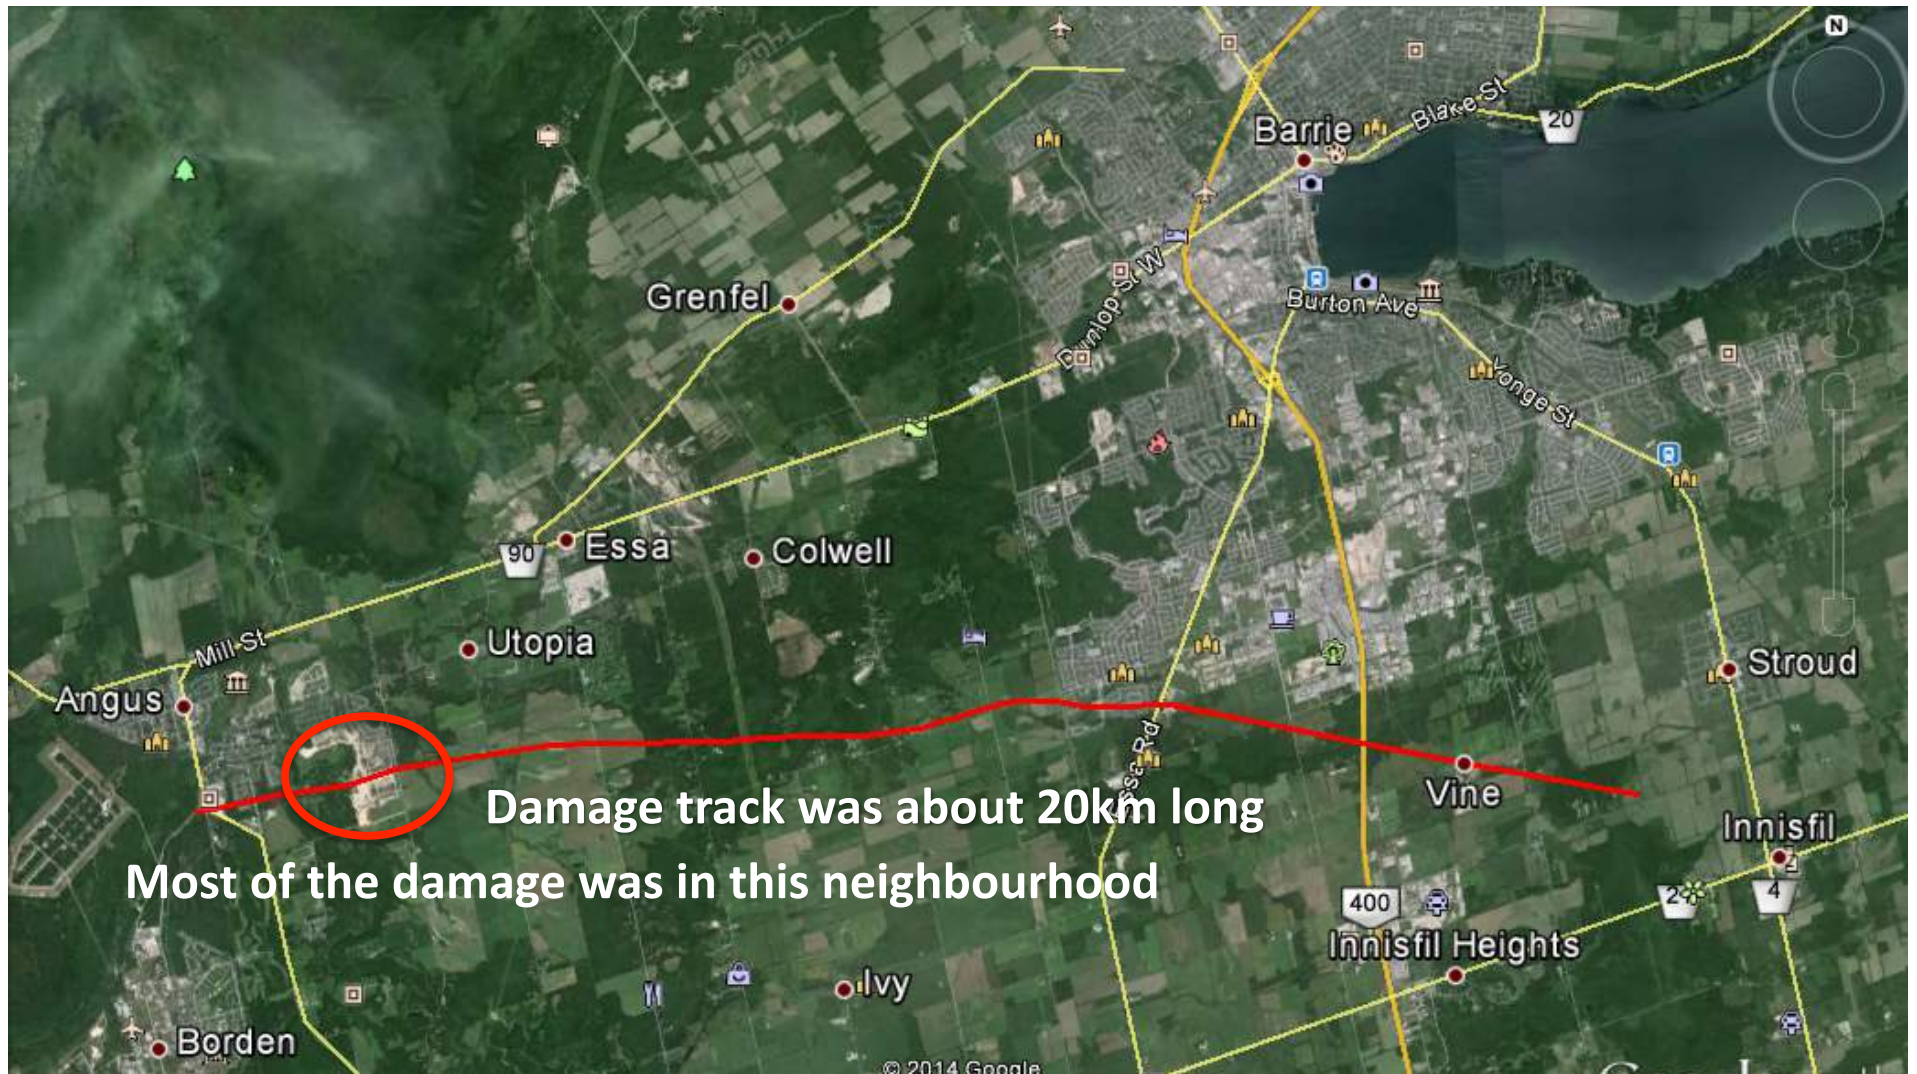
## Damage track of the Angus Tornado

Preliminary track courtesy of Environment Canada

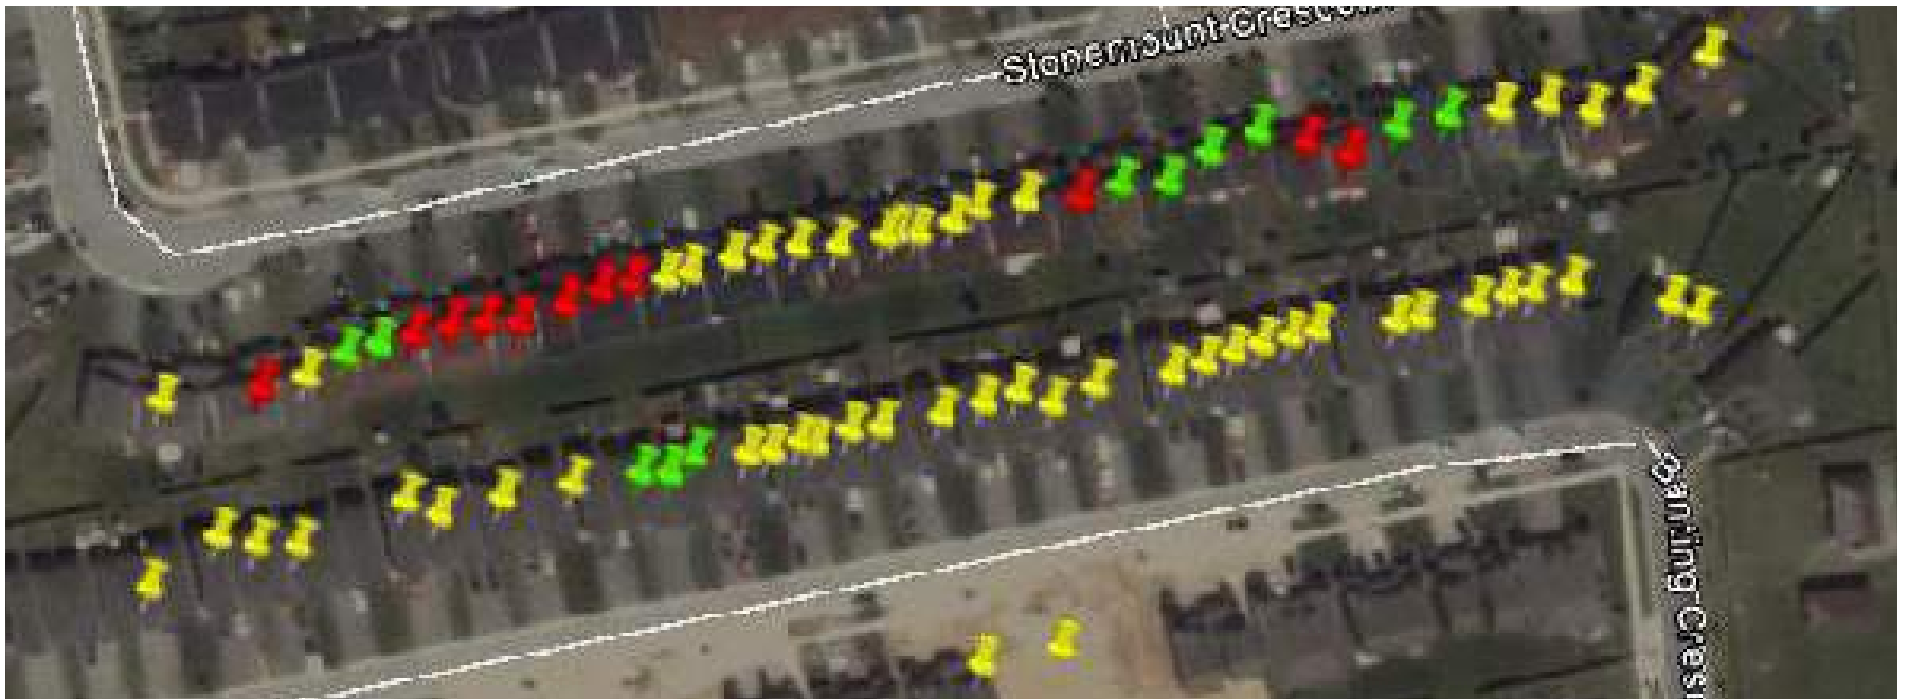
Red = houses with roof-to-wall-connection failures (ie, roof is gone)

Green = roof sheathing (ie, small part of roof is gone)

Yellow = everything else.

The bulk of the damage was along two streets; however, the major structural roof damage (~22 houses) was along only one street

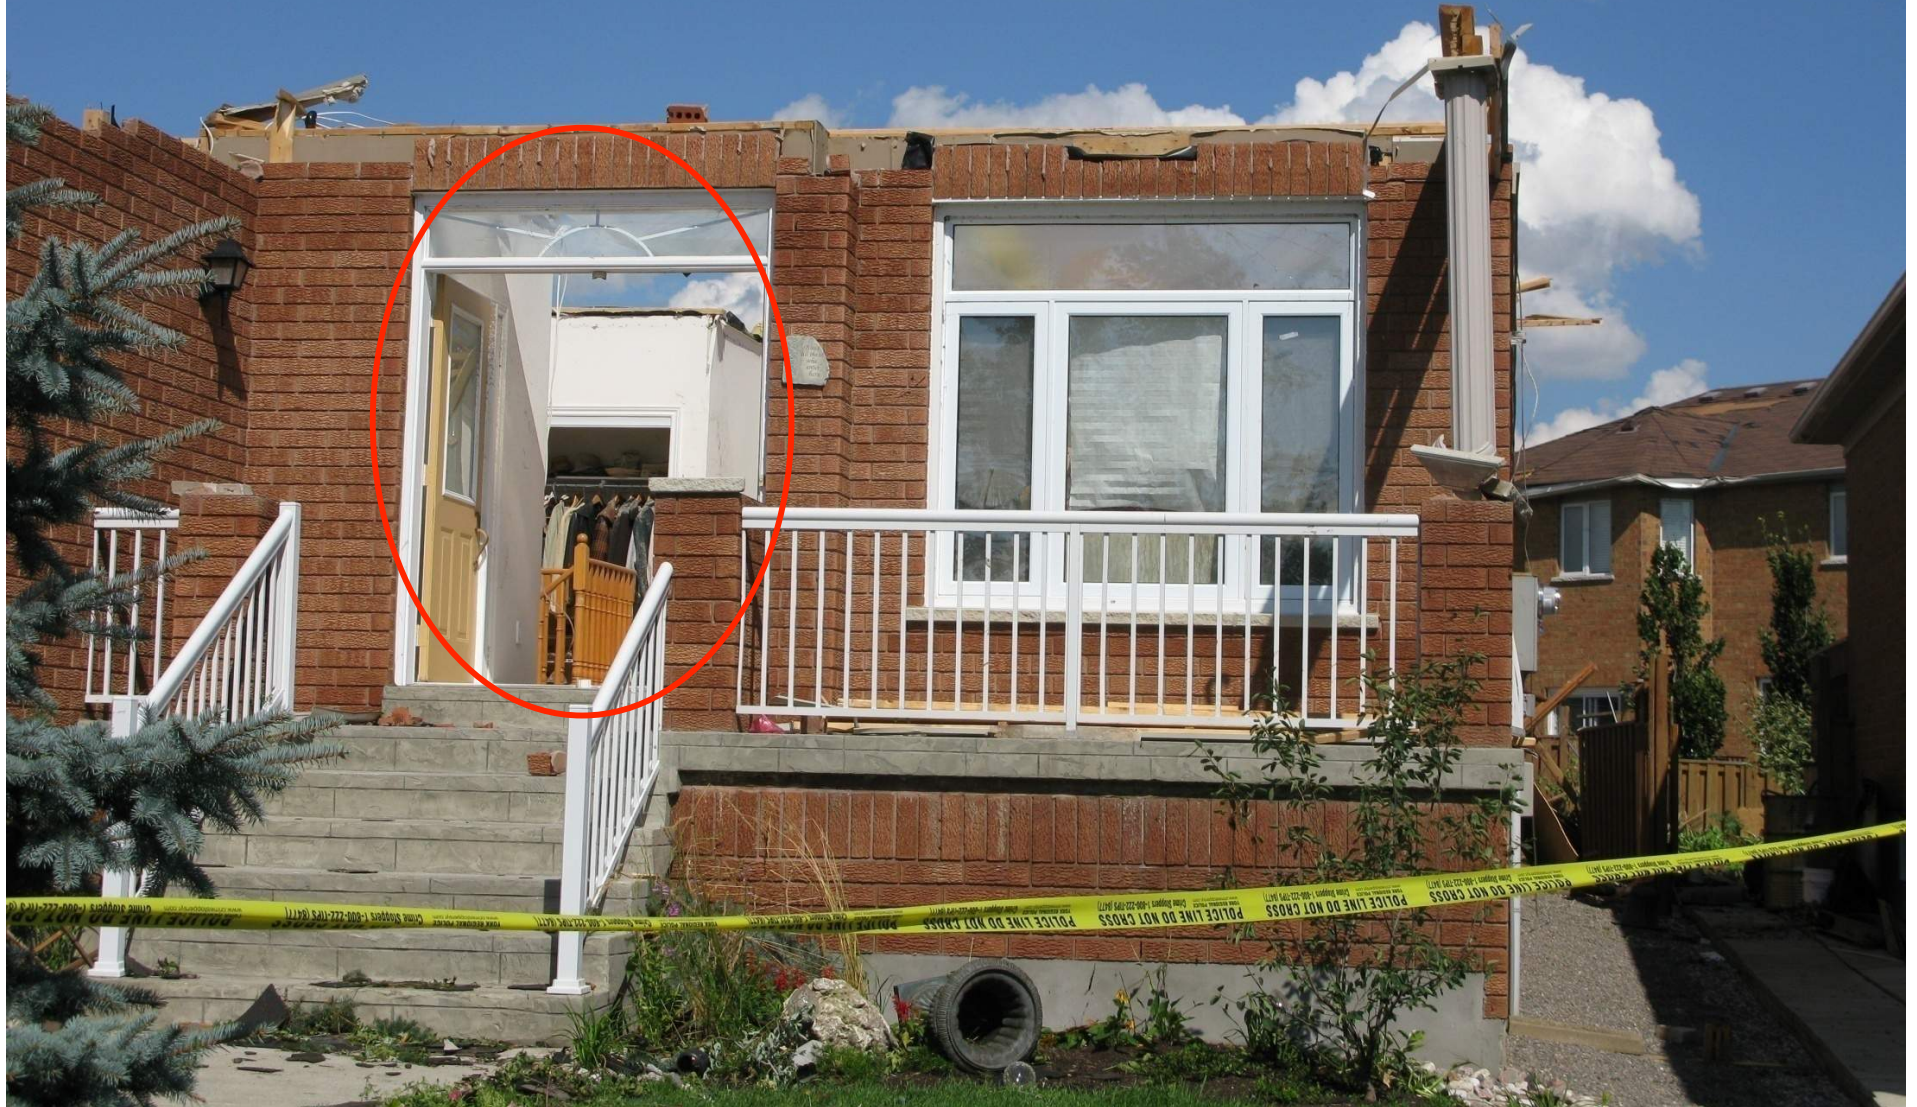
VAUGHAN, 2009

Large windward wall opening – internal pressurization – roof failure

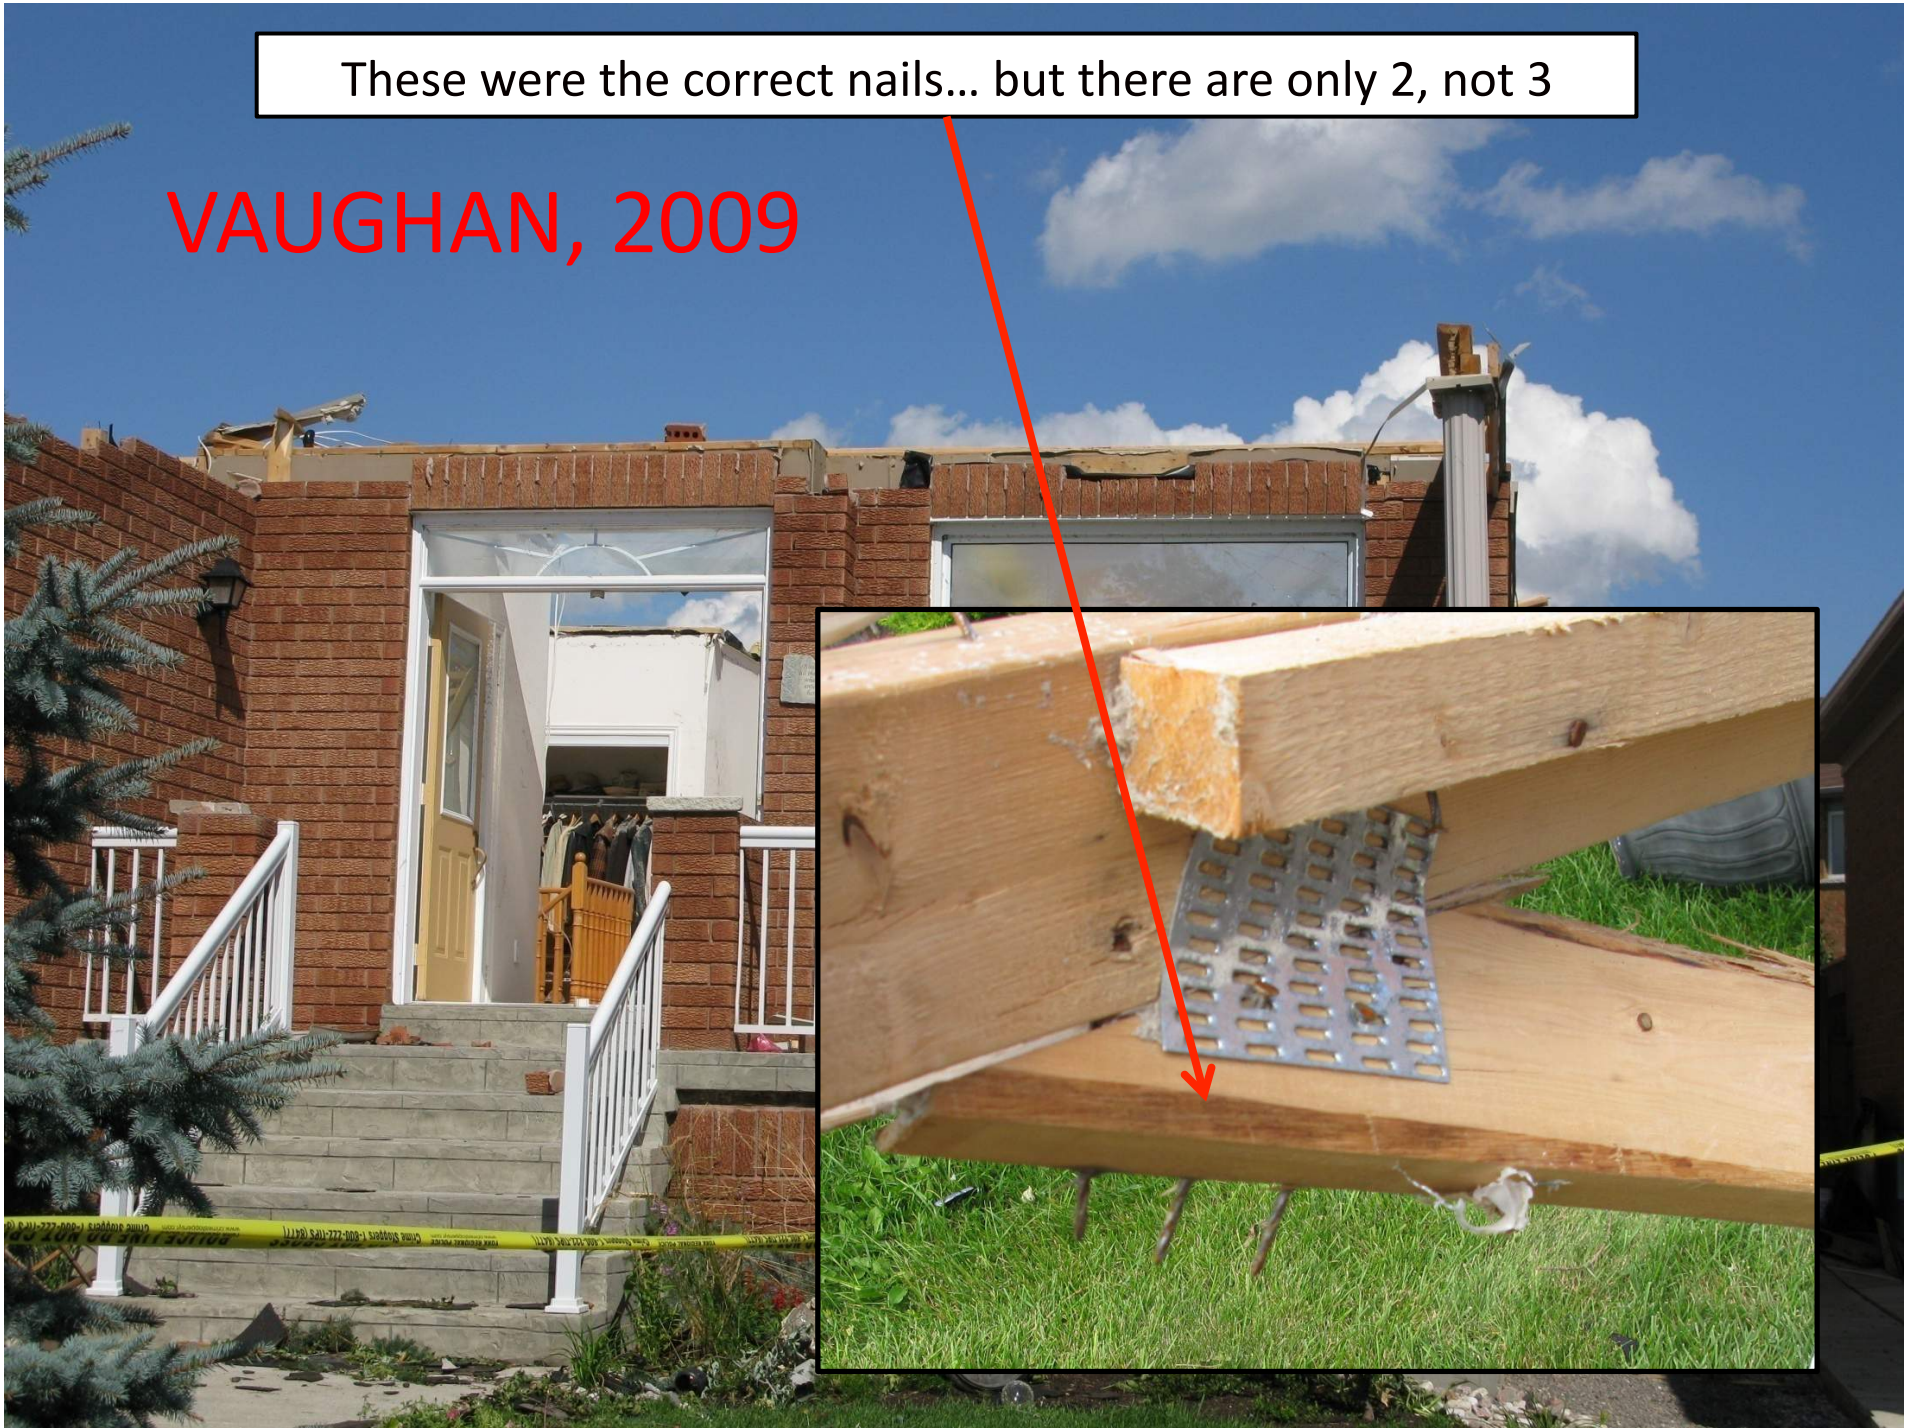
VAUGHAN, 2009

These were the correct nails... but there are only 2, not 3

**Our preliminary analysis suggests that 2 missing nails per connection reduces the failure inducing wind speed by about 40%**

The building code requires 3 nails to connect each roof truss to the top plate of the walls.

In contrast, inexpensive hurricane clips roughly double the capacity. **Our analysis of the Vaughan Tornado suggests that these would have kept the roofs on in these events.**

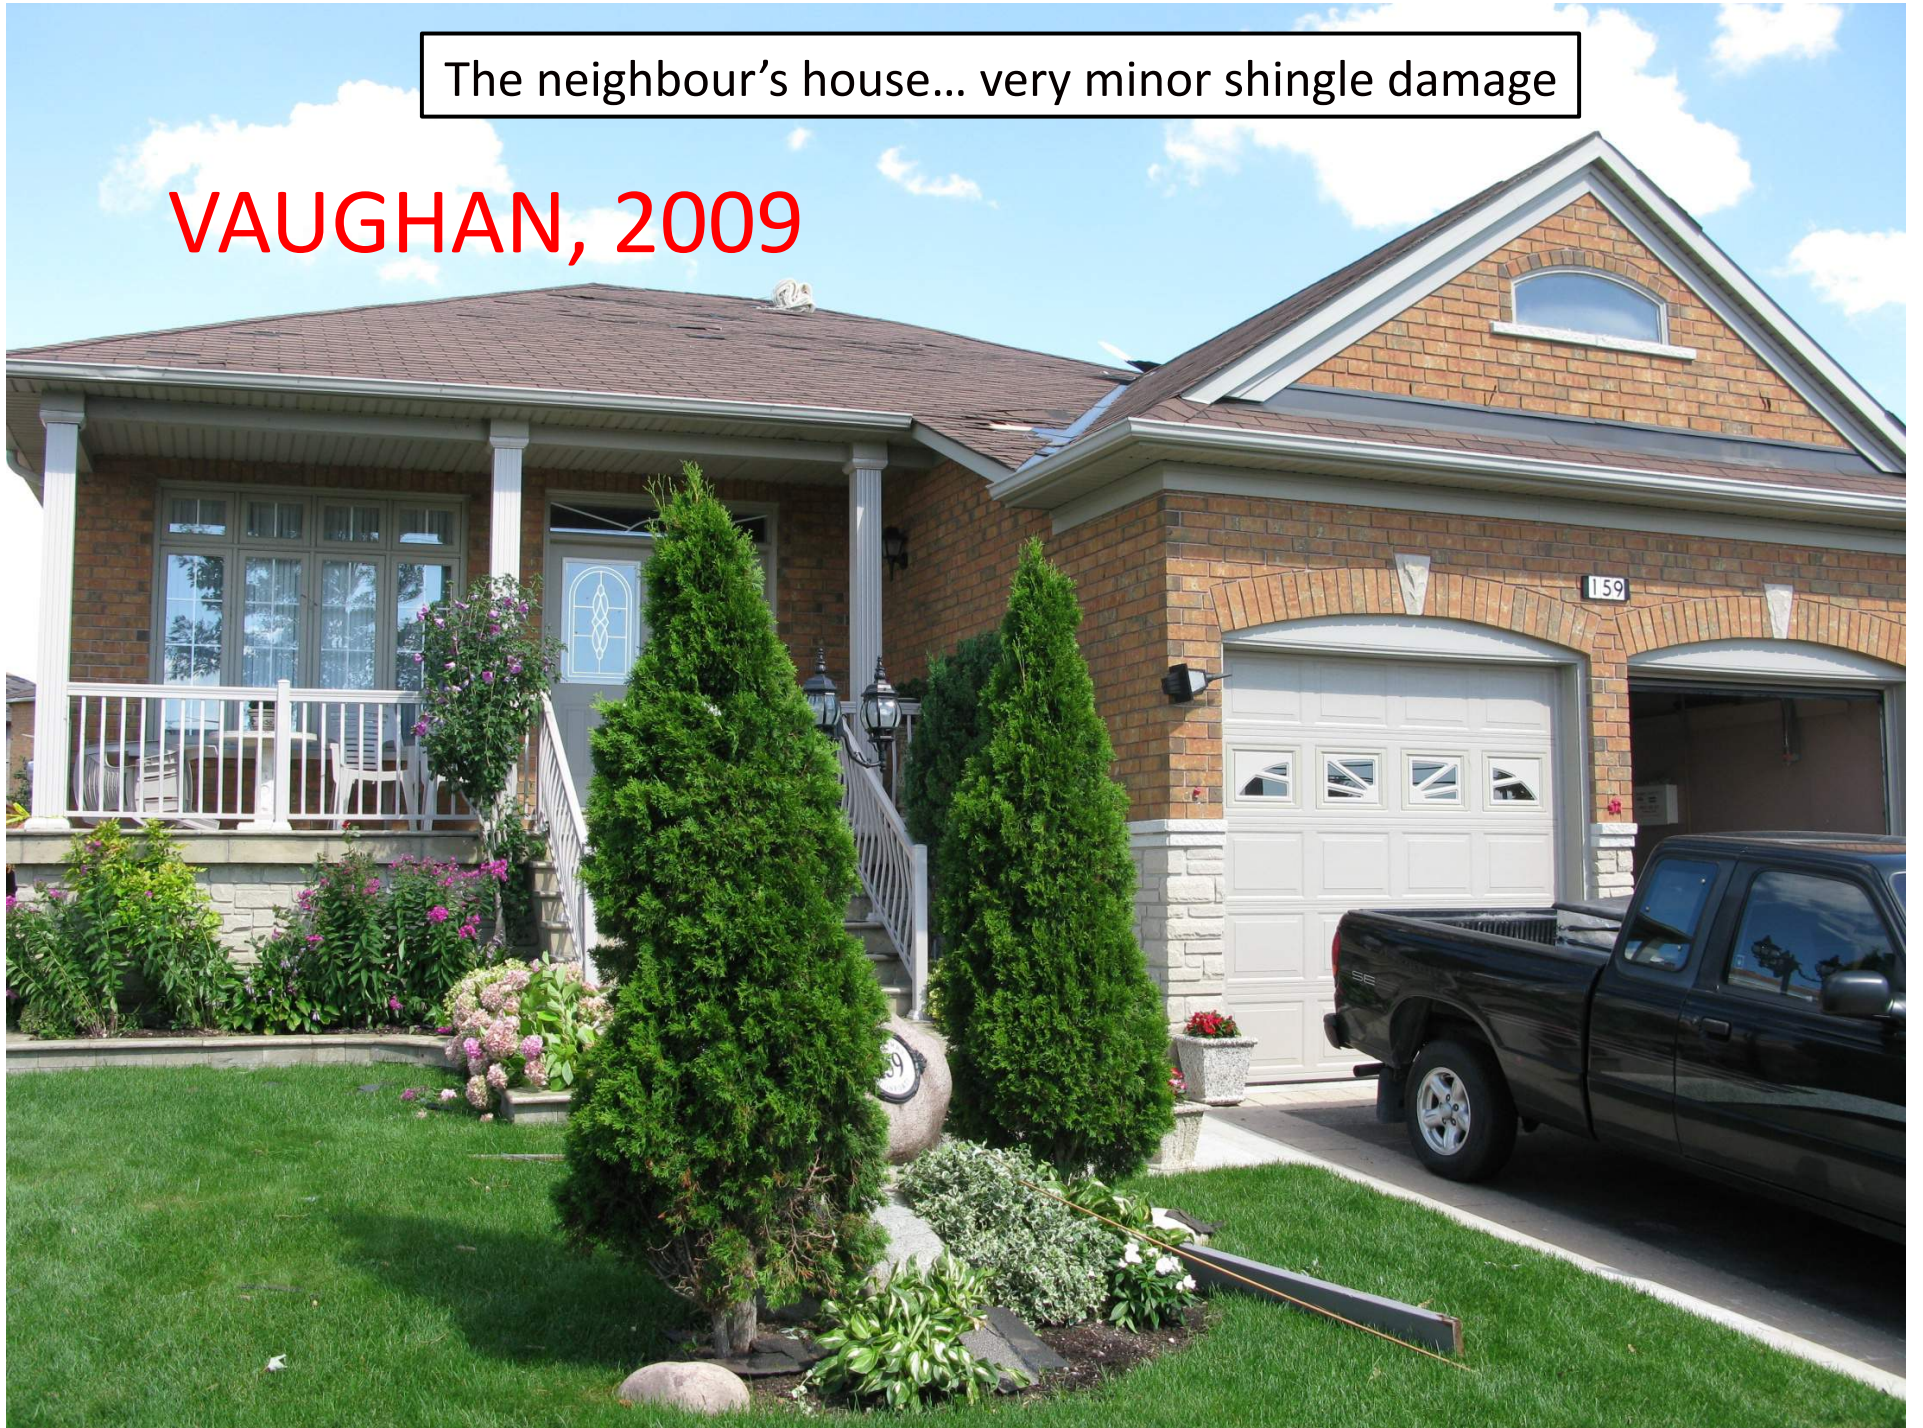
**VAUGHAN, 2009**

The neighbour's house... very minor shingle damage

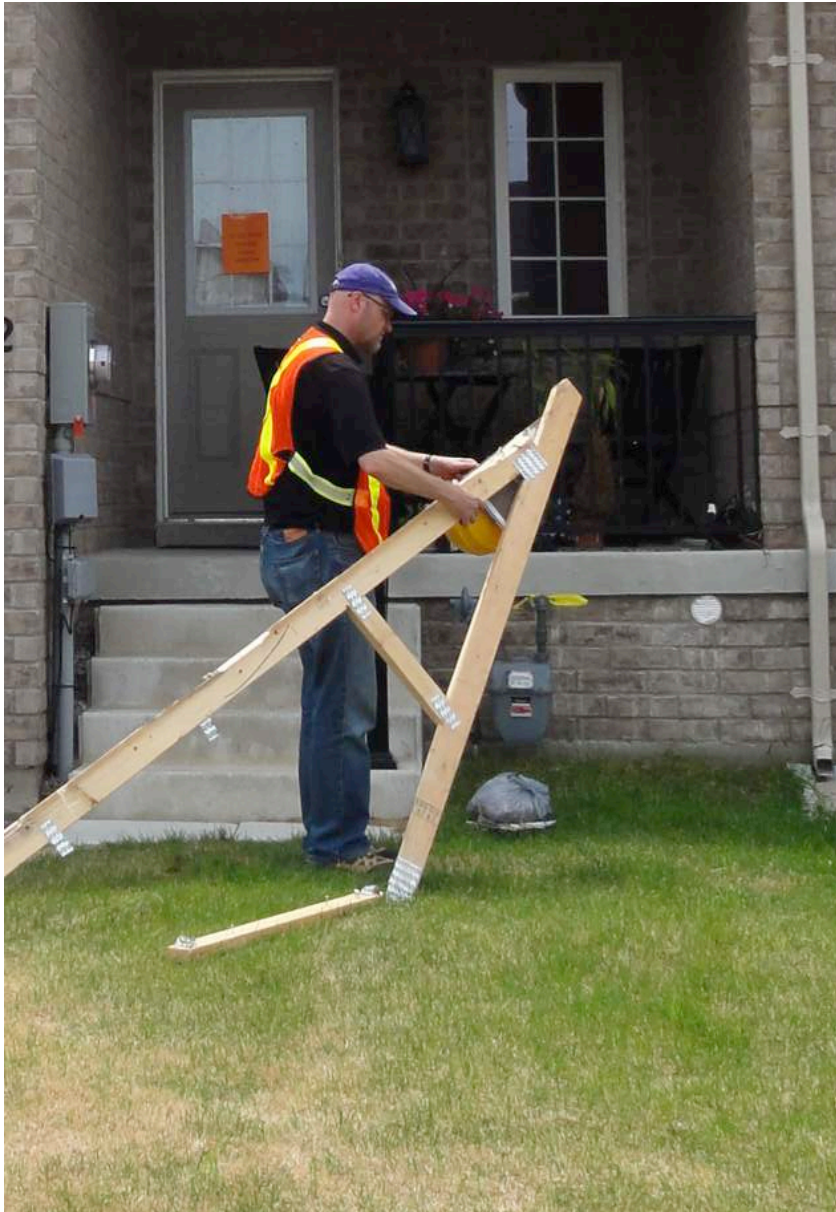
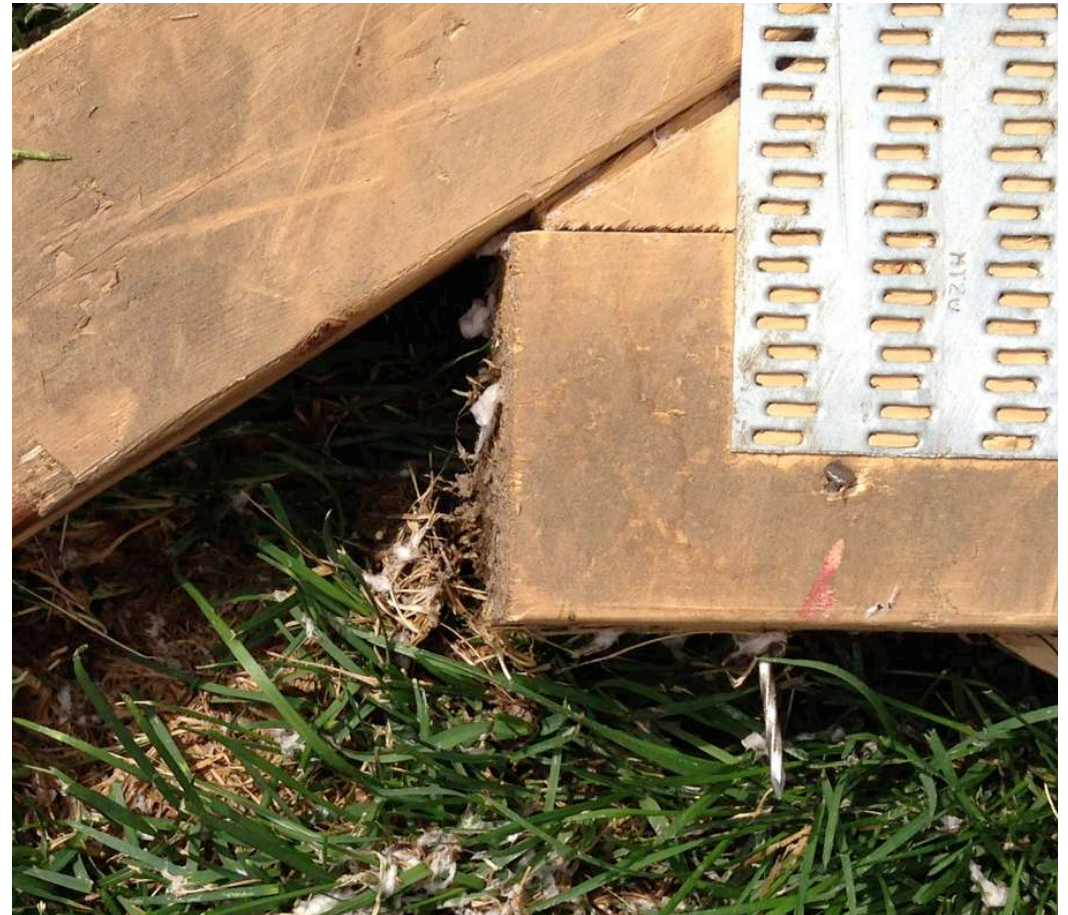
Incorrect toe-nailed, roof-to-wall-connections were prevalent

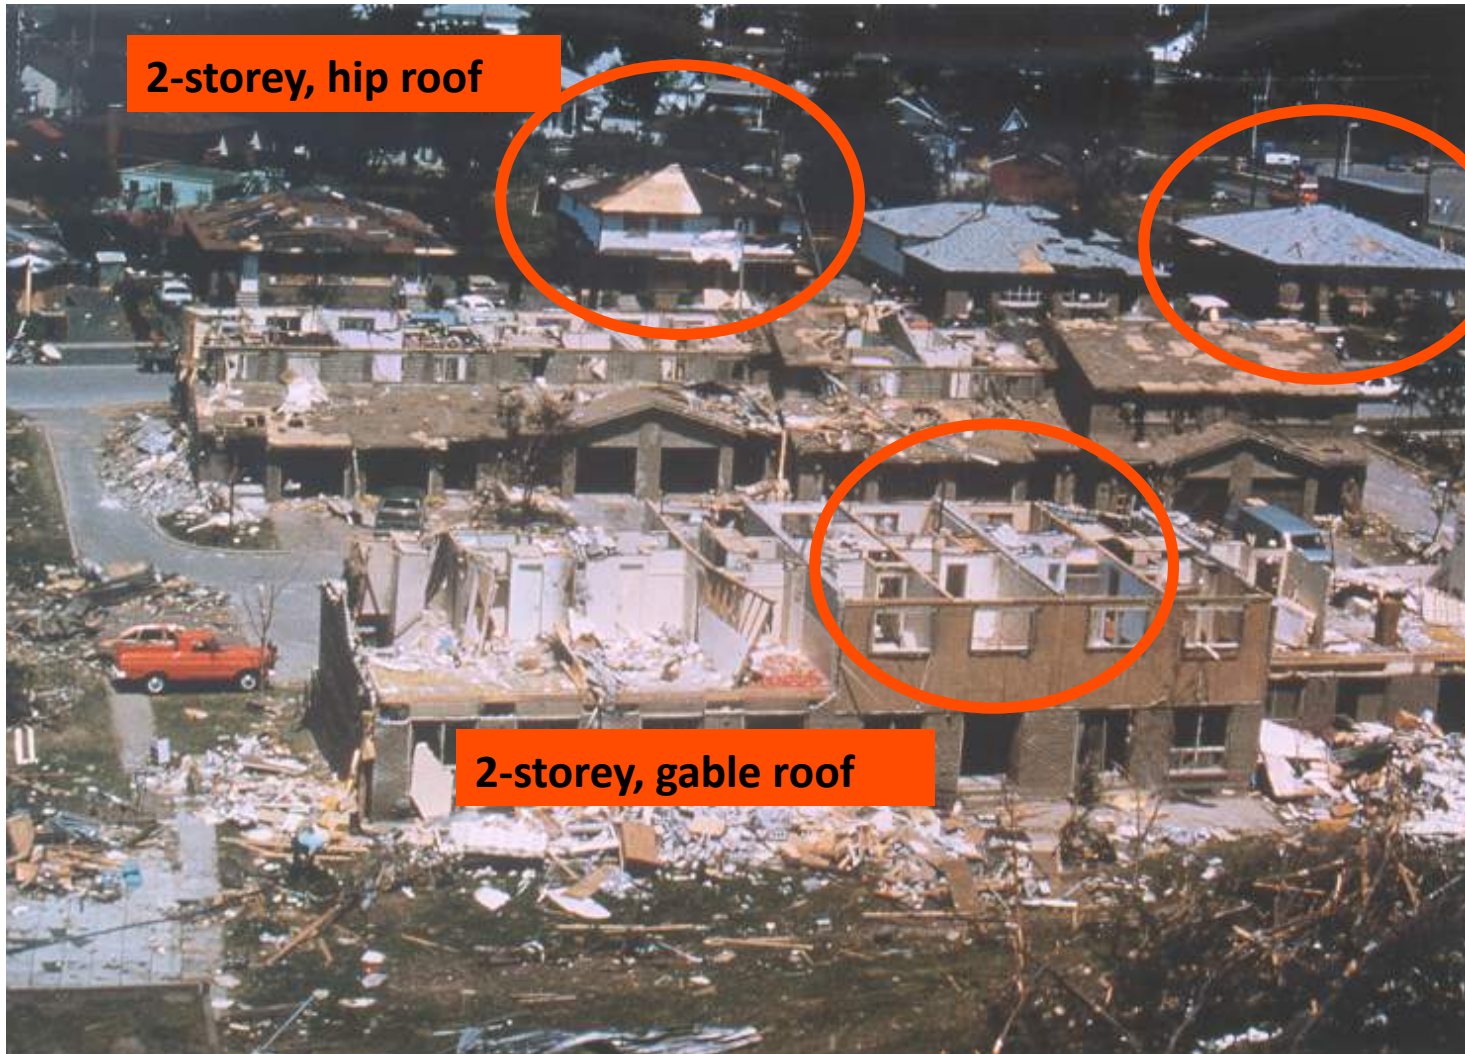
Barrie Tornado, 1985

Looking at this Barrie photo...

- Peak coefficient for hip roof is about 0.8. For a two storey gable it is about 1.2 (50% larger)
- Hip roofs have larger capacity due to connections on all 4 walls, compared to two walls for gable.
- These two factors lead to about a 40% difference in failure wind speed, all else being equal.

**... although the damage is clearly DOD-6,  
we are still analyzing the wind speeds  
that may have caused the Angus roof  
failures.**

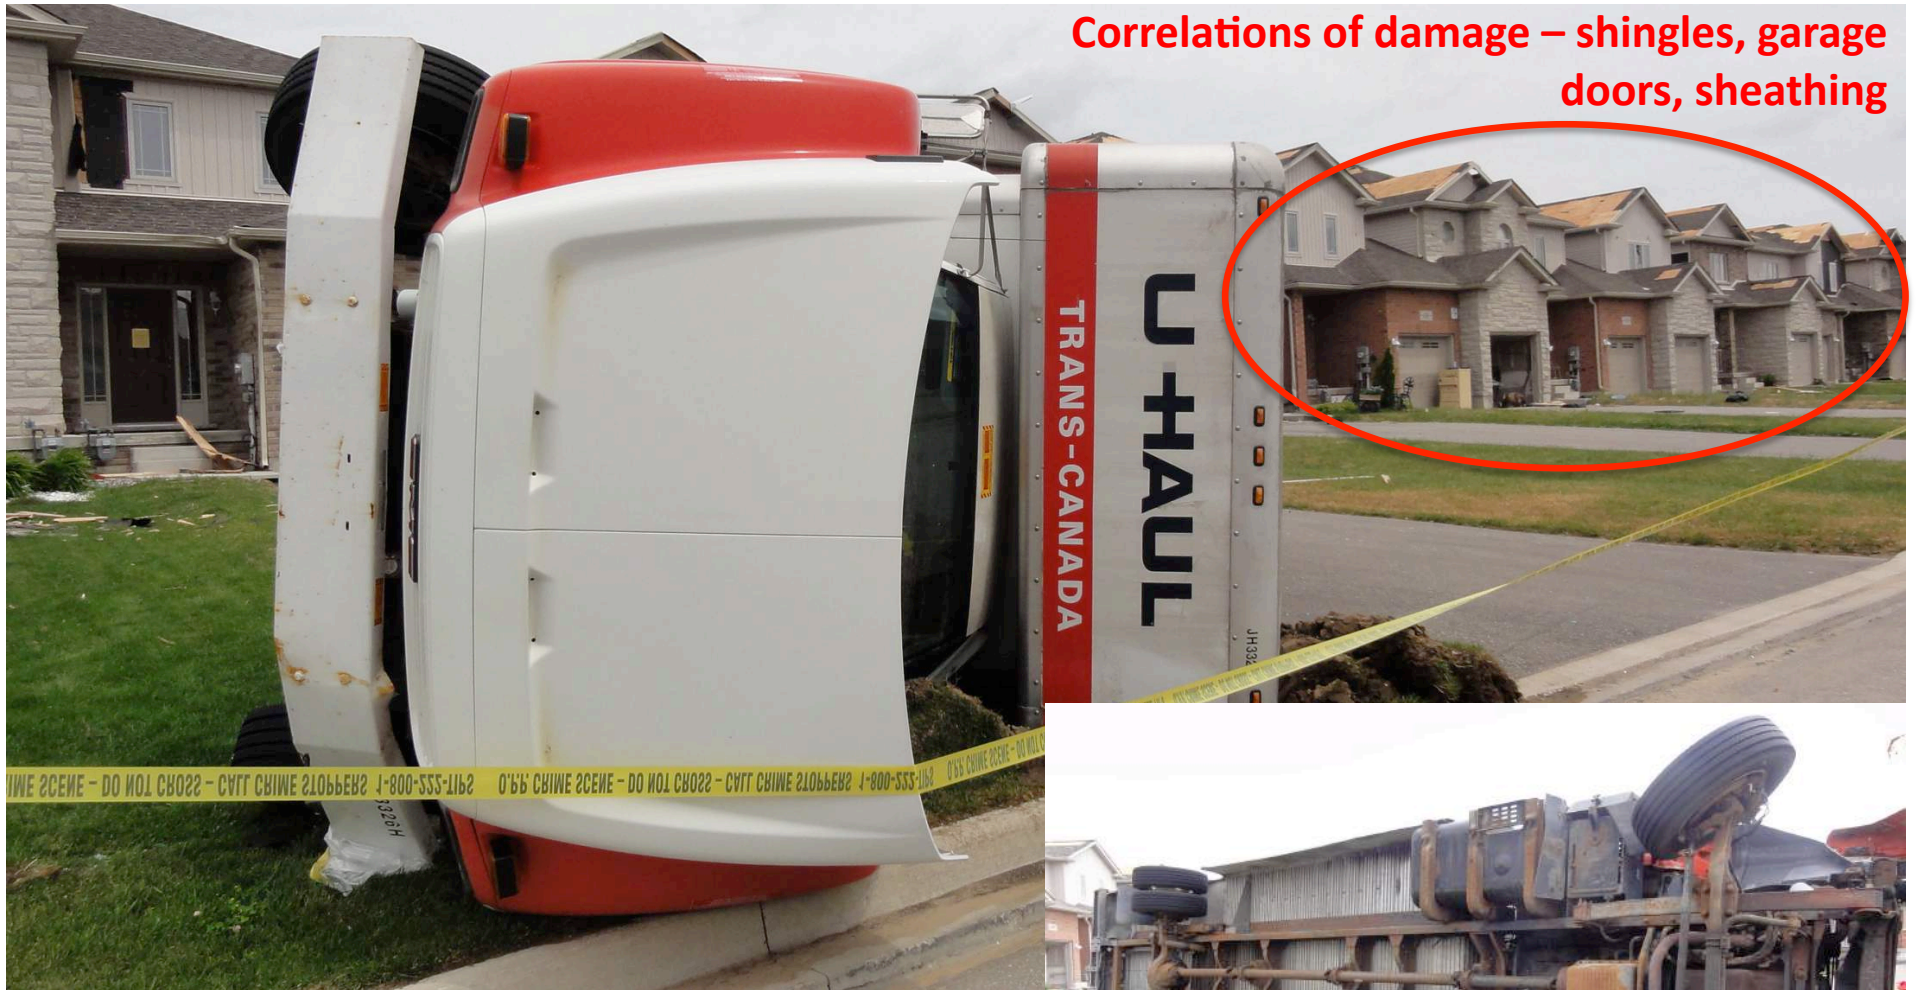
## Vehicles – the overturned U-Haul truck

Vehicles are not included in the EF-Scale  
...but they were in the original Fujita Scale

The overturned U-Haul correlates with DOD-4: 130 – 187 km/h  
 → This falls into the EF-1 range

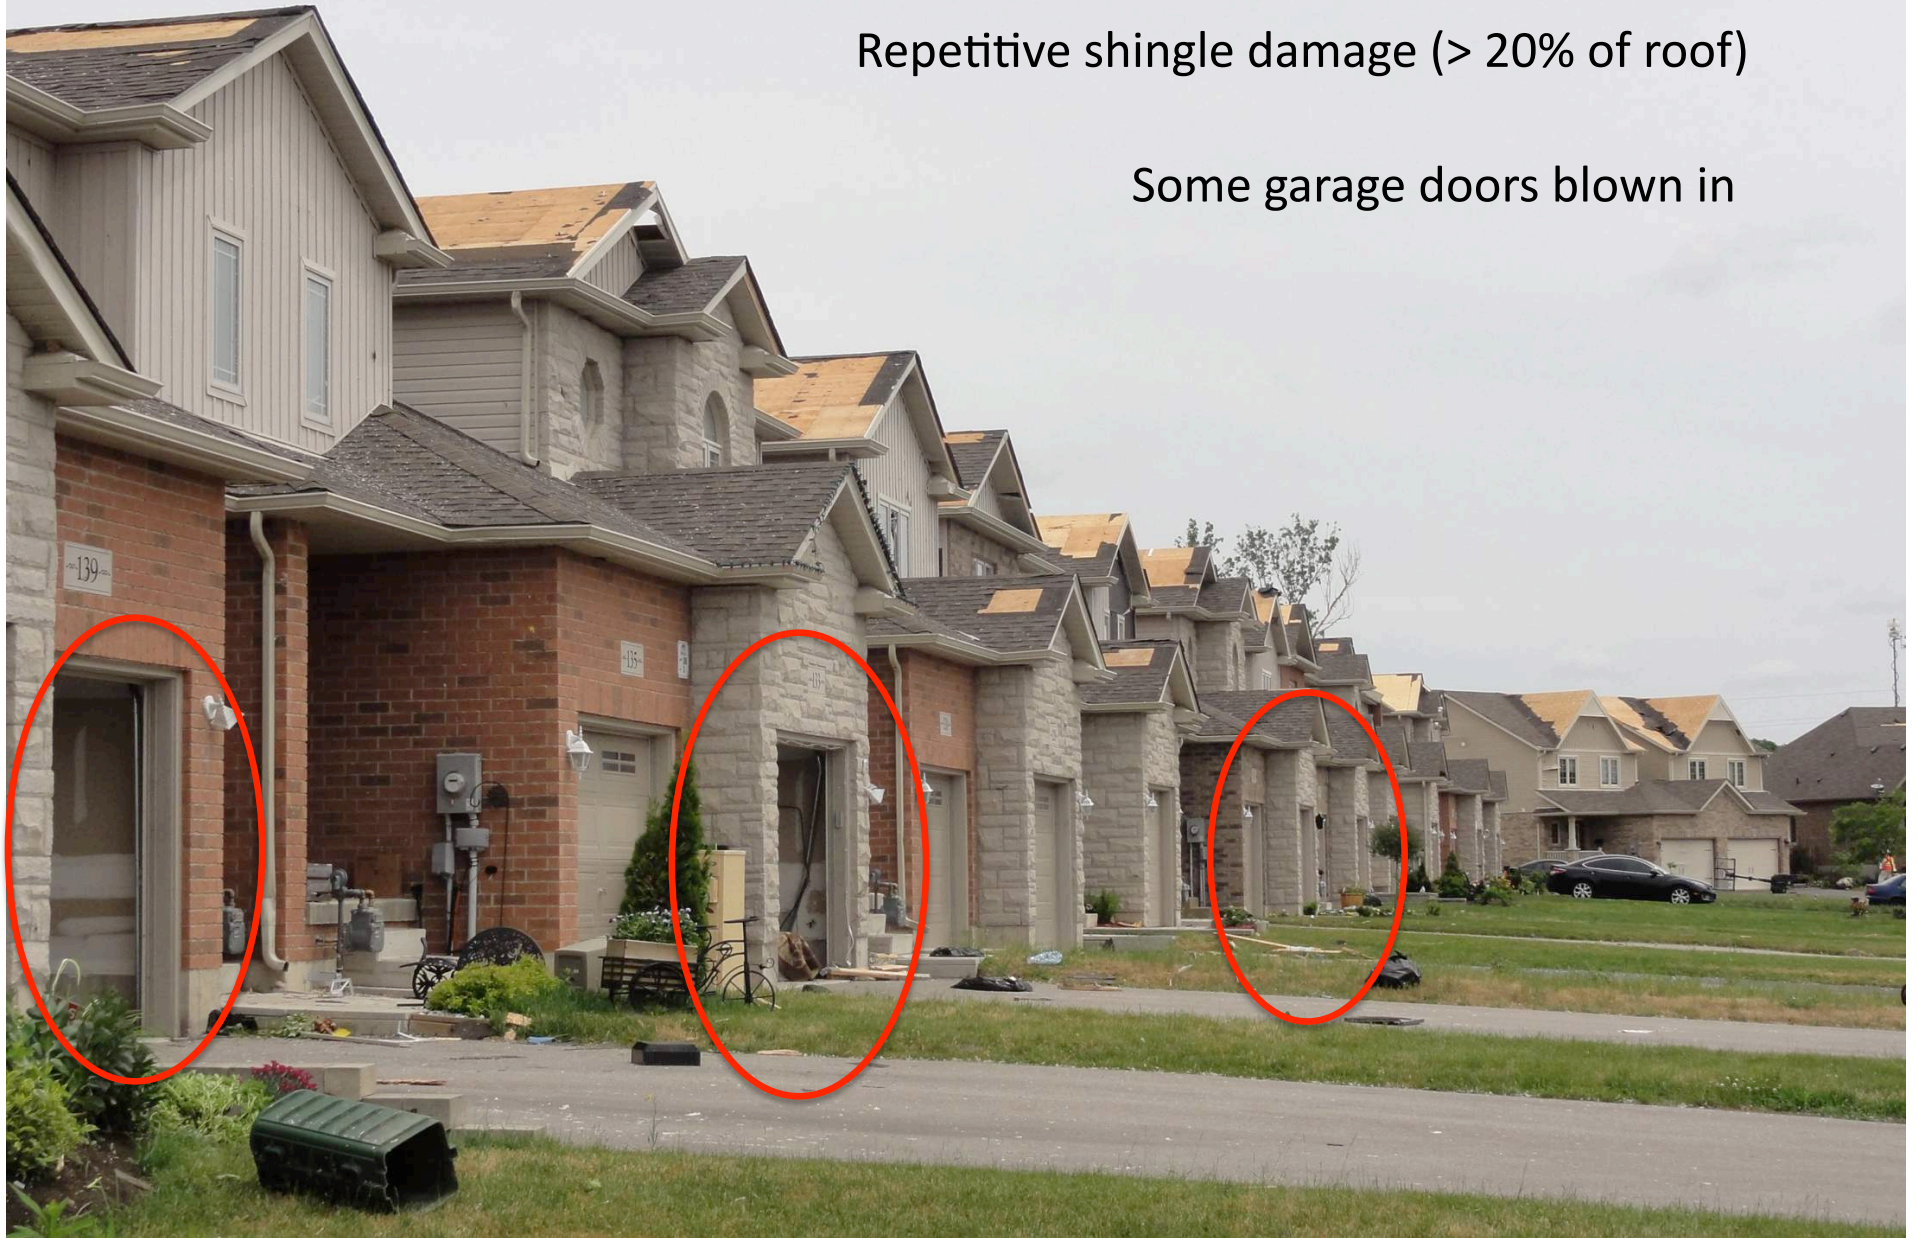
Repetitive shingle damage (> 20% of roof)

Some garage doors blown in

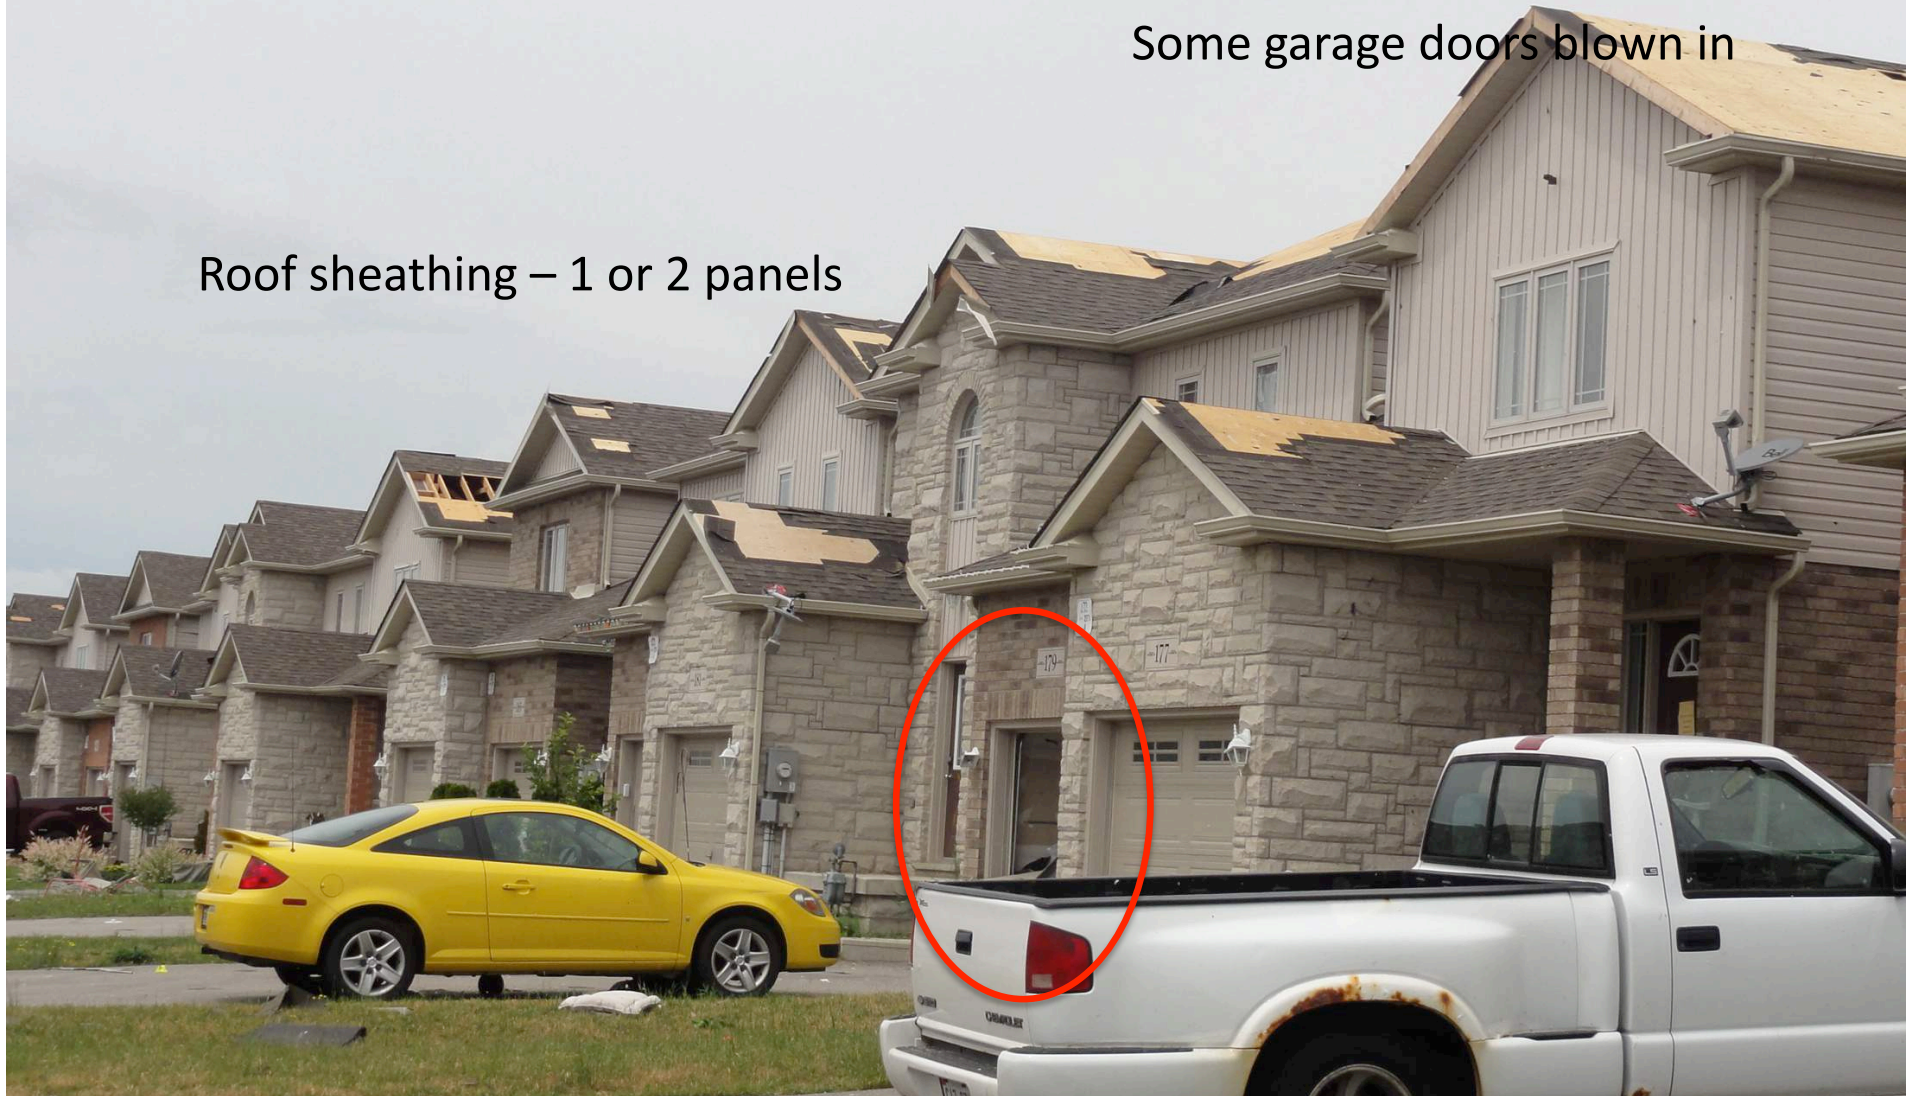
LOOKING IN OTHER DIRECTION

Repetitive shingle damage (> 20% of roof)

Some garage doors blown in

Roof sheathing – 1 or 2 panels
