# Observations from the Angus Tornado, 2014 June 17

**Gregory A. Kopp**

Boundary Layer Wind Tunnel Laboratory,  
Faculty of Engineering, Western

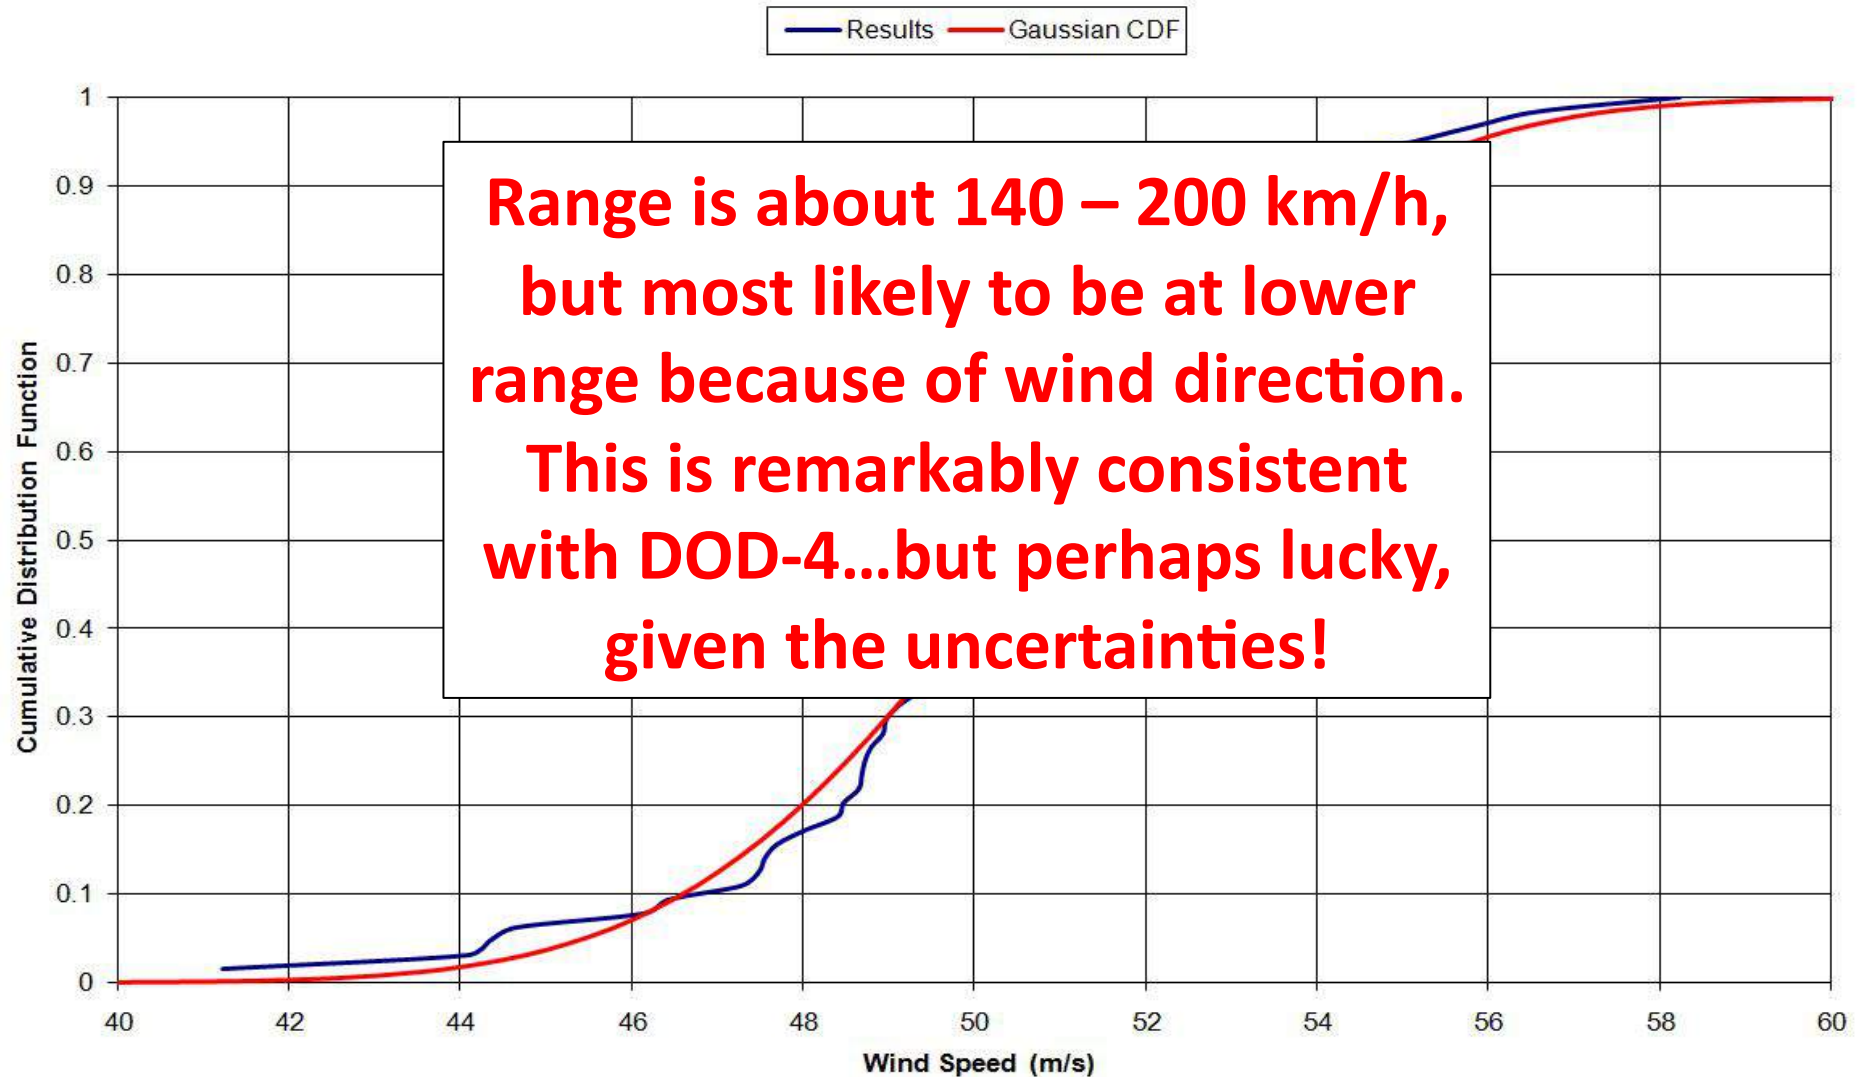
27' UHaul Truck Probability Distribution

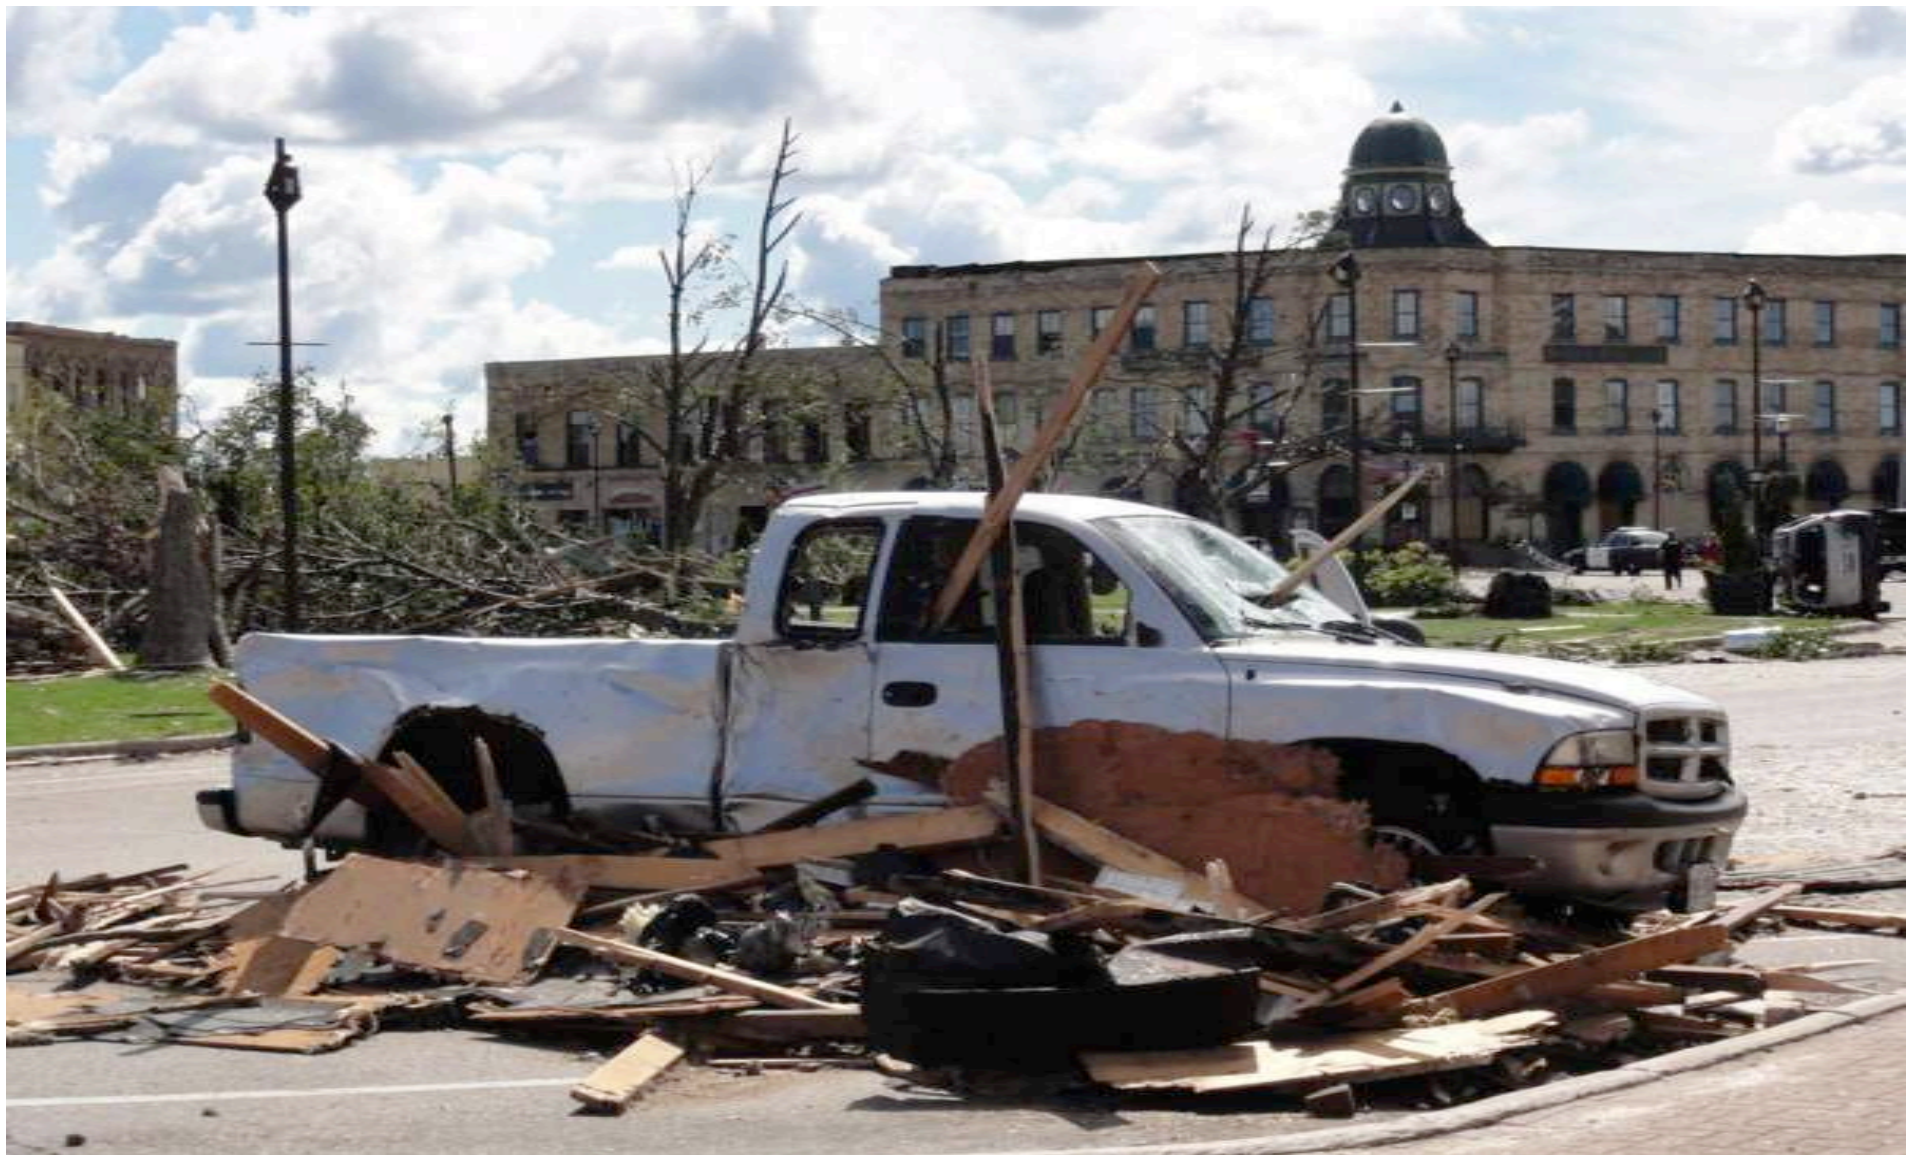
**Wind-borne debris**  
Goderich, ON, F3, August 2011

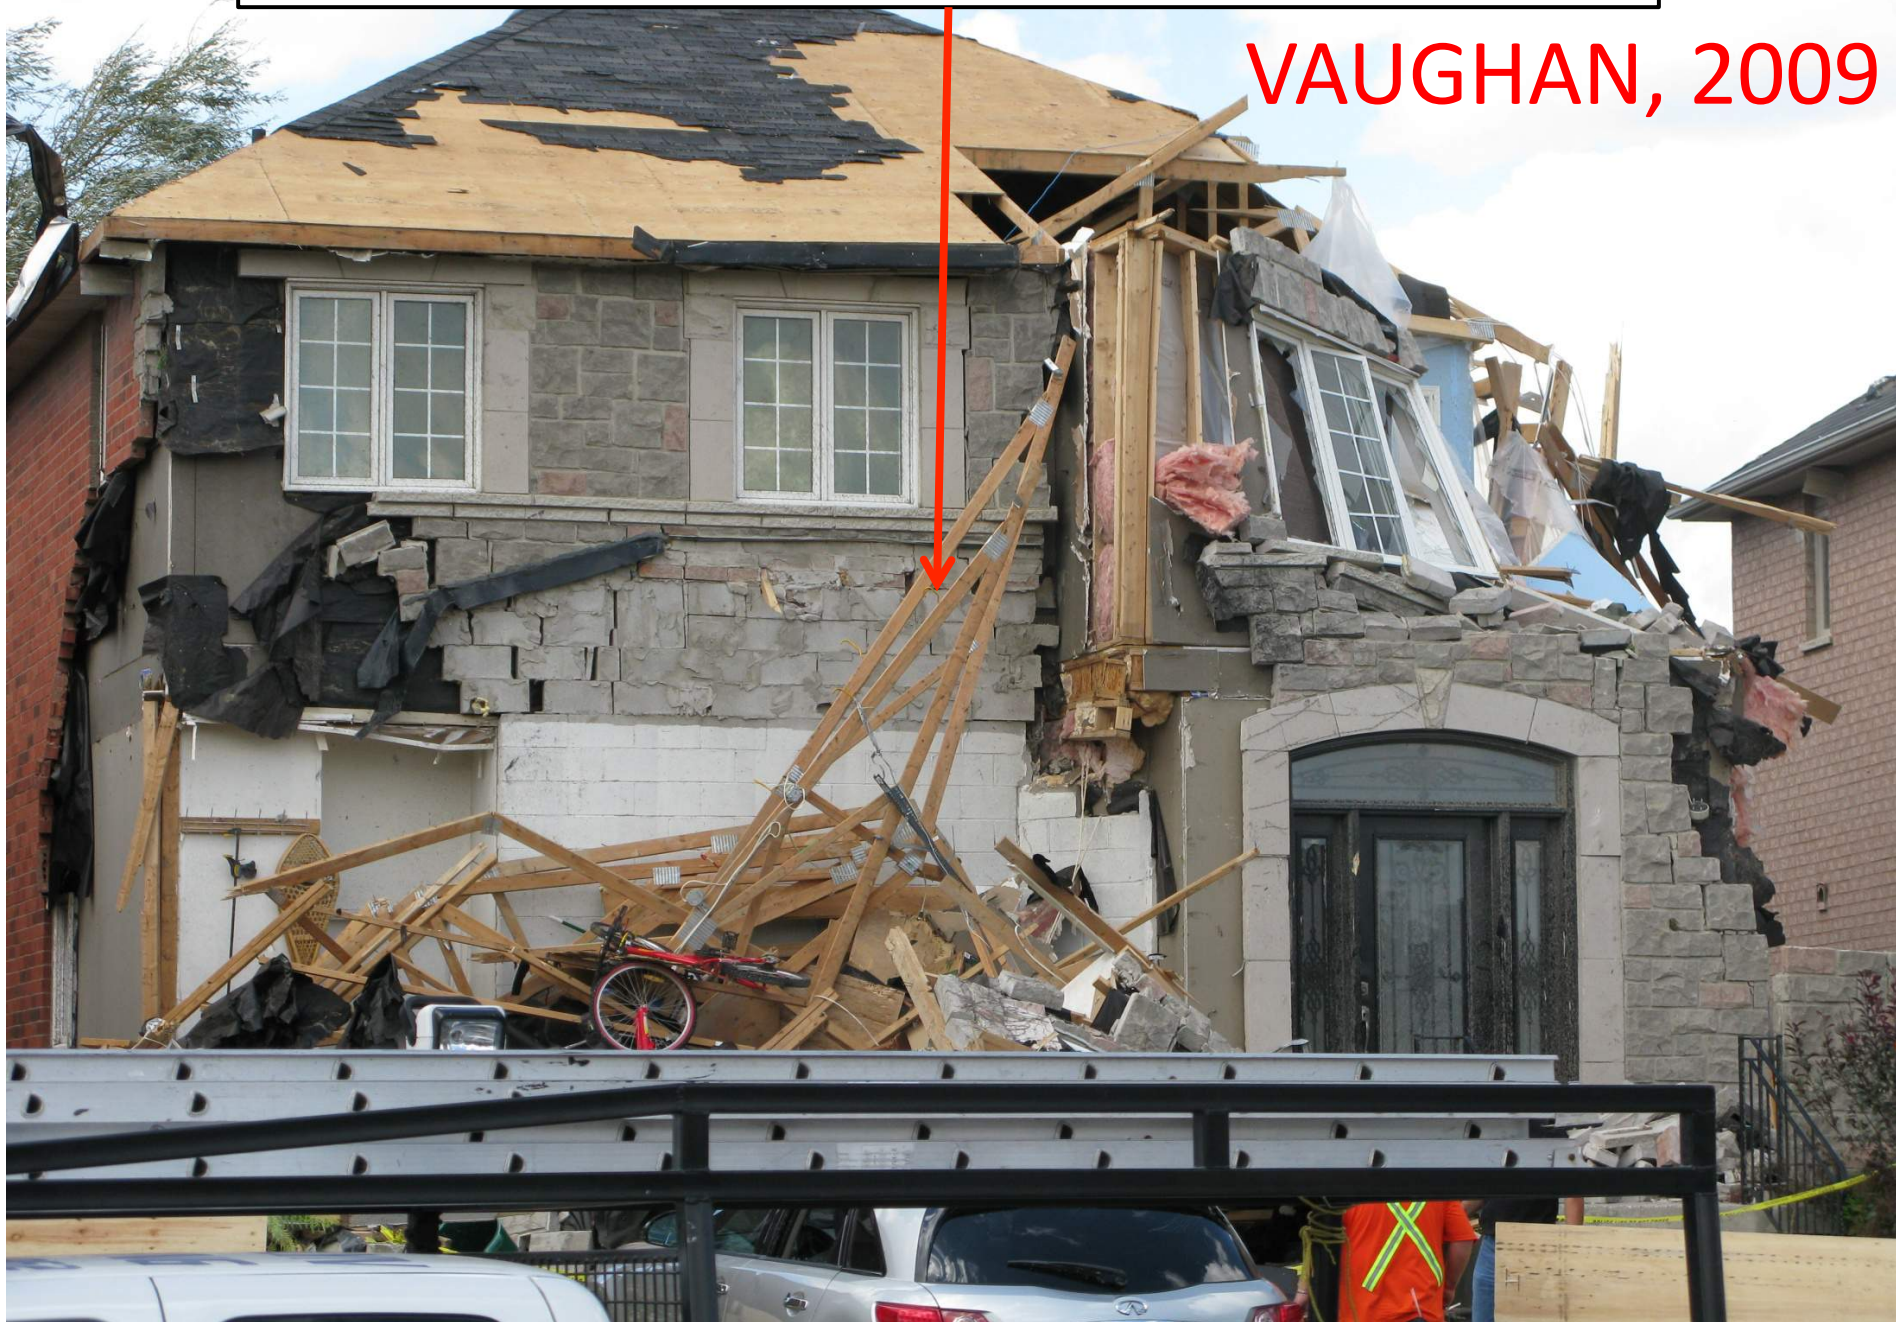
VAUGHAN, 2009

DEBRIS IMPACTS - Neighbour's garage roof landed on this house

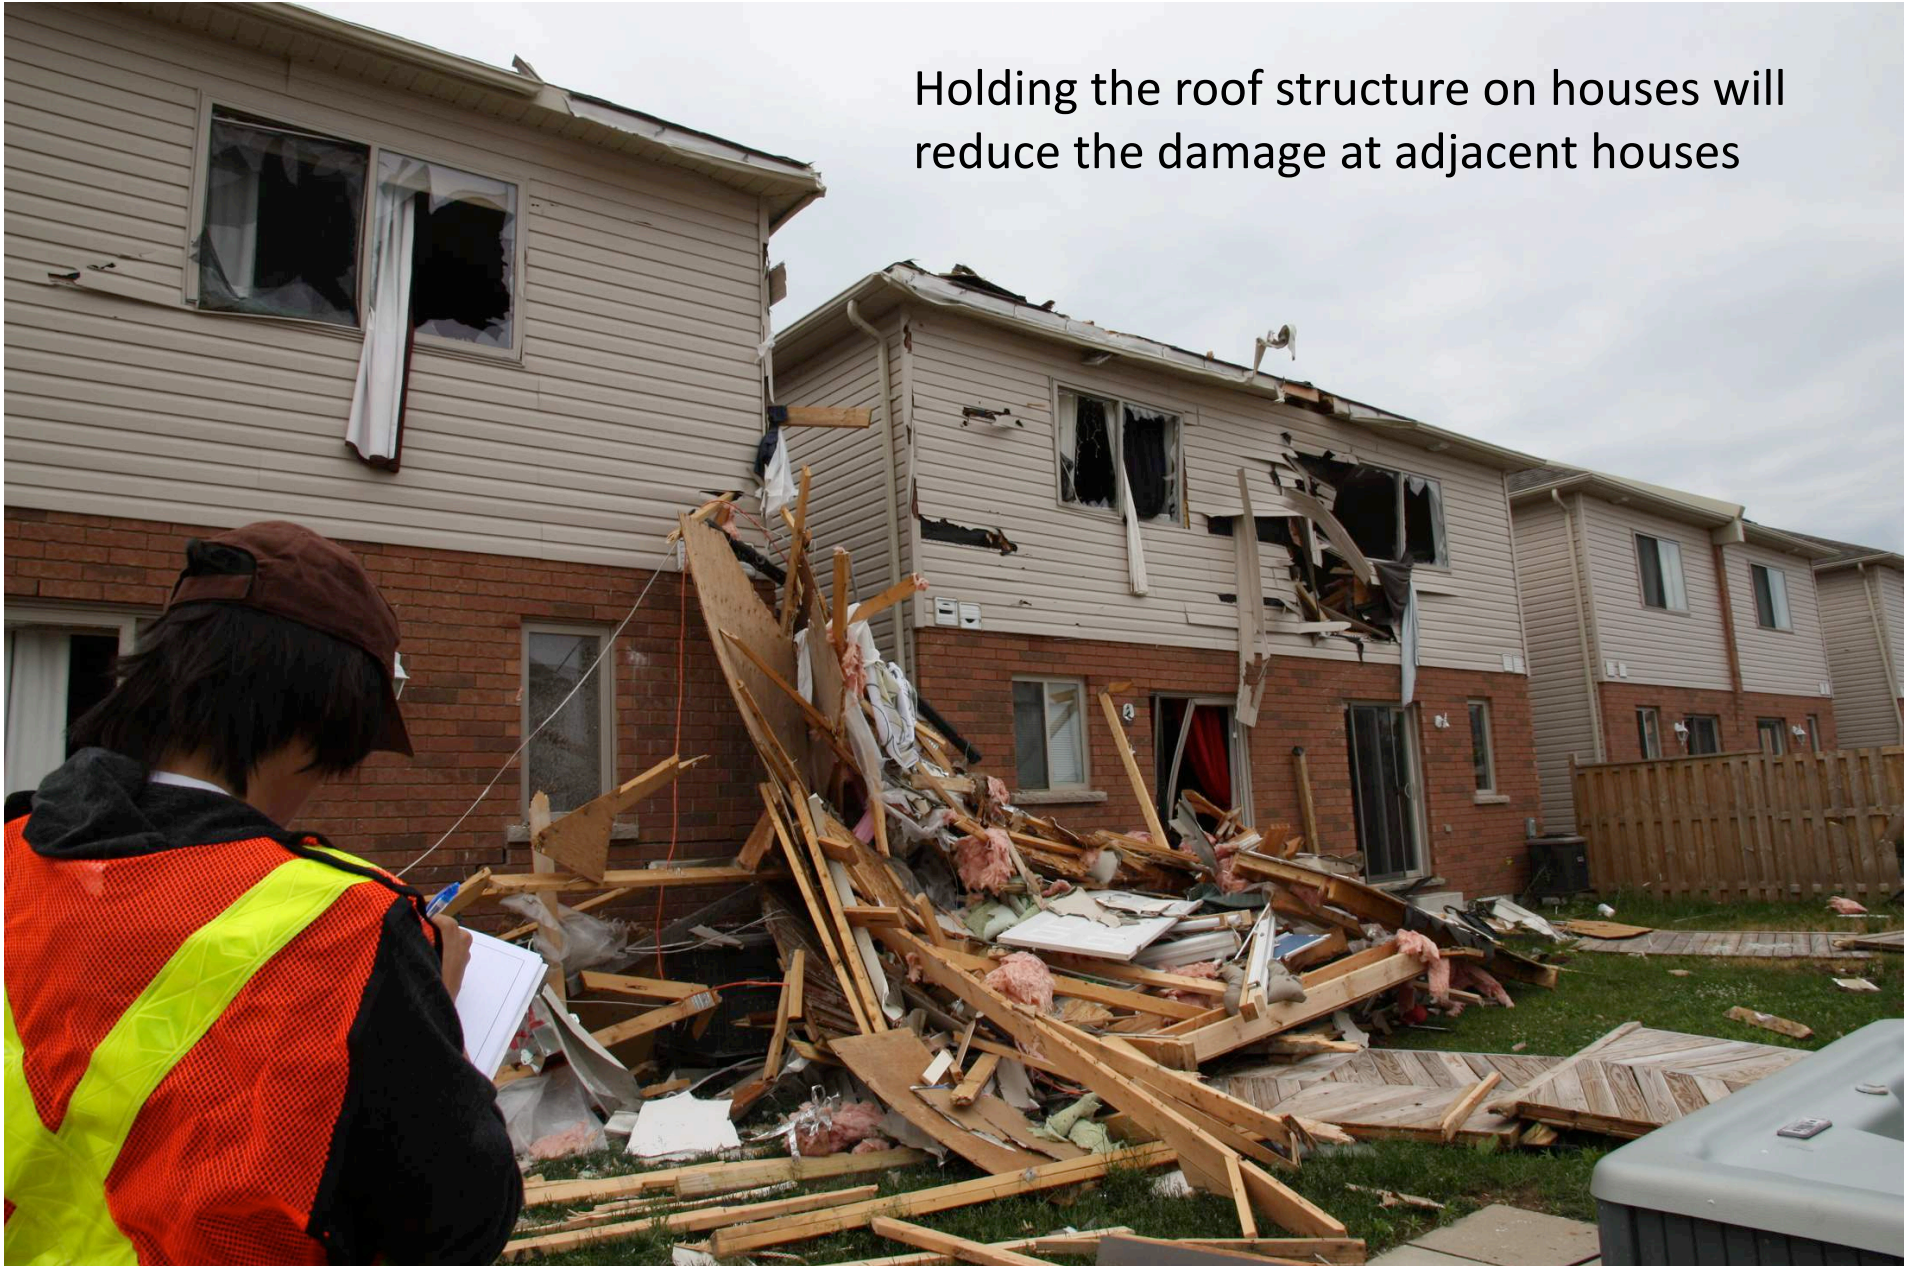
Holding the roof structure on houses will reduce the damage at adjacent houses

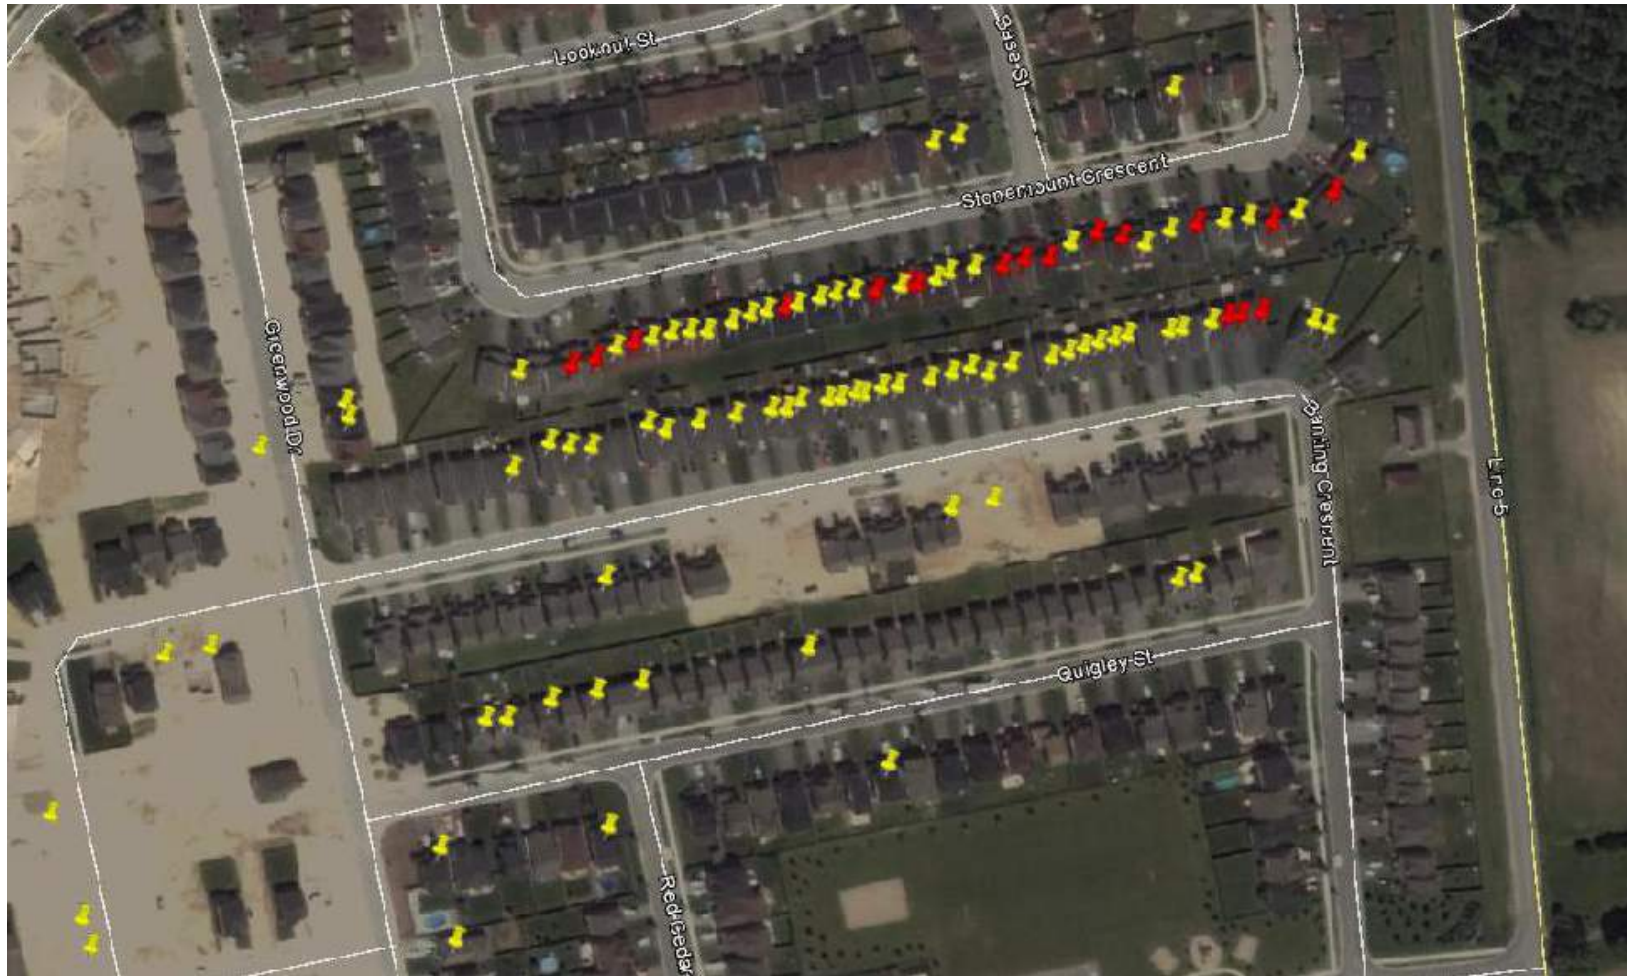
Red = debris impacts; Yellow = everything else.

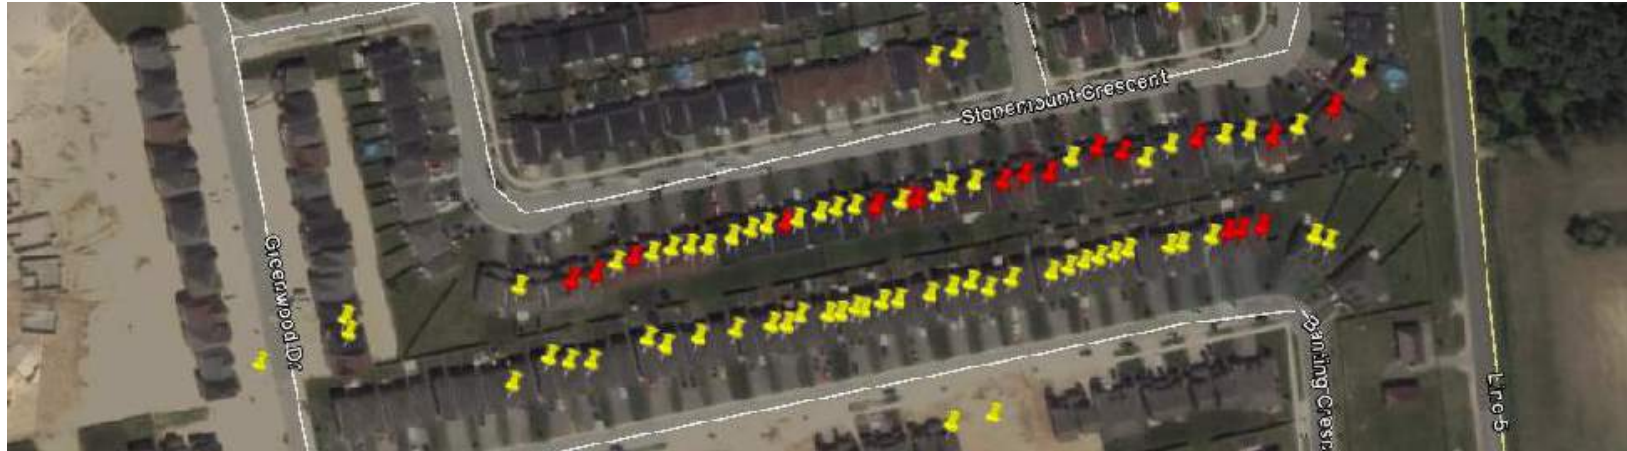
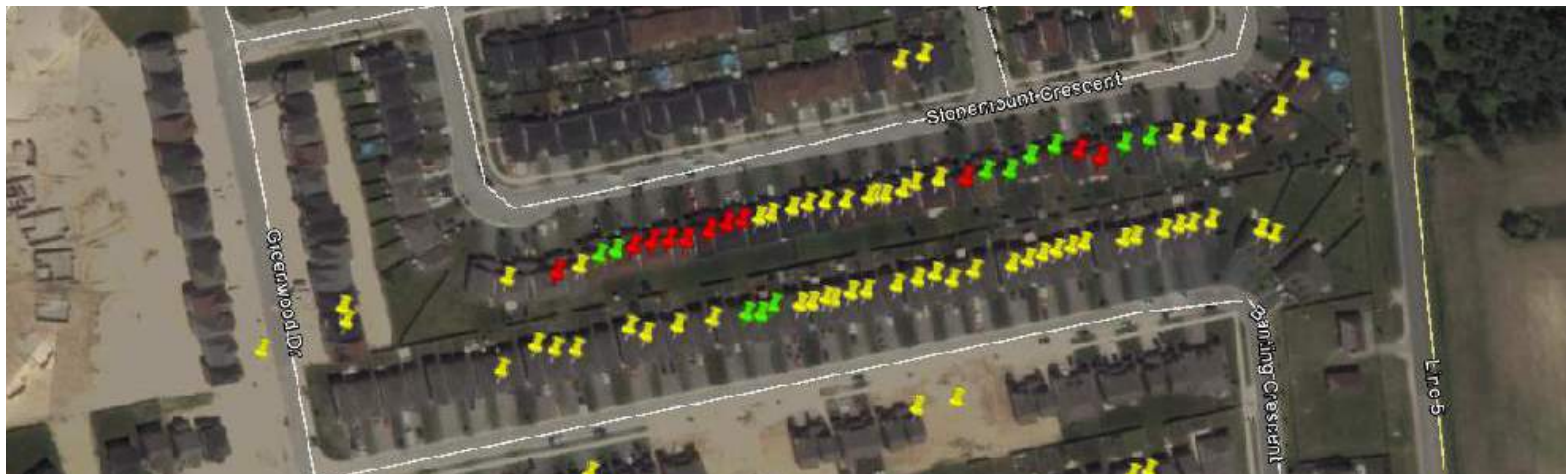
Preliminary analysis: Red = debris impacts; Yellow = everything else.

Debris impact damage is strongly correlated with **Structural Roof Damage**

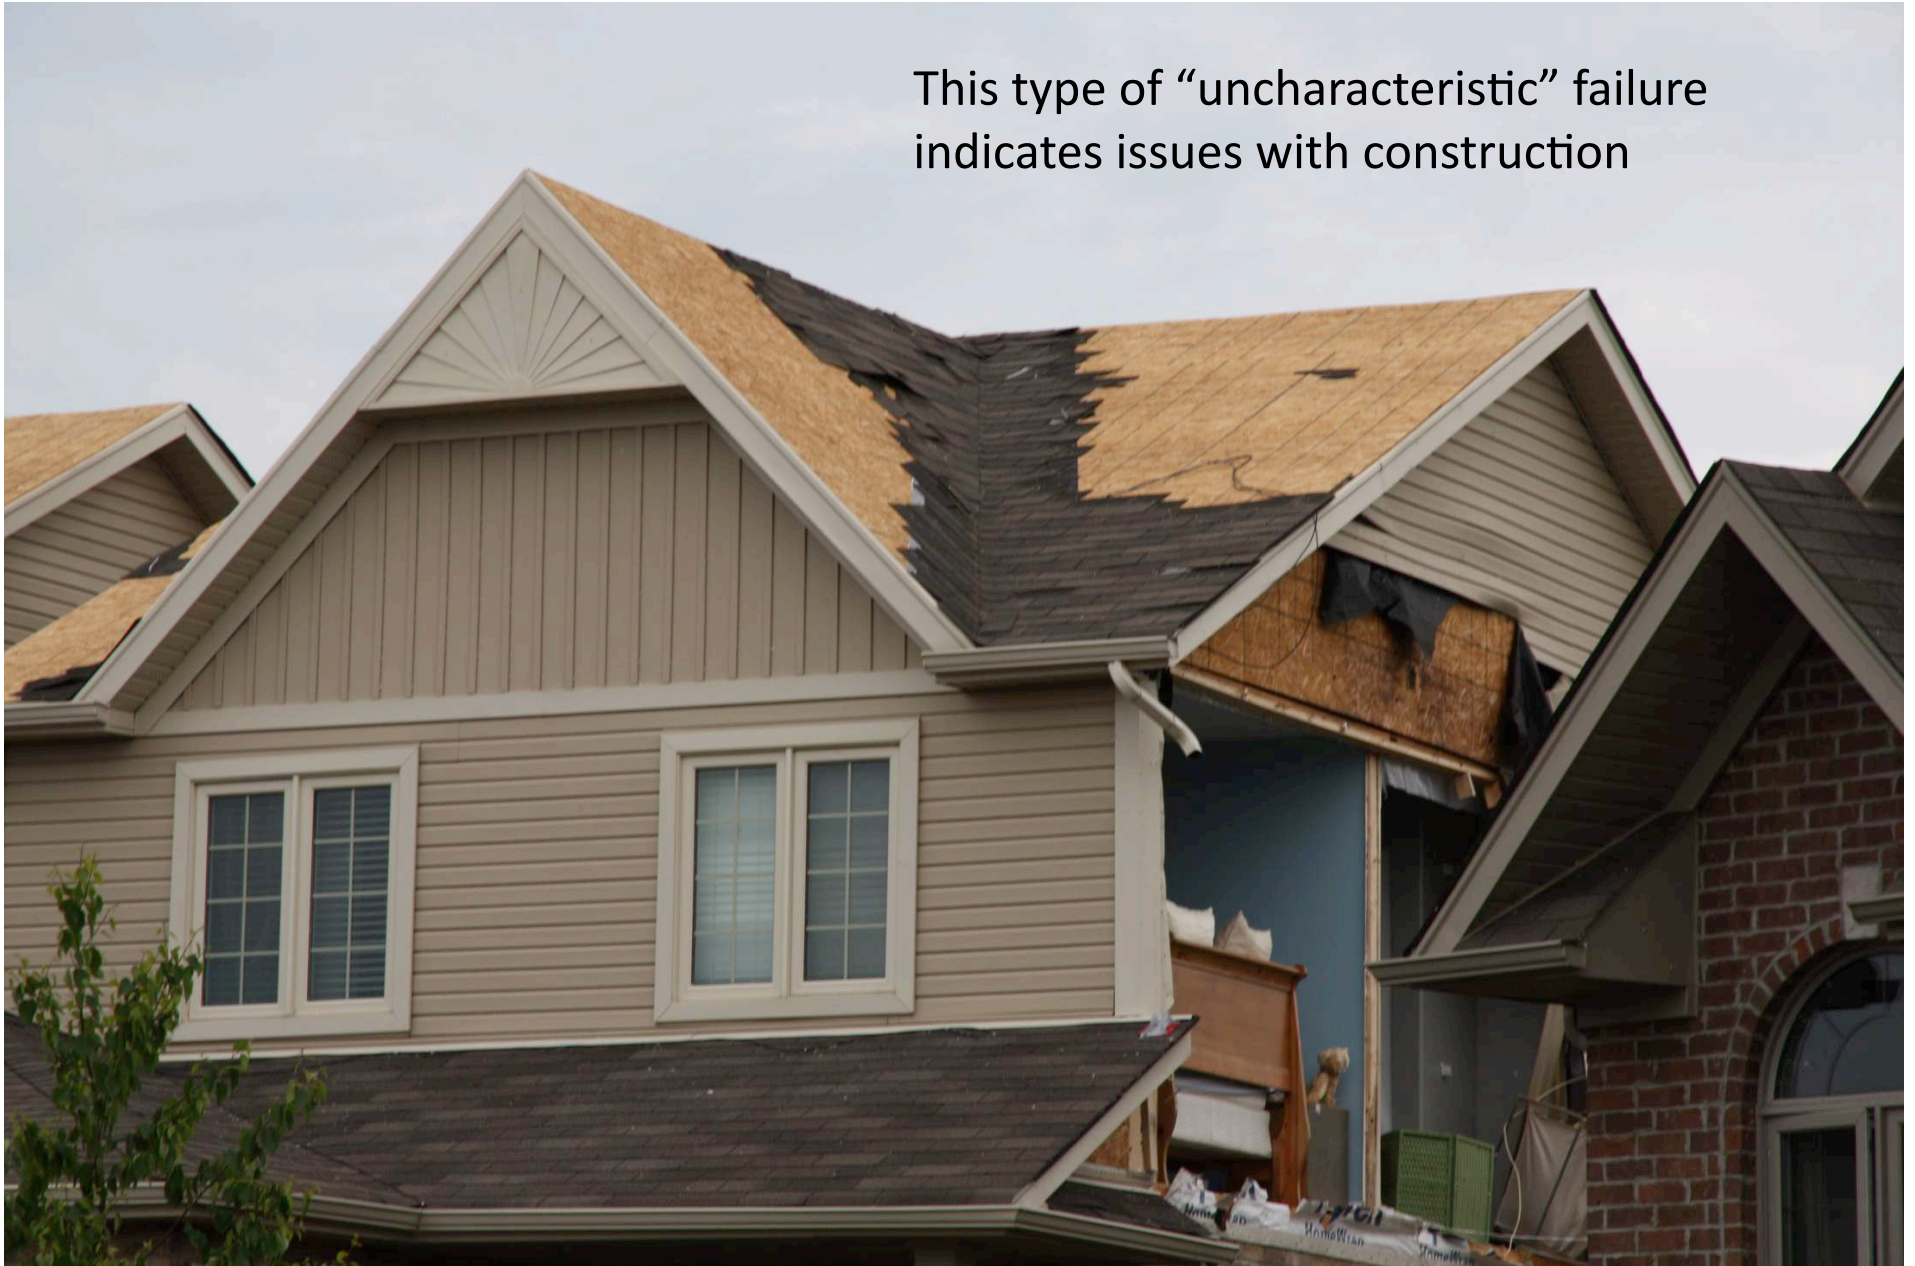
# Wall Failures

This type of “uncharacteristic” failure indicates issues with construction
