Observations from the Goderich Tornado

Sarah Stenabaugh

Goderich Damage Survey

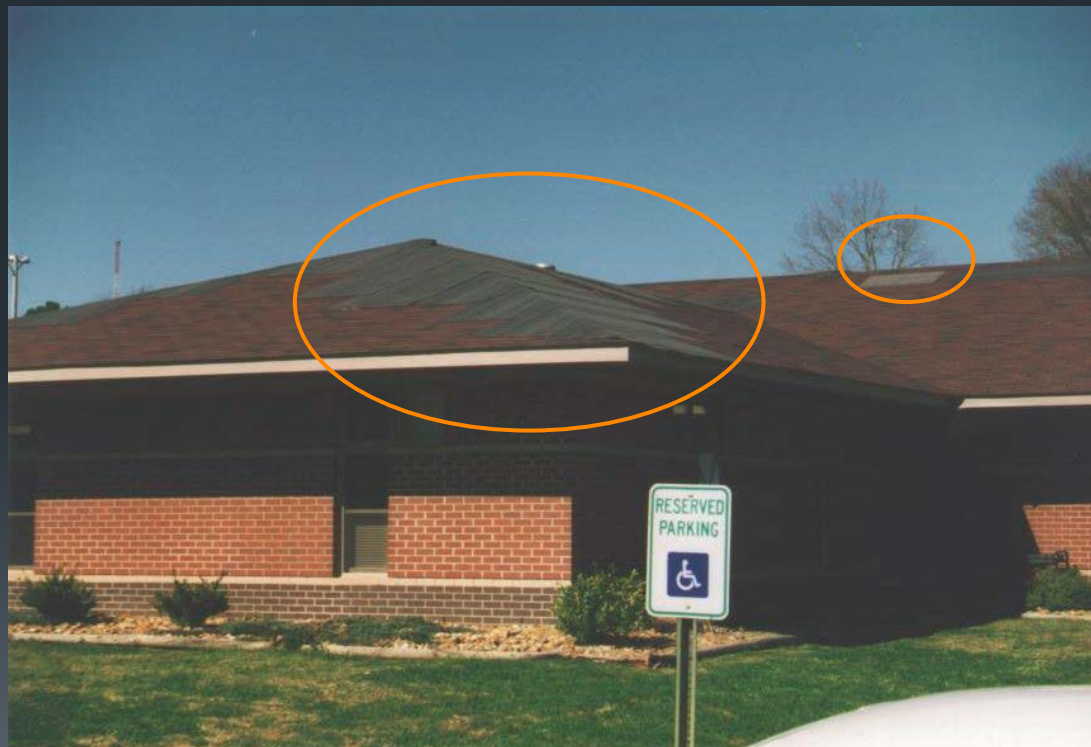
Escalating Damage – DoD 2

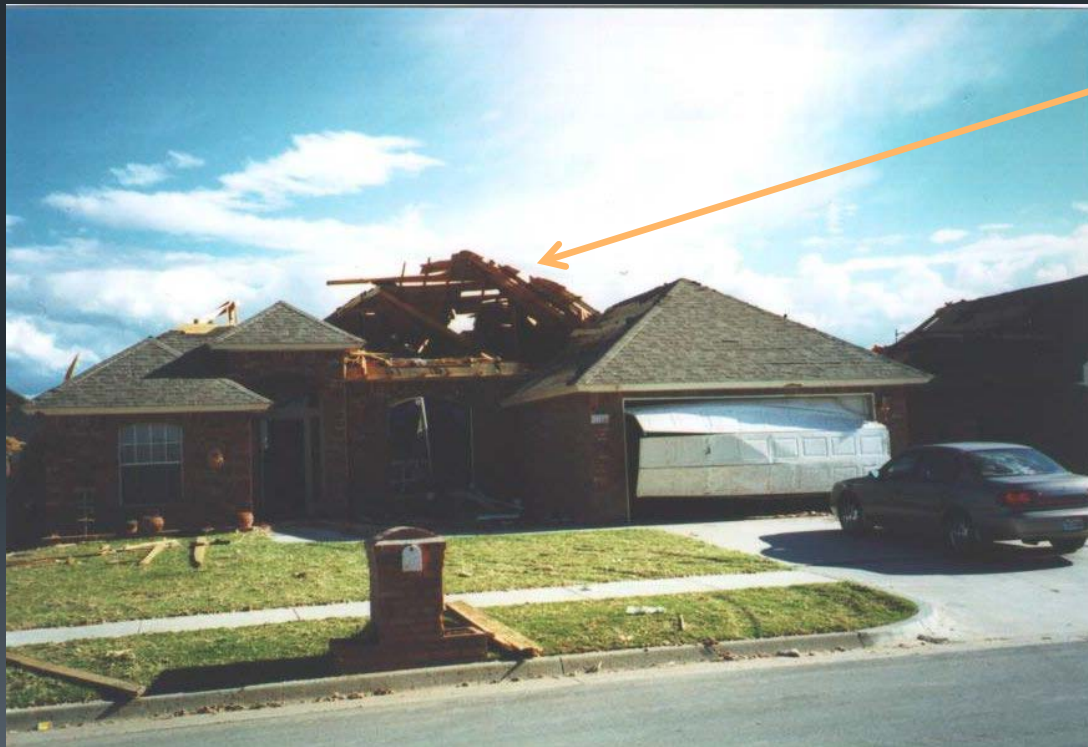
Escalating Damage – DoD 4

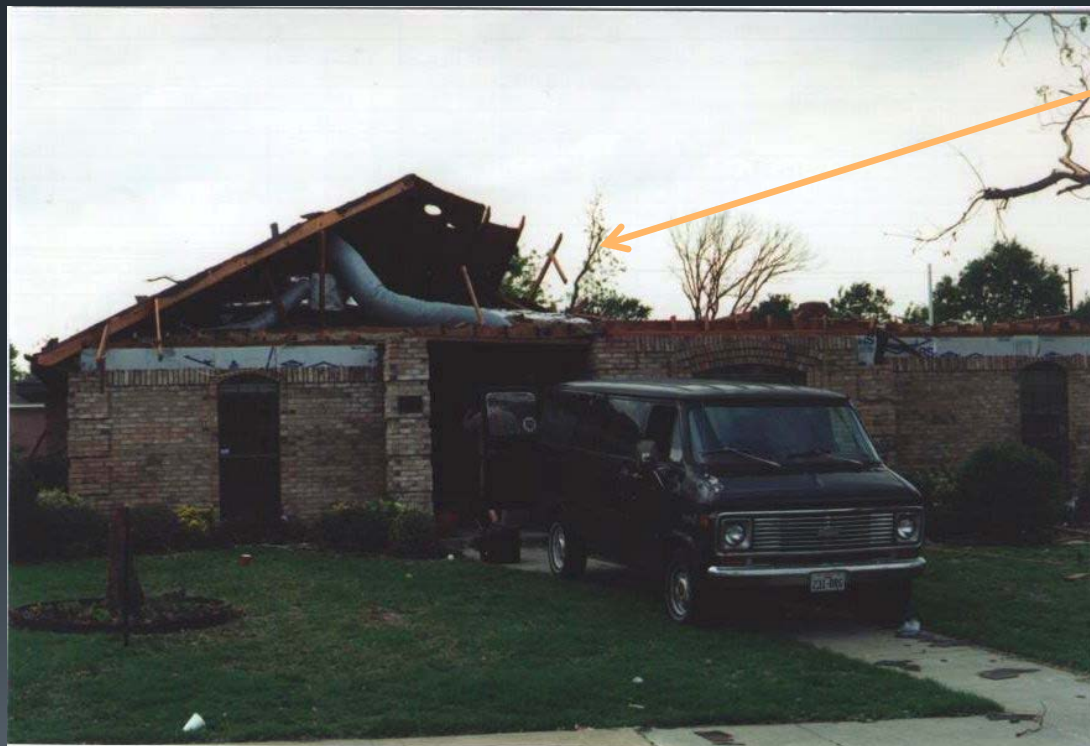
Escalating Damage – DoD 6

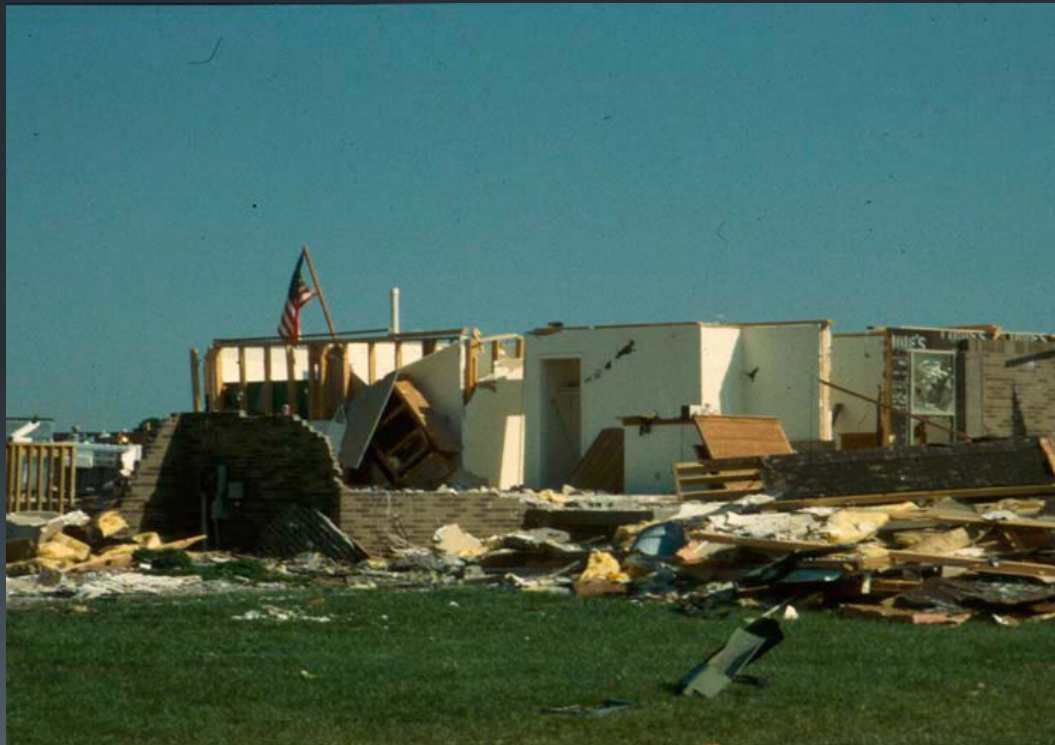
Escalating Damage – DoD 7

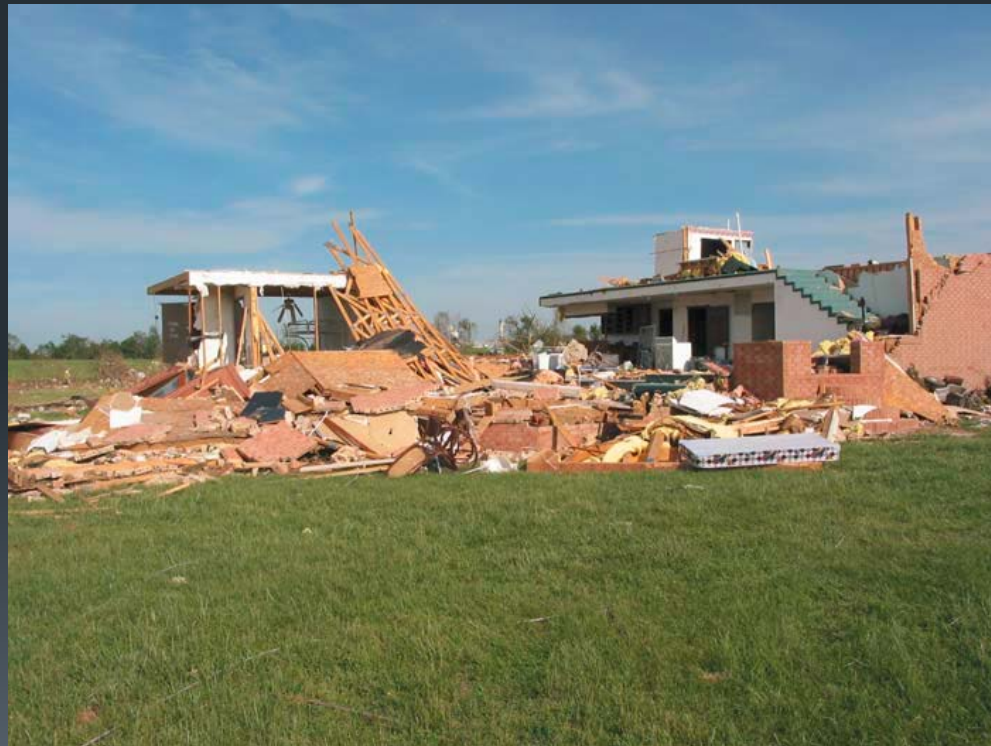
Escalating Damage – DoD 10

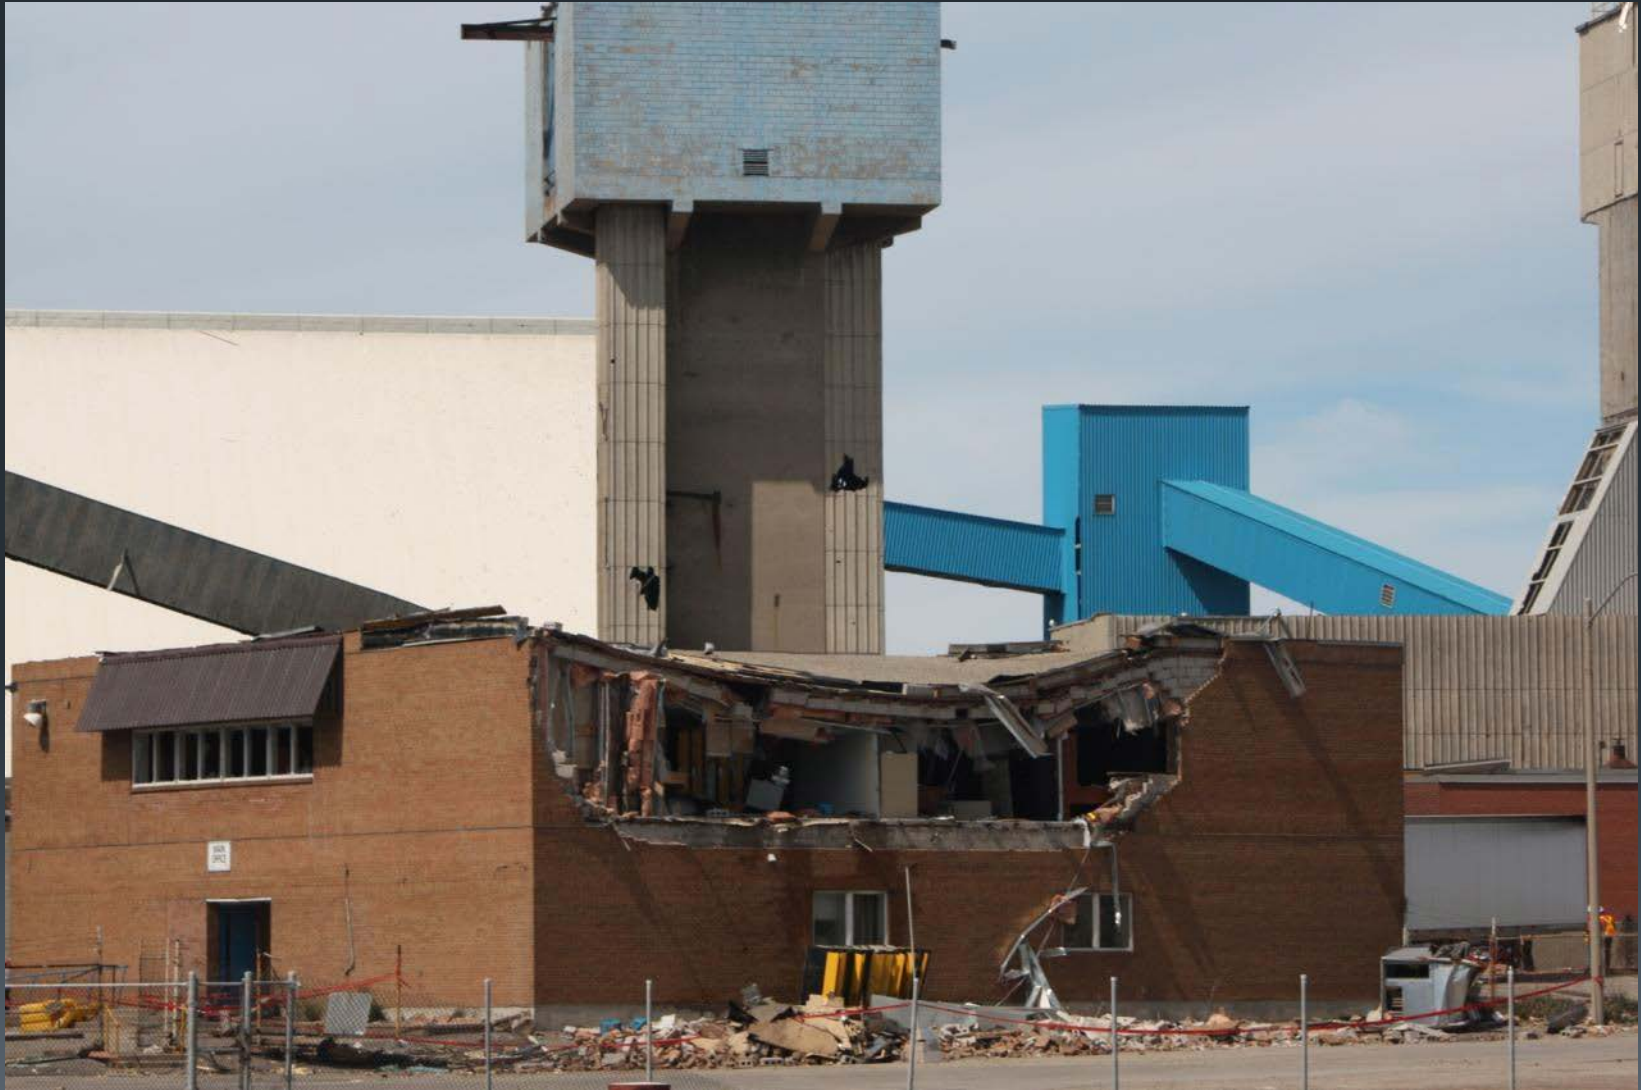
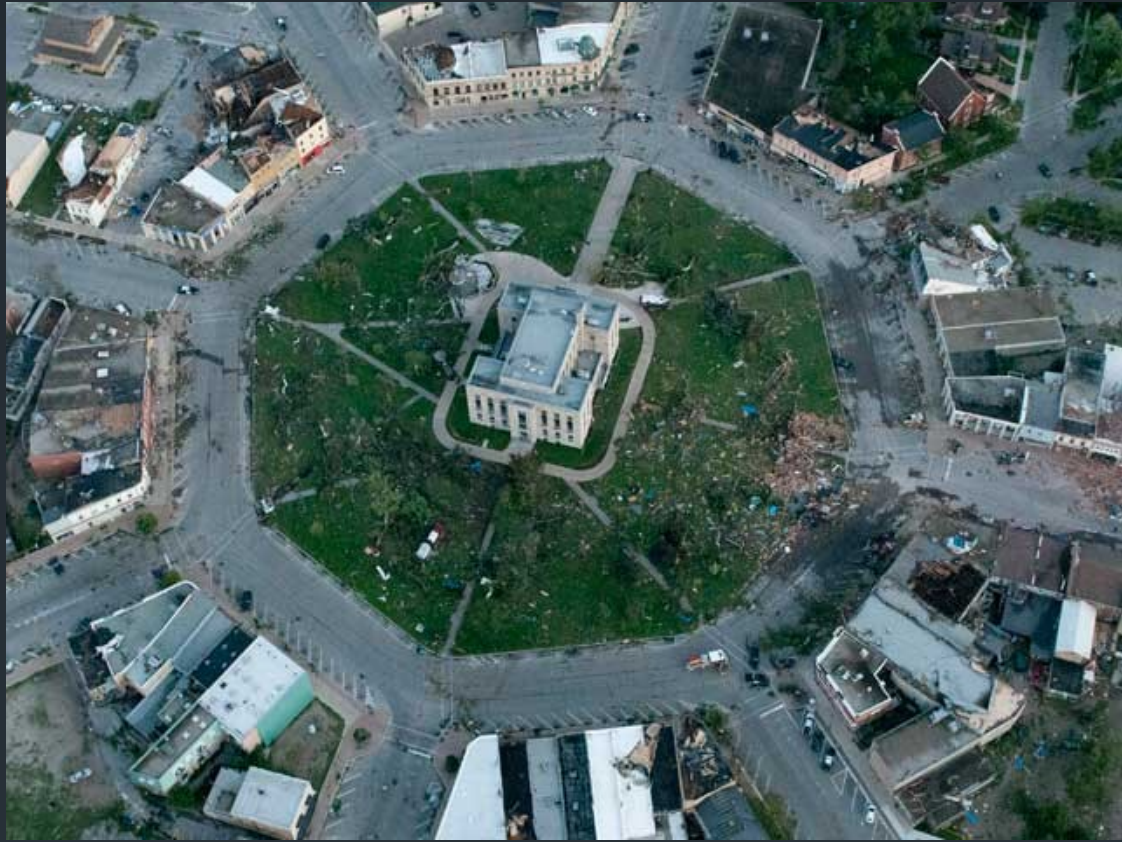
Damage Path – Landfall and Downtown Core

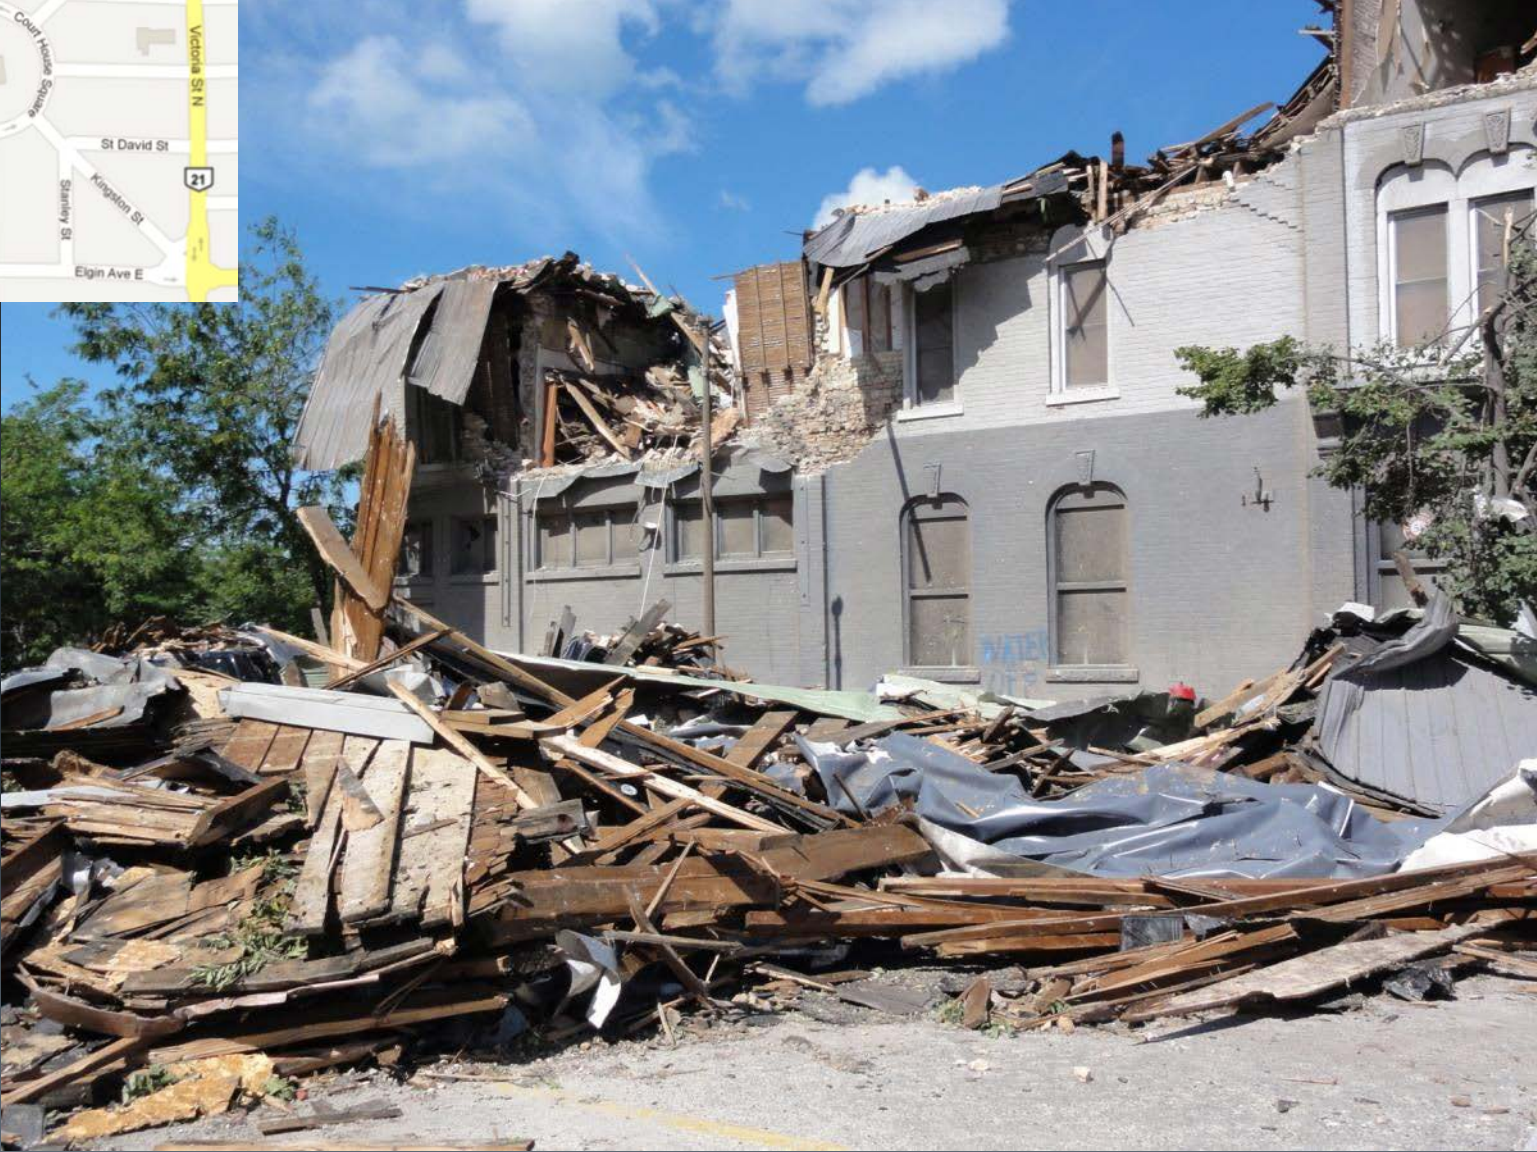
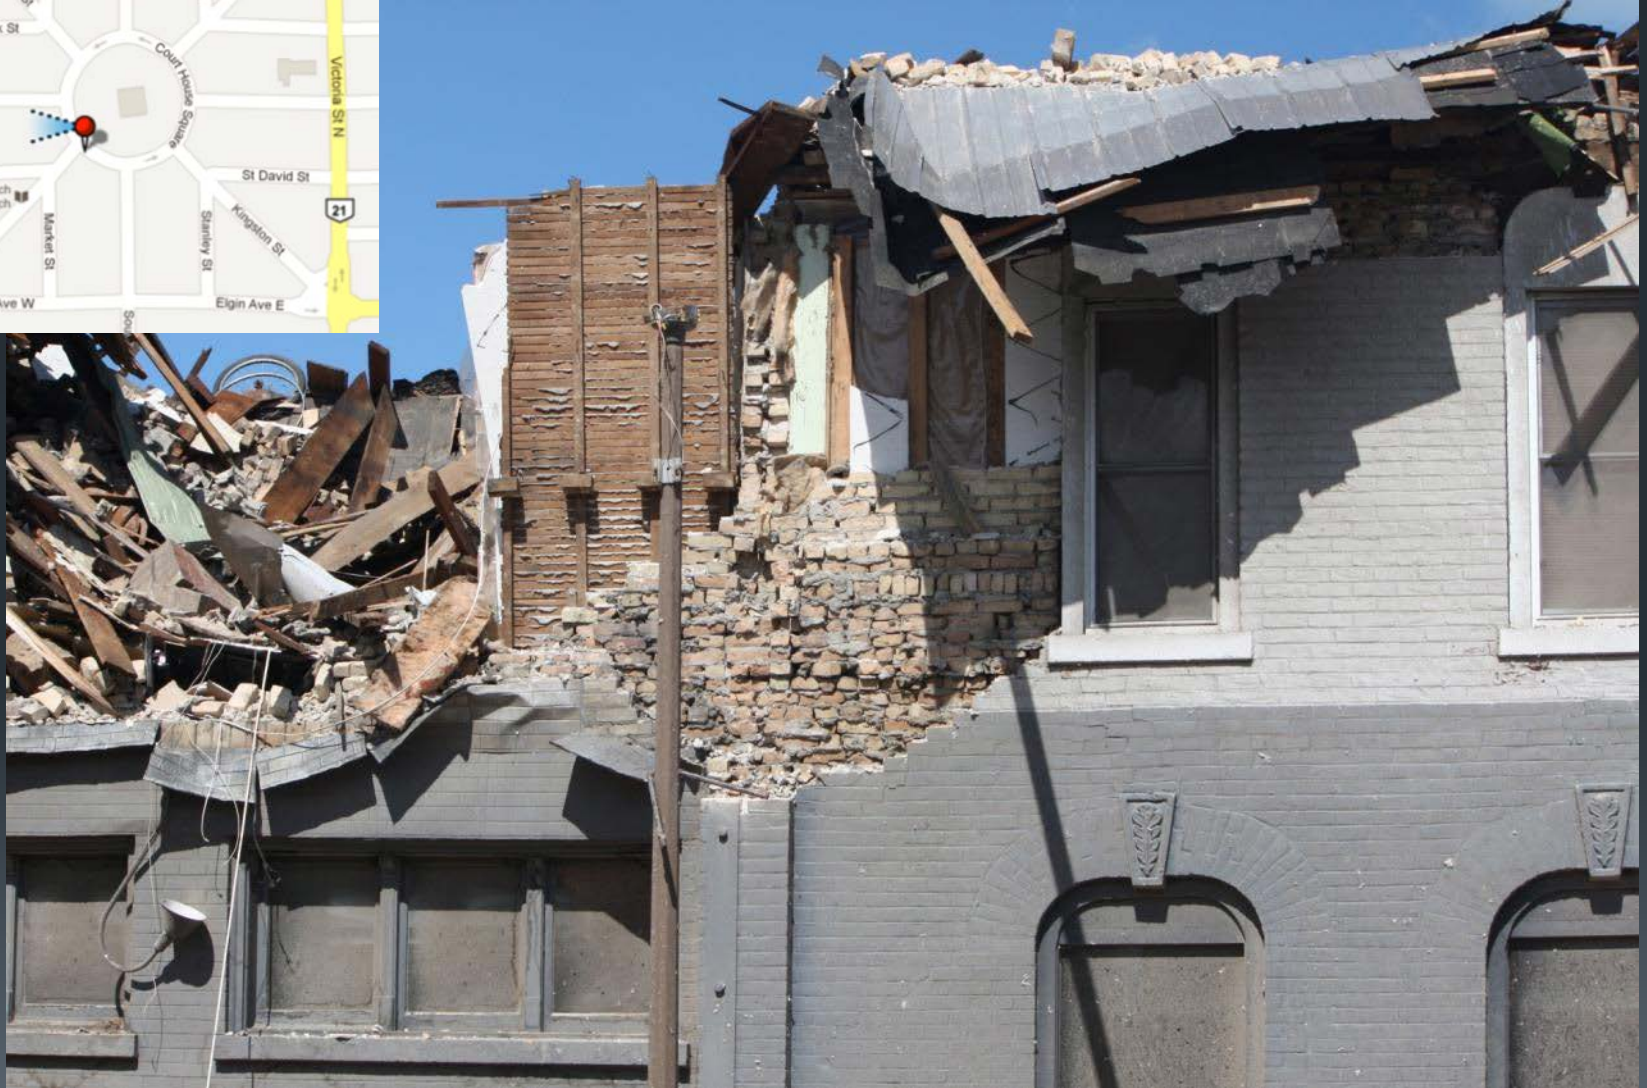
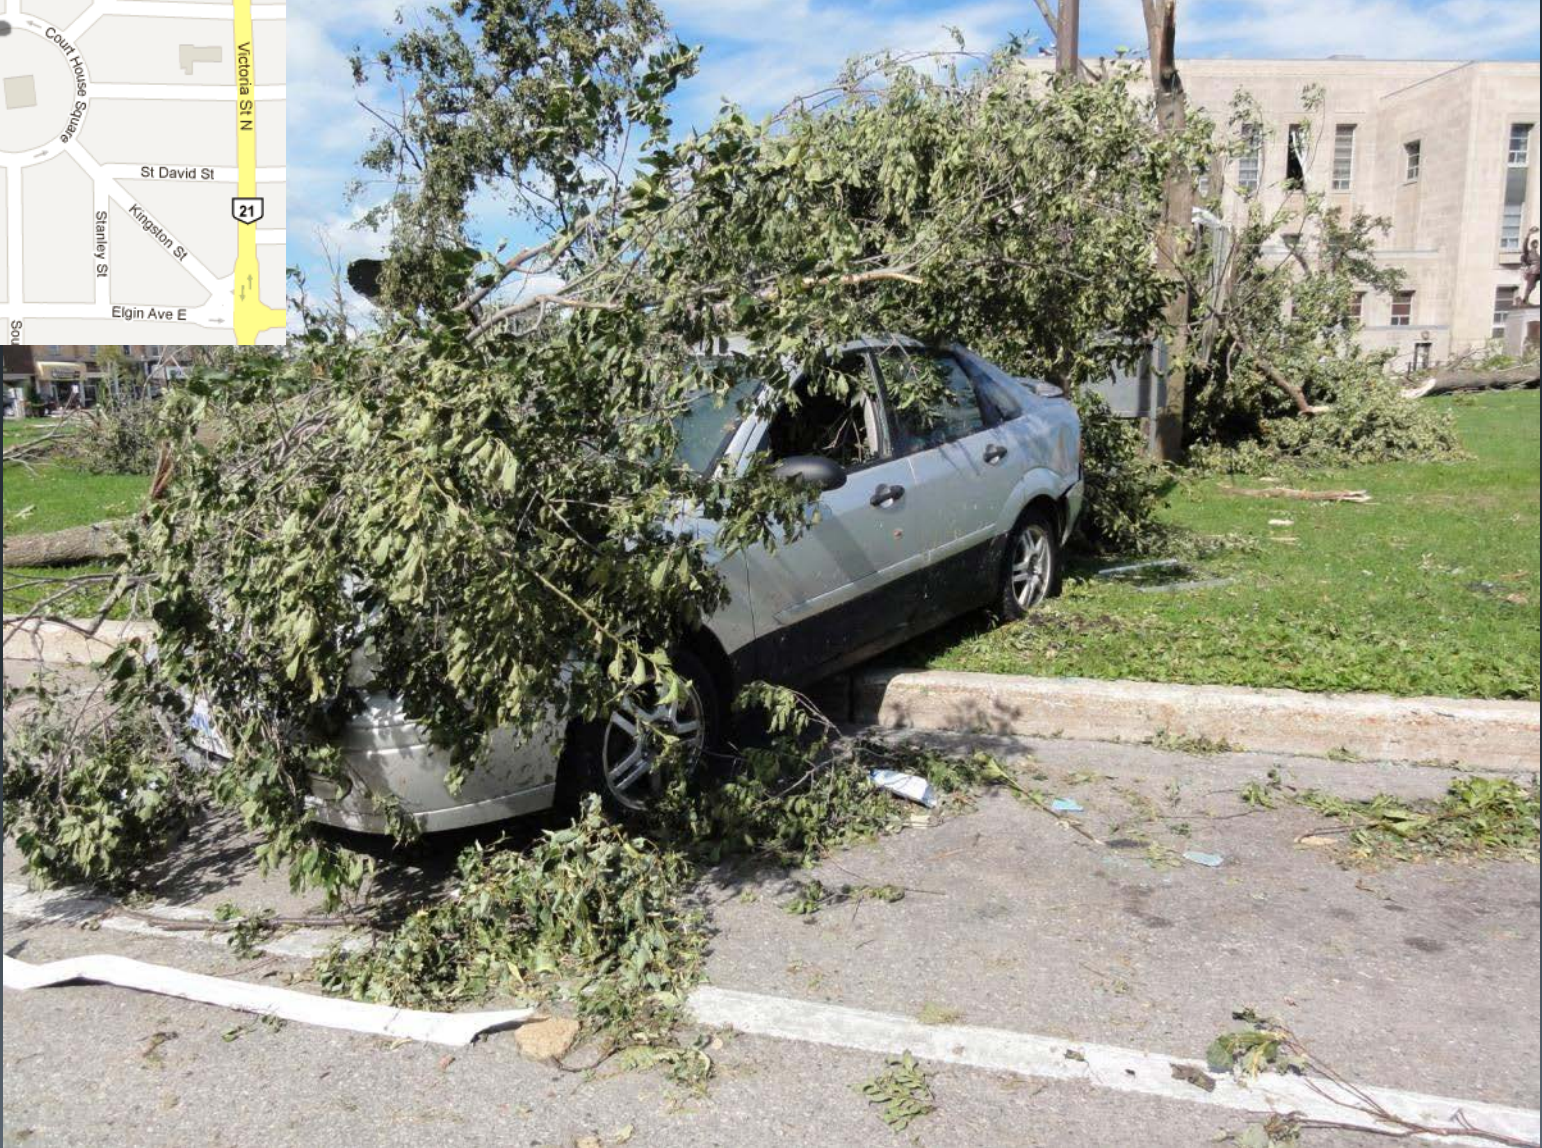
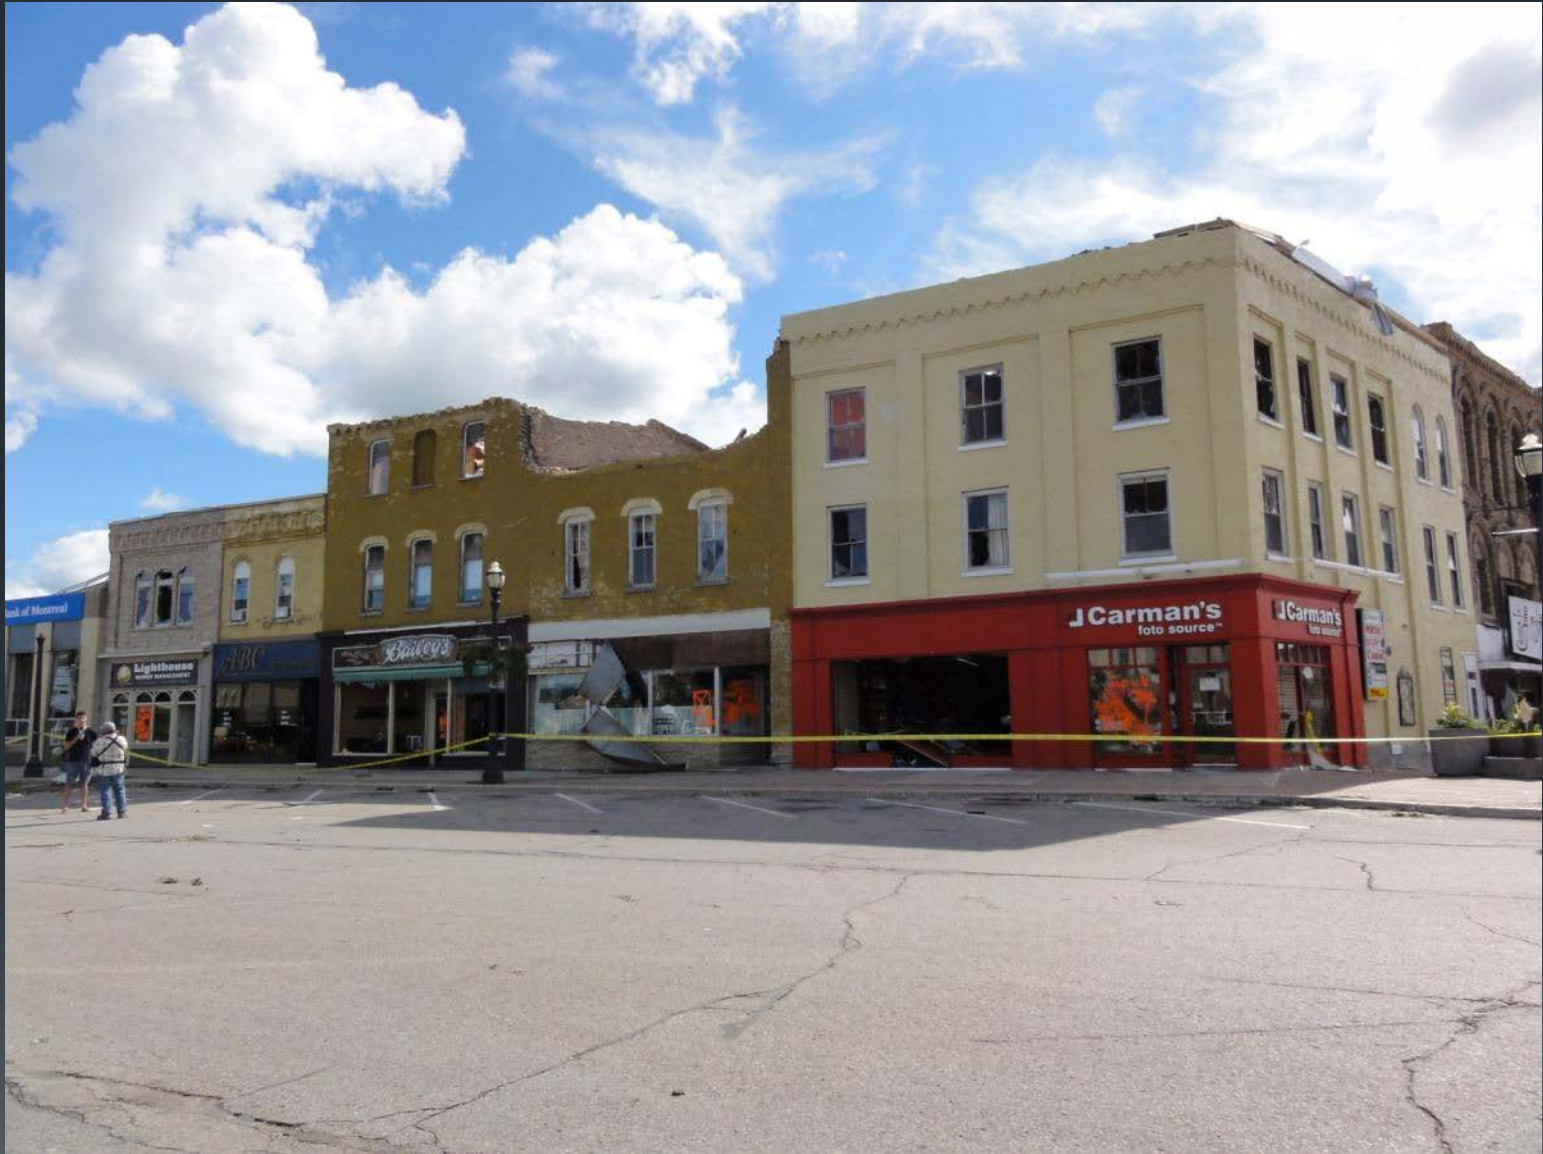
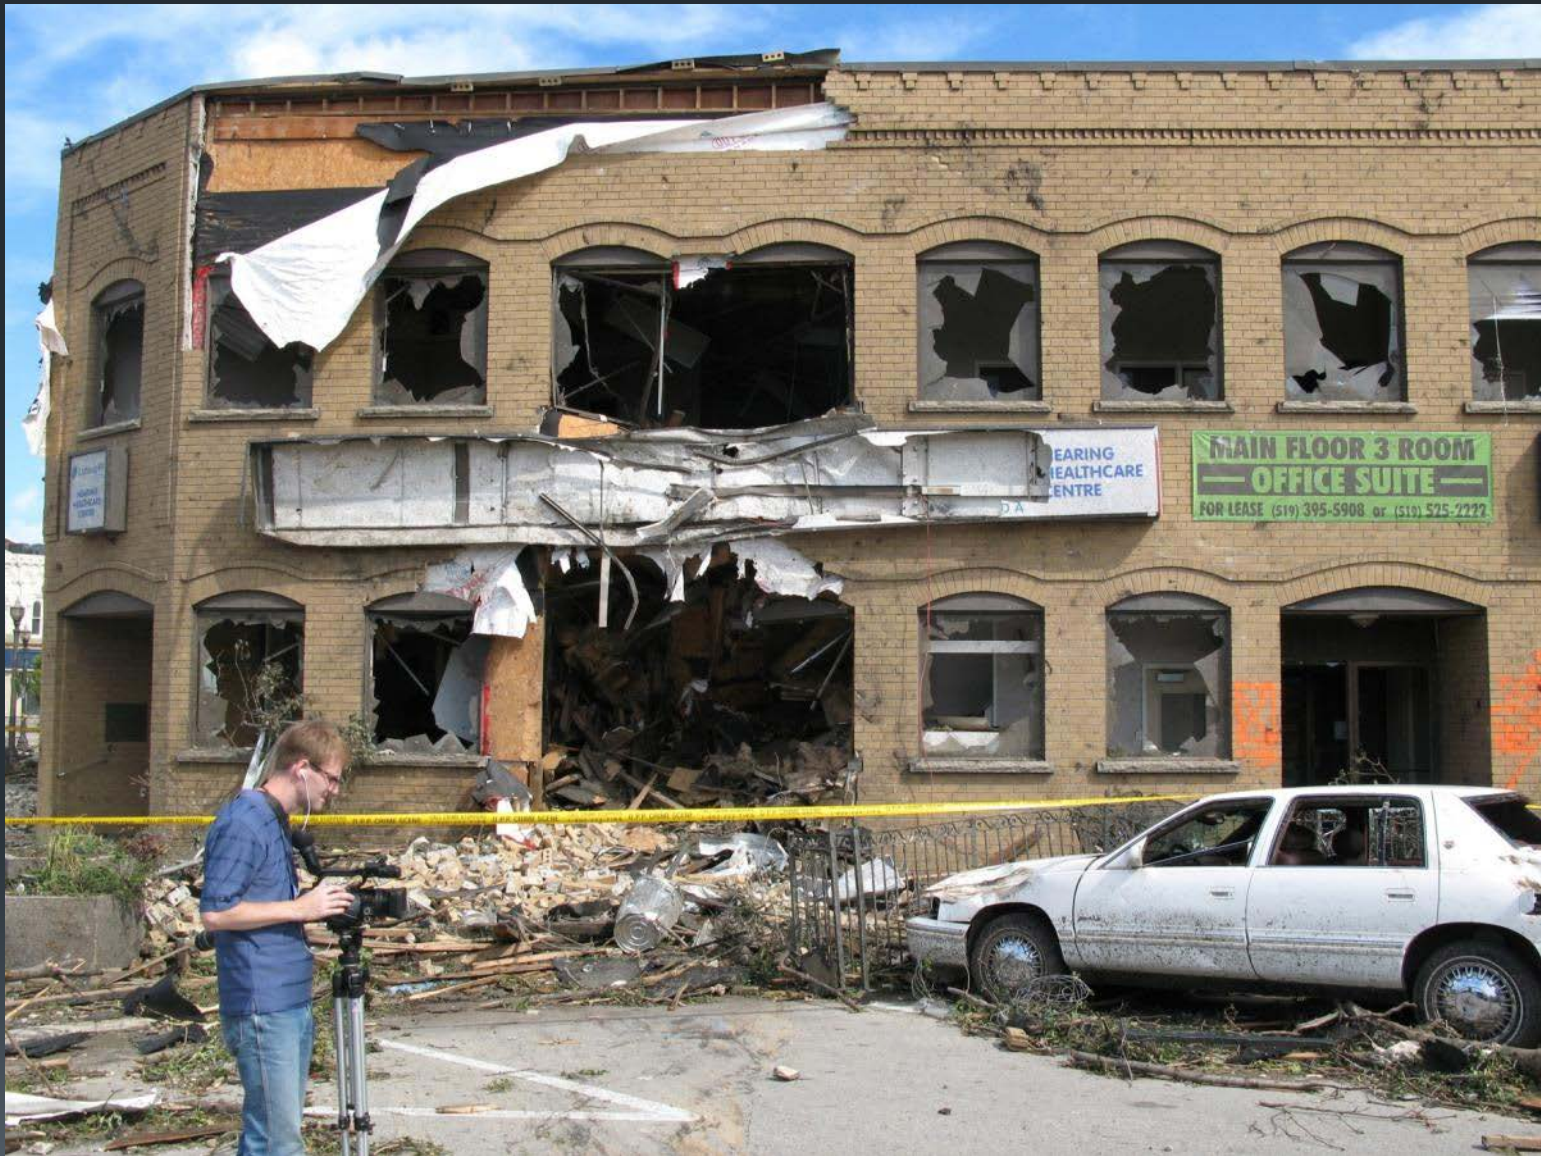
Downtown Core
