Observations from the Goderich Tornado

Sarah Stenabaugh

Goderich Damage Survey

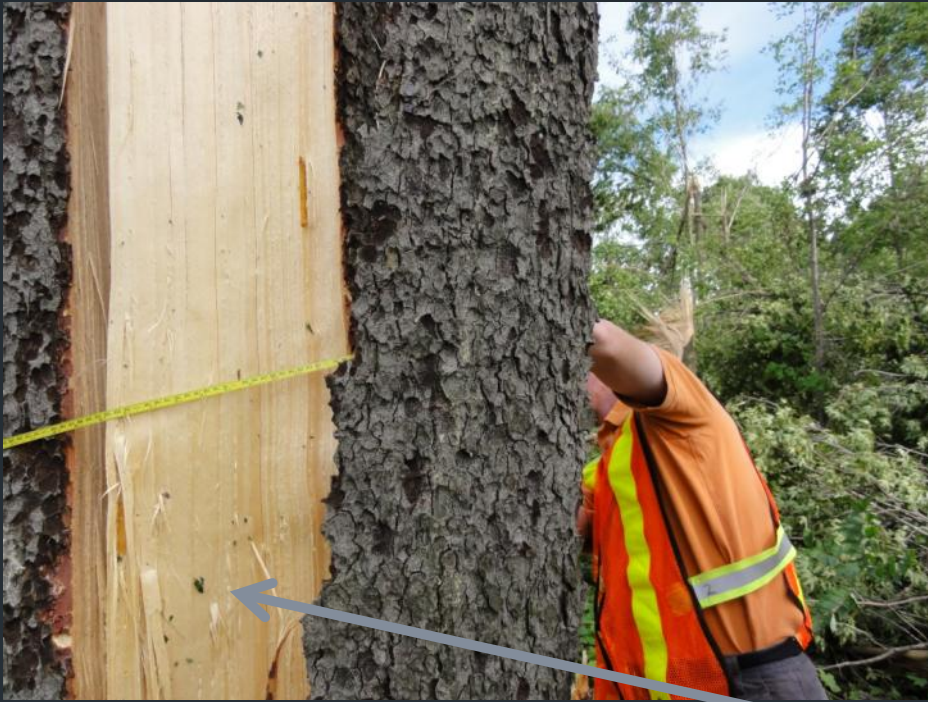
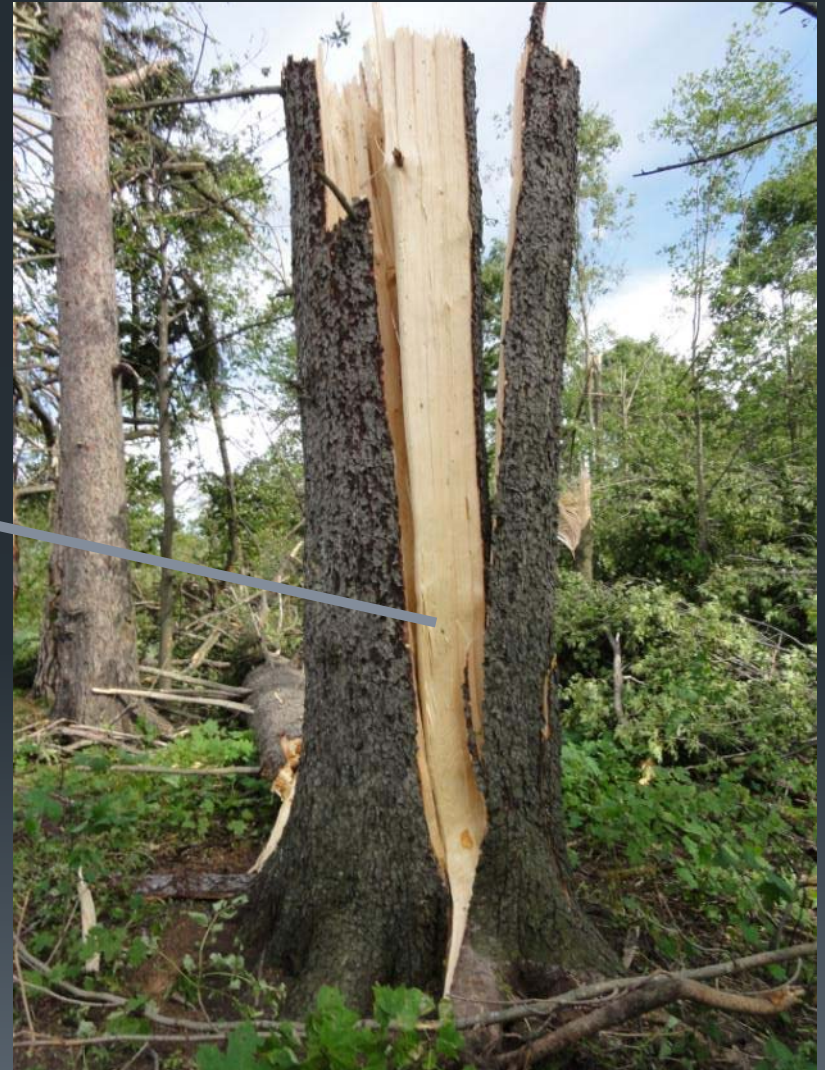
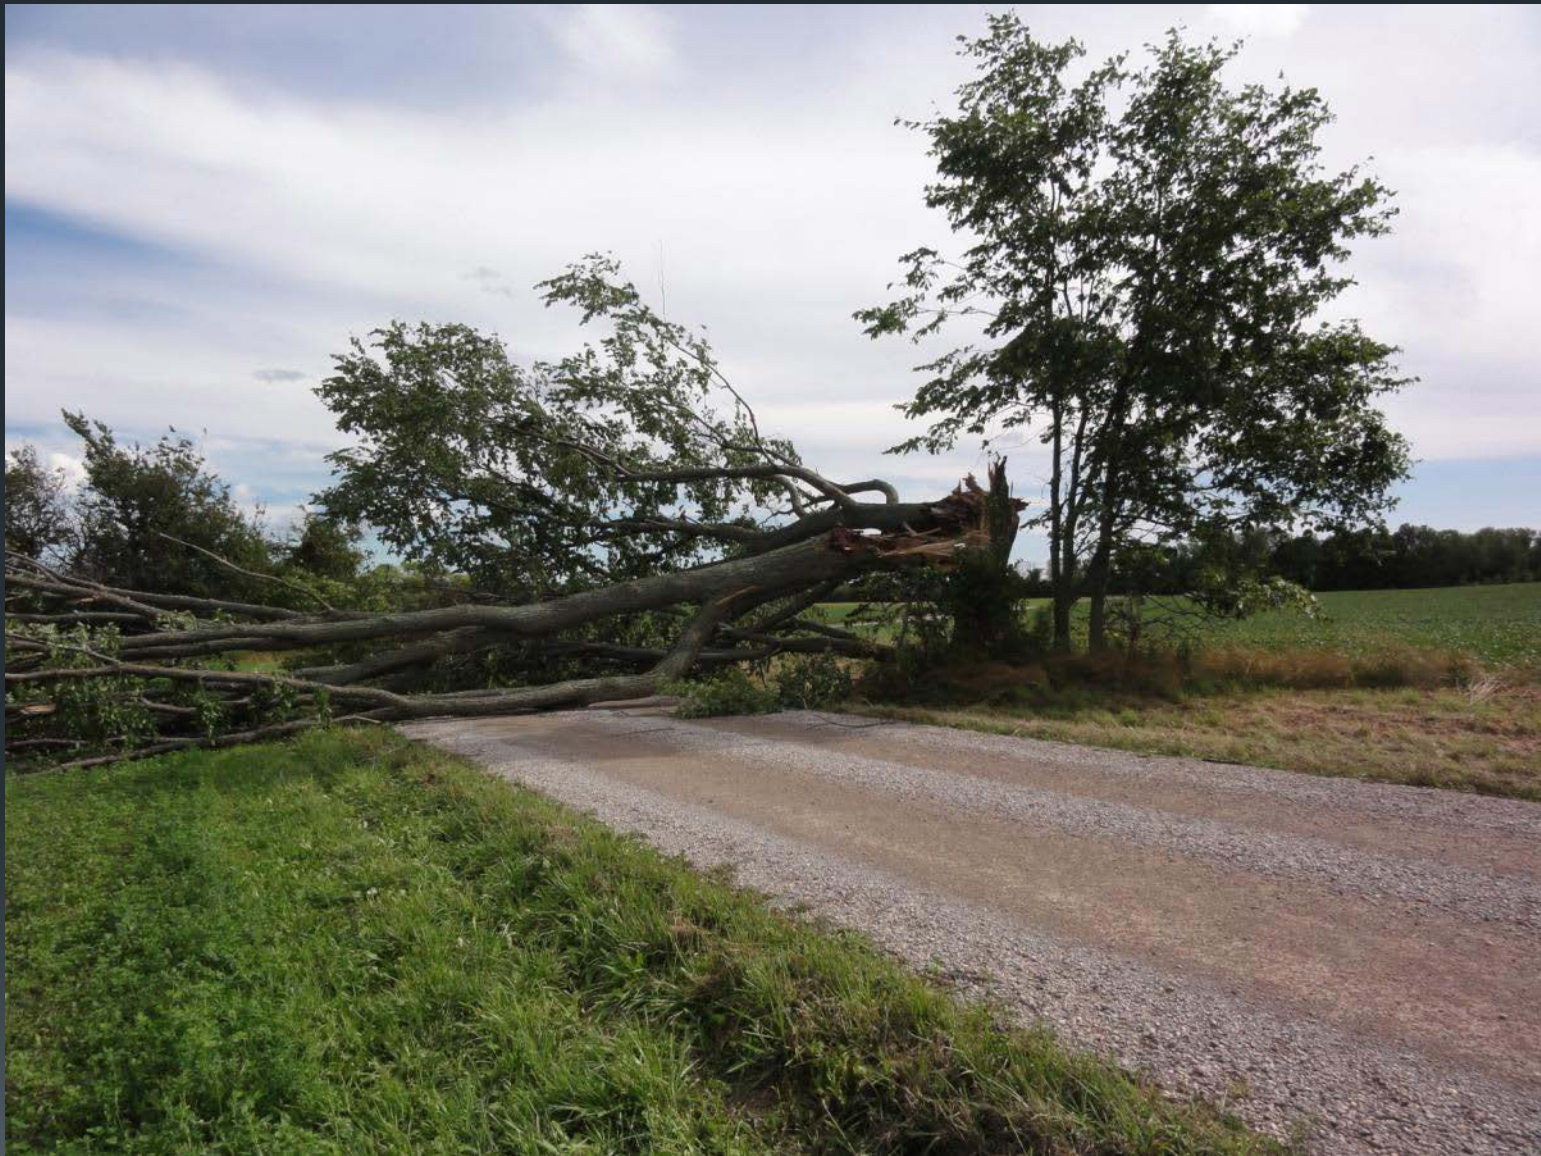
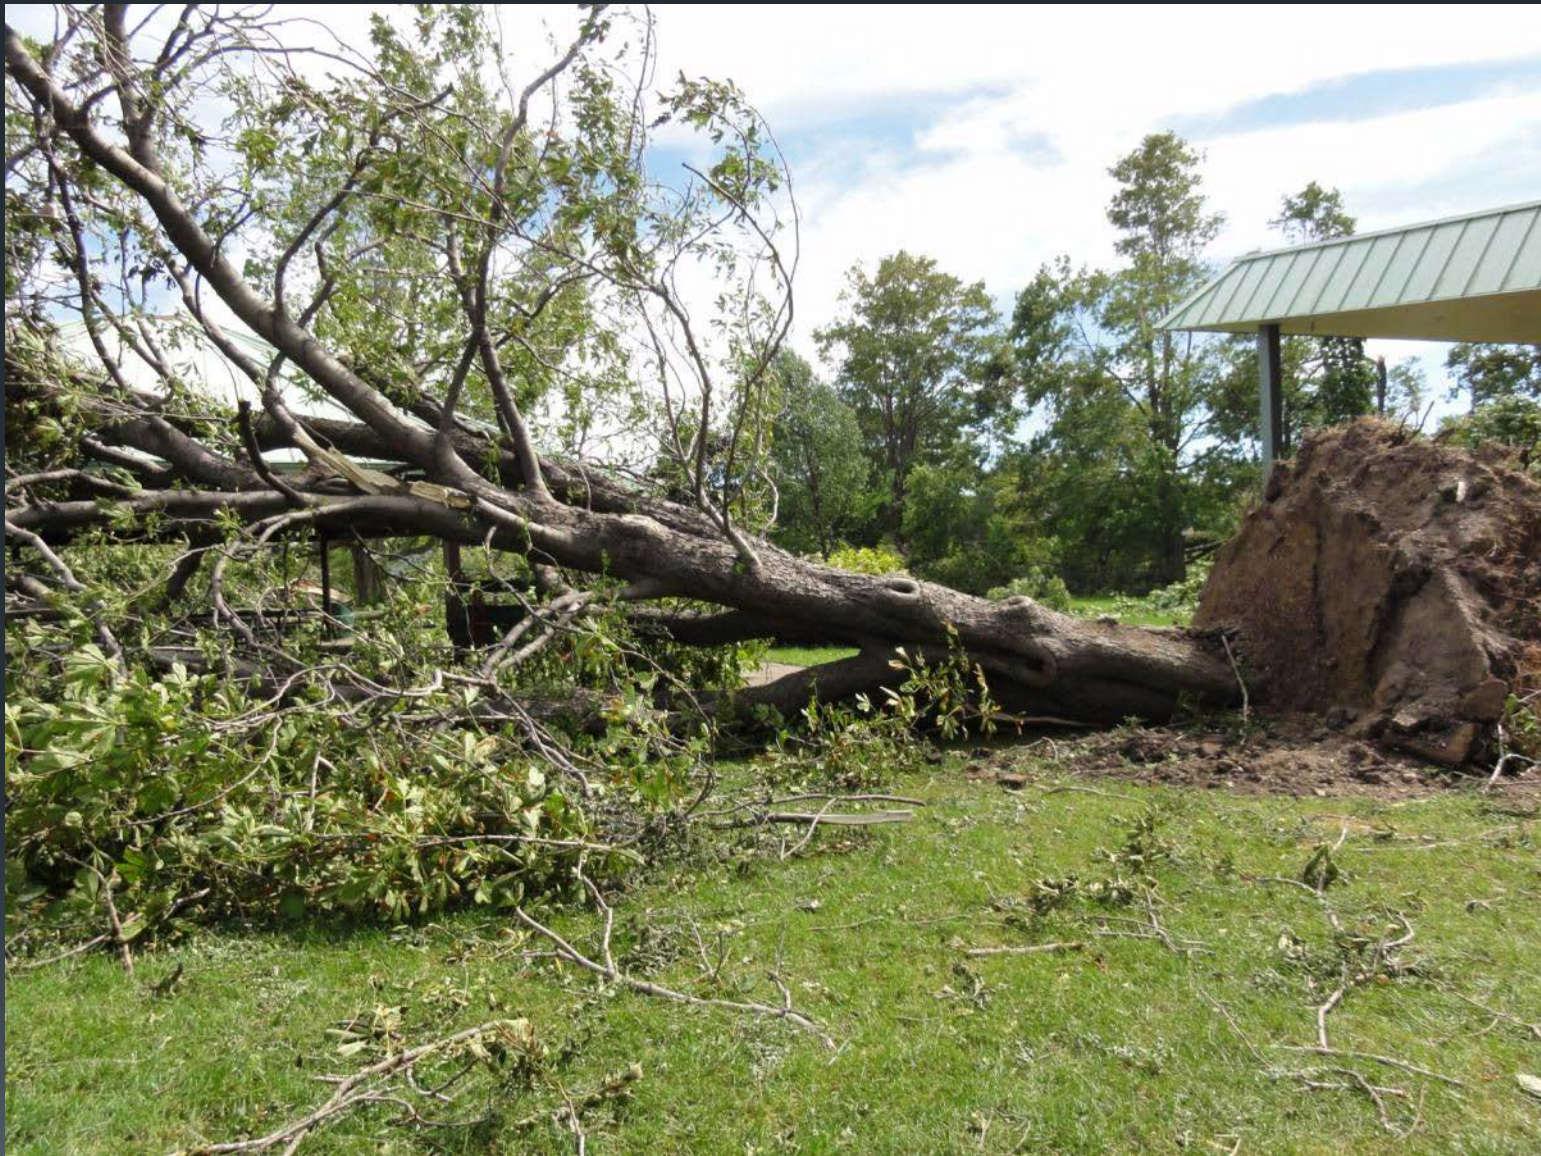
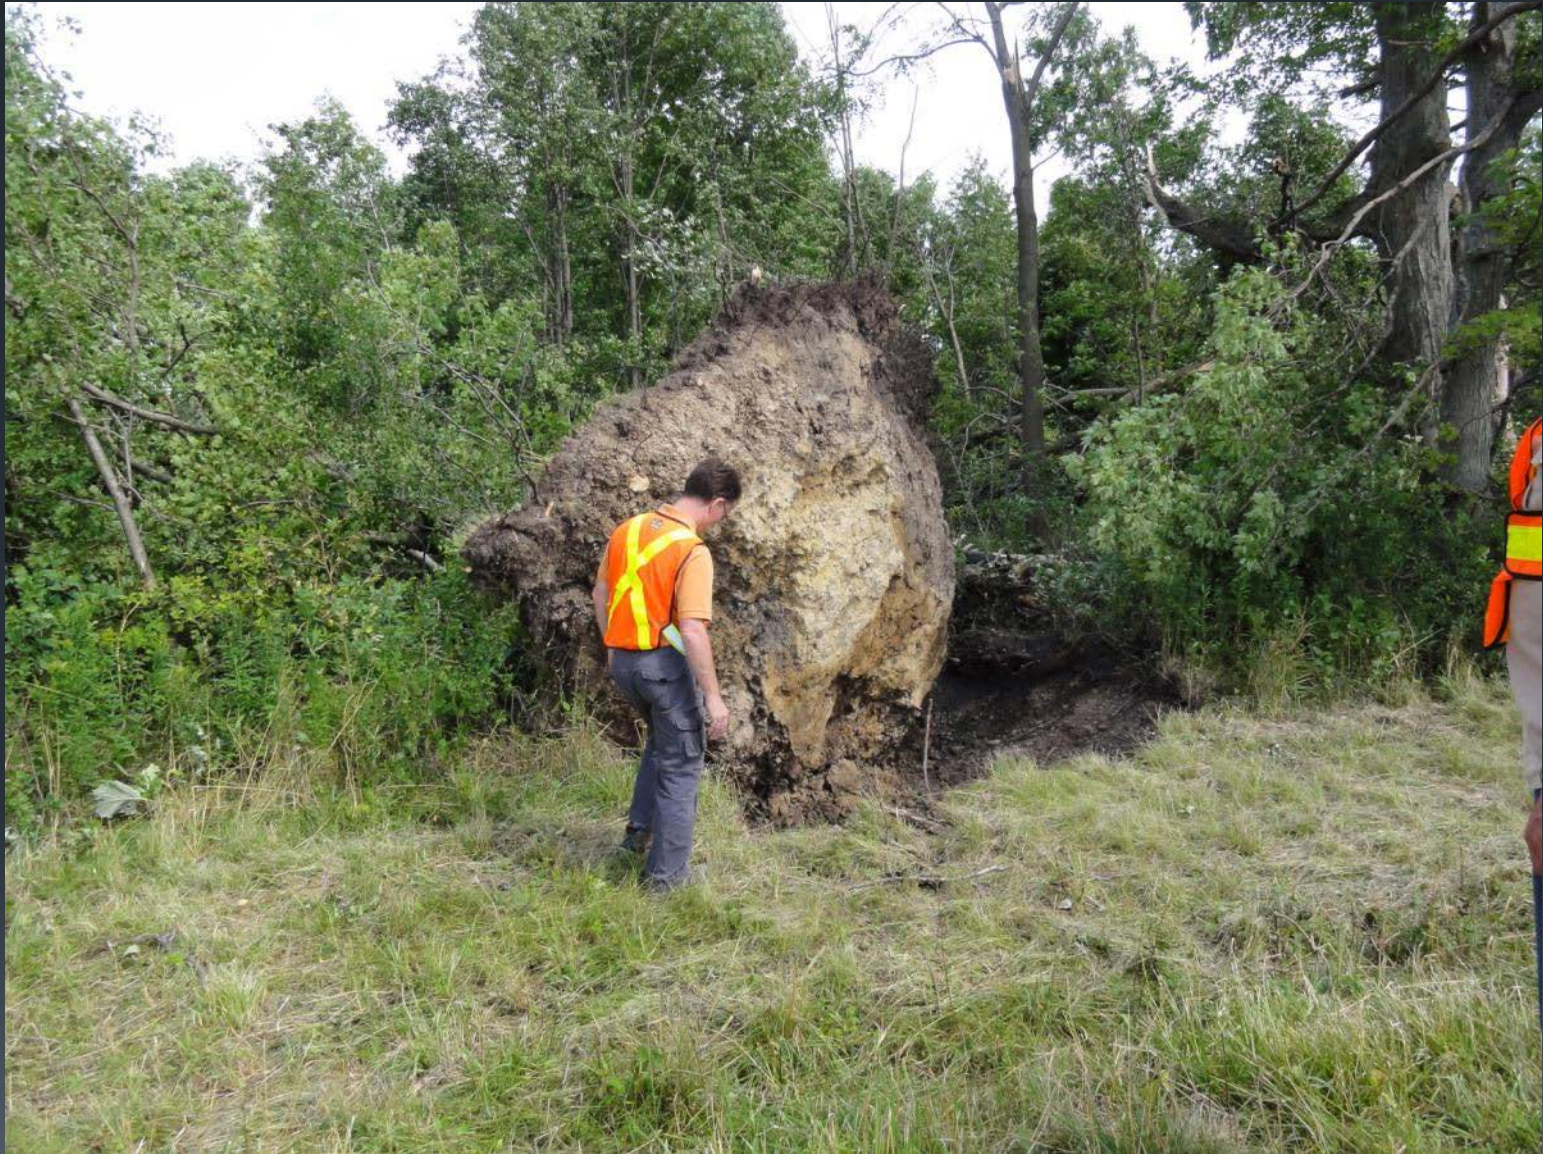
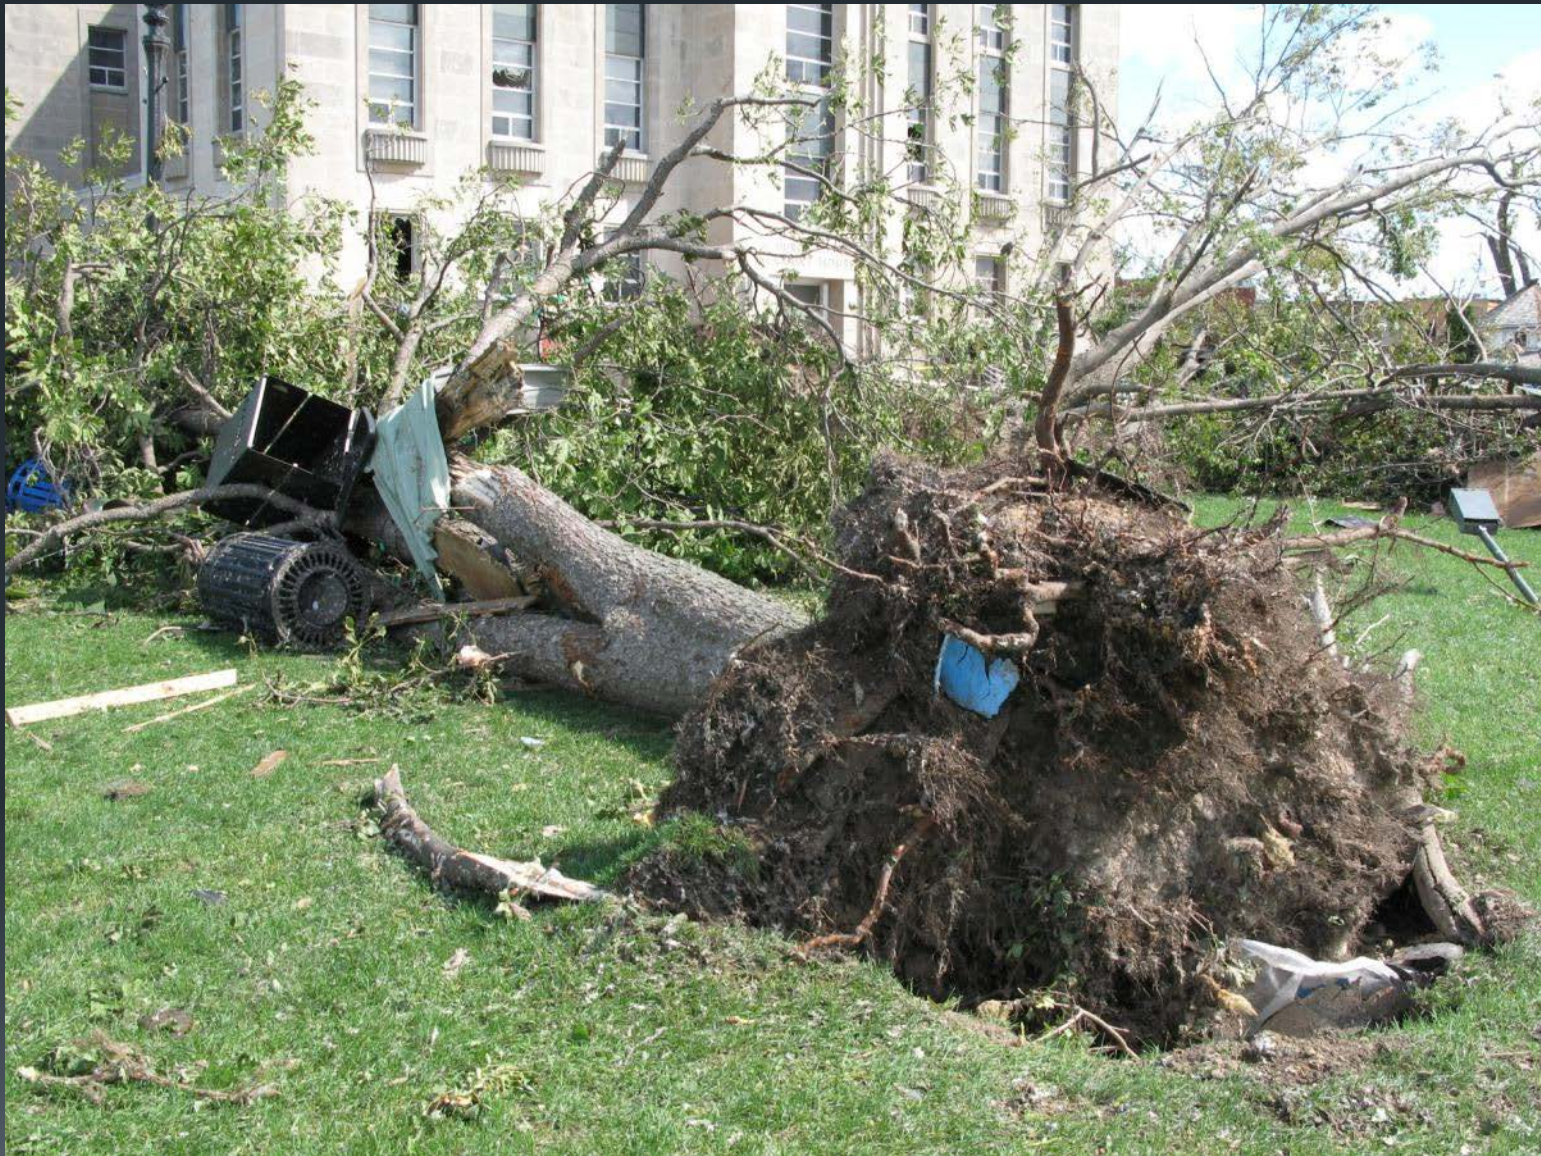
Tree Failures

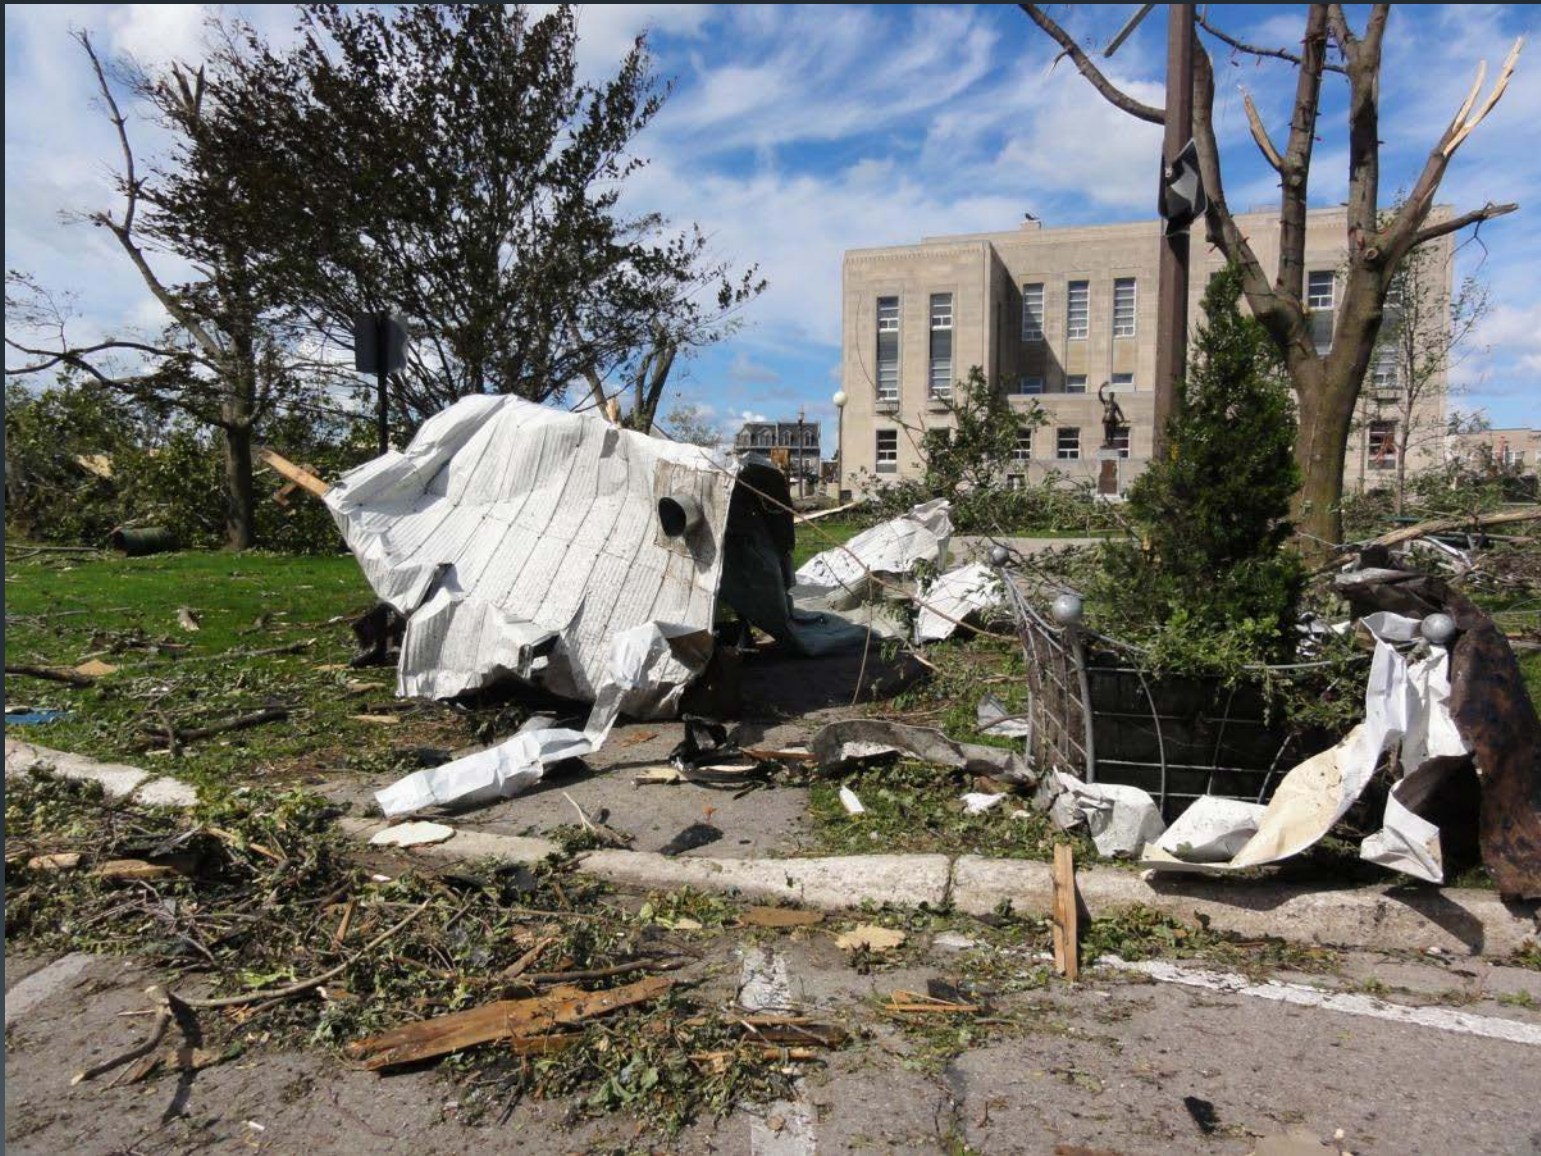
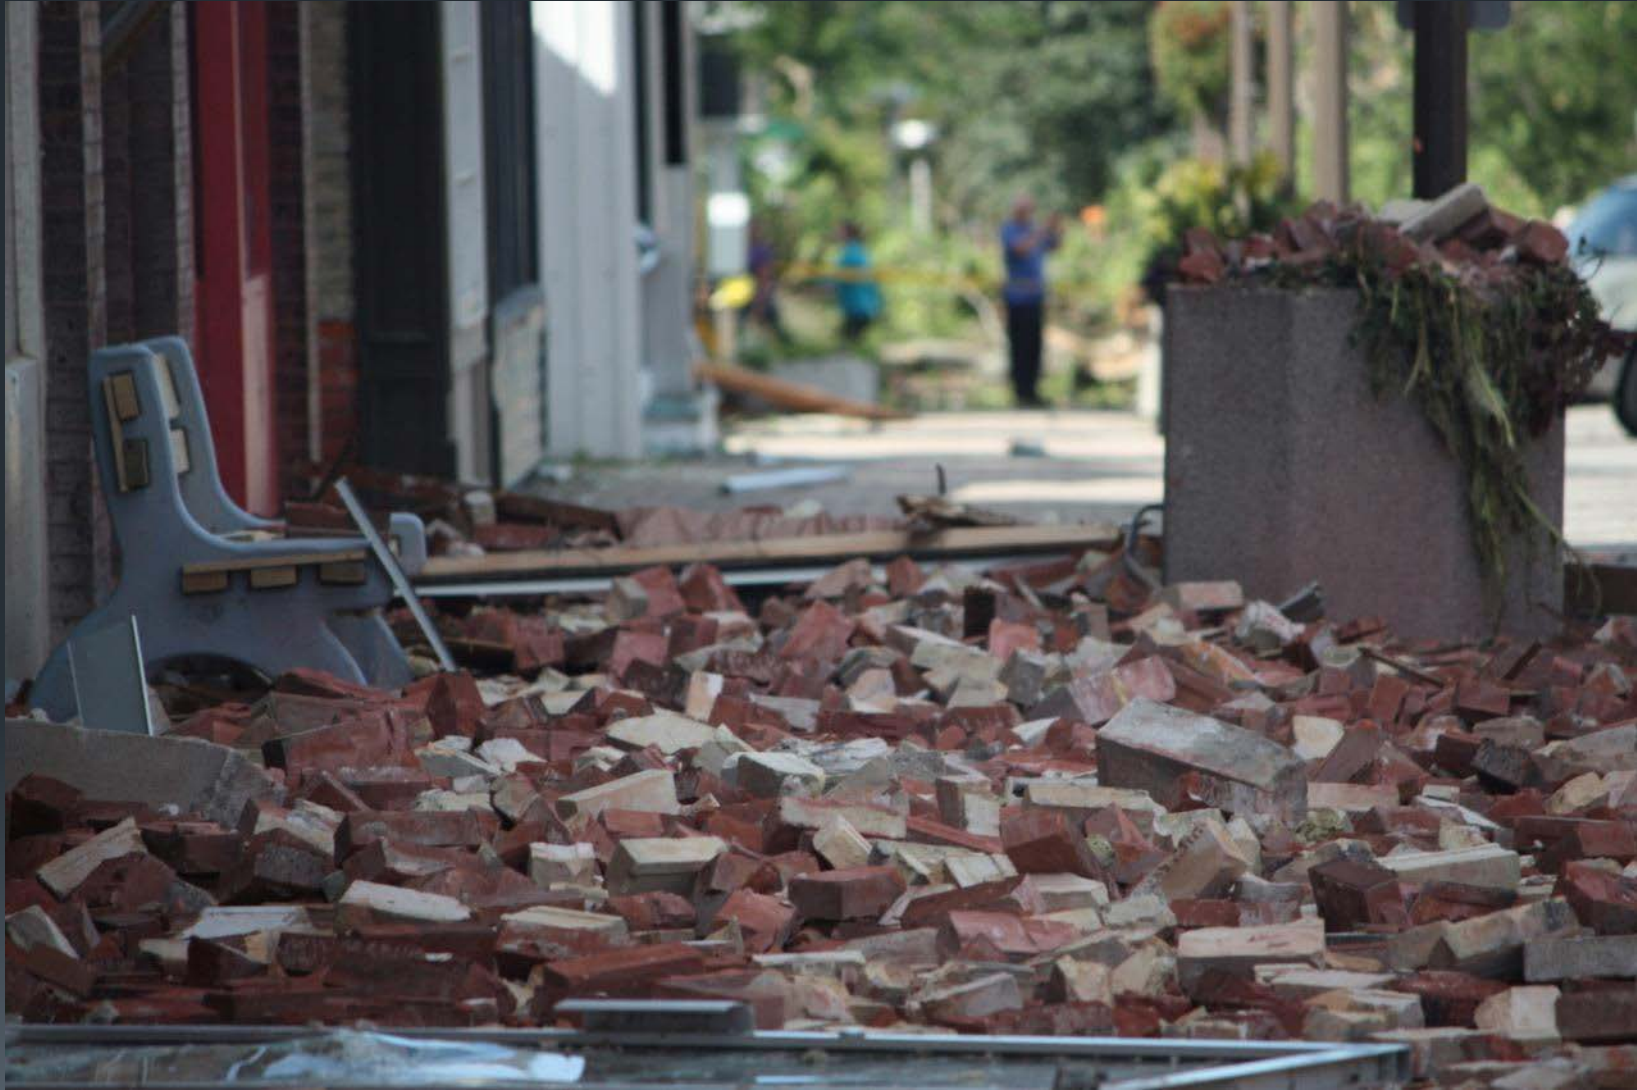
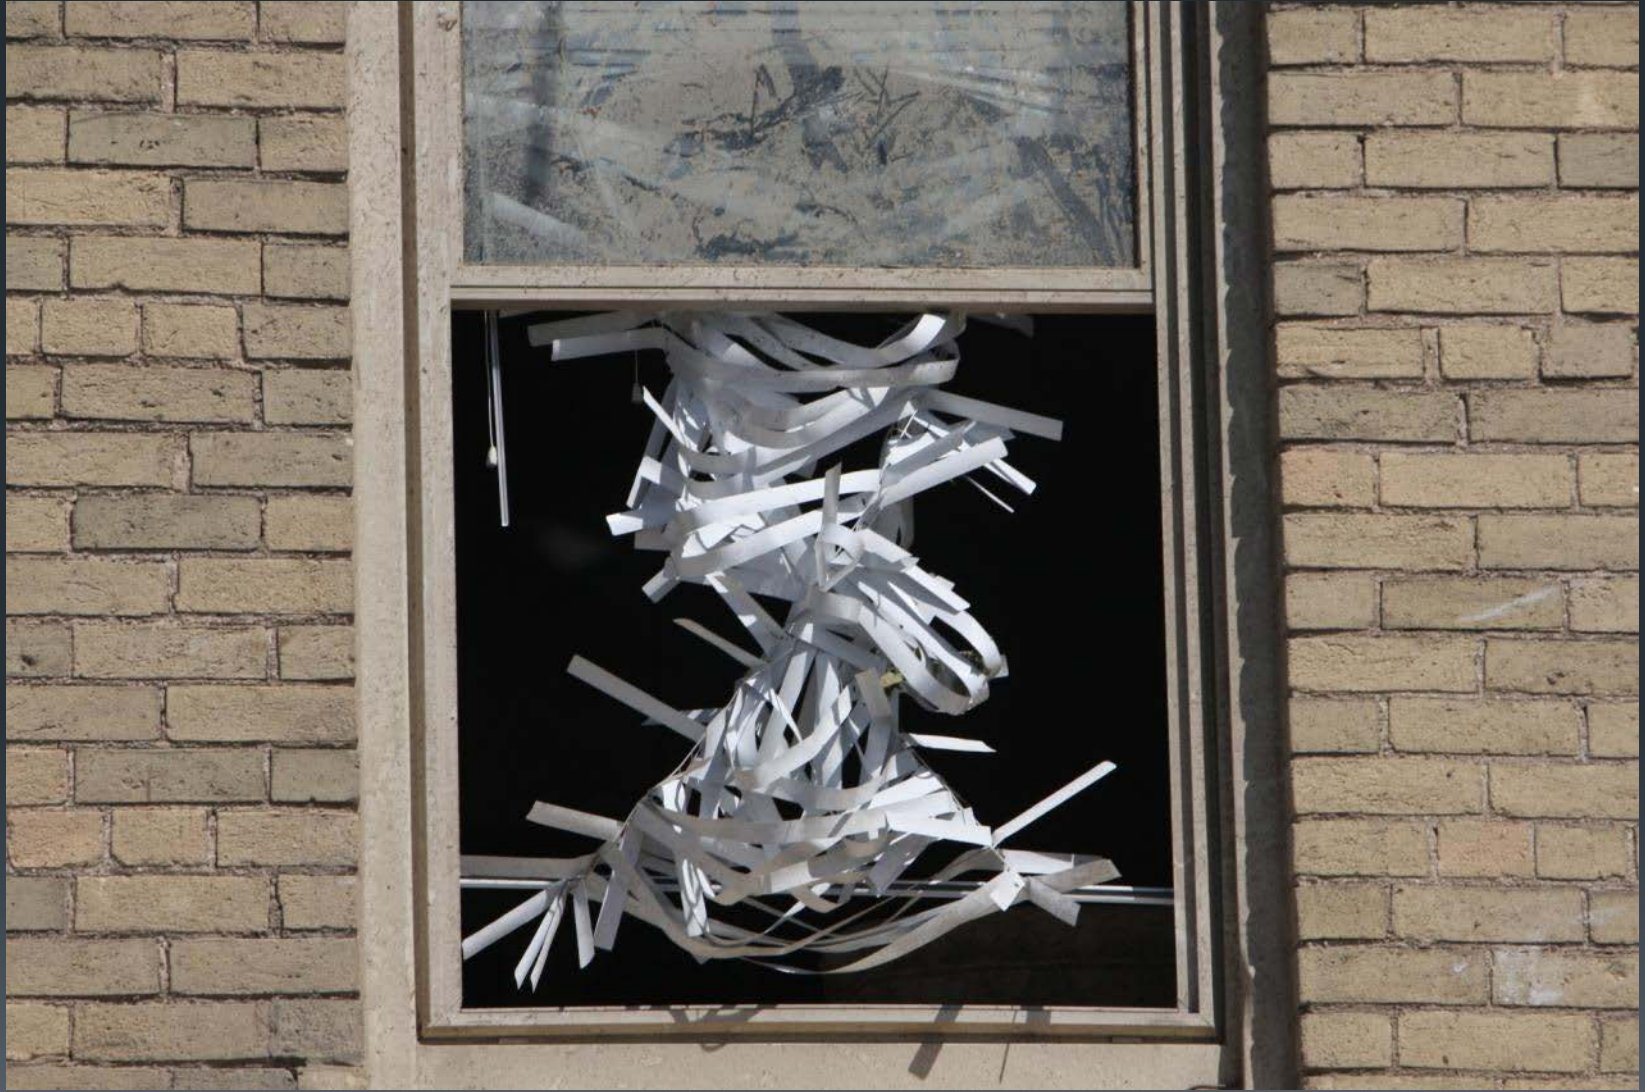
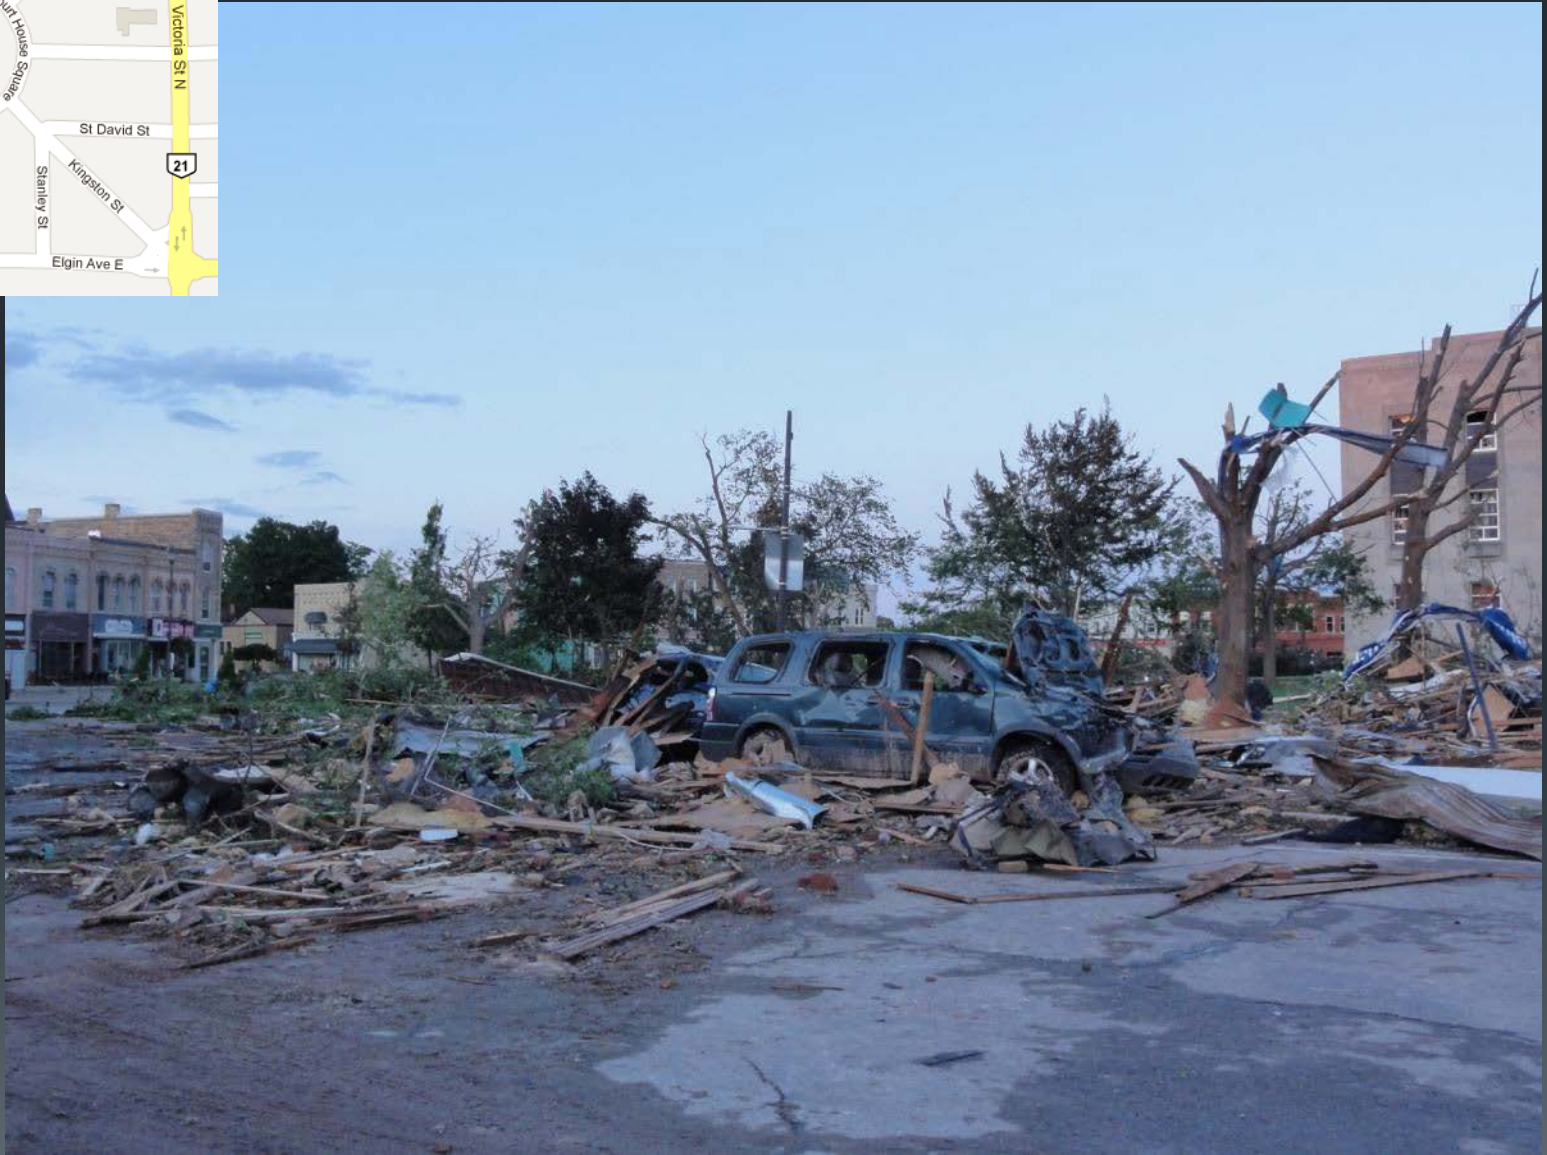
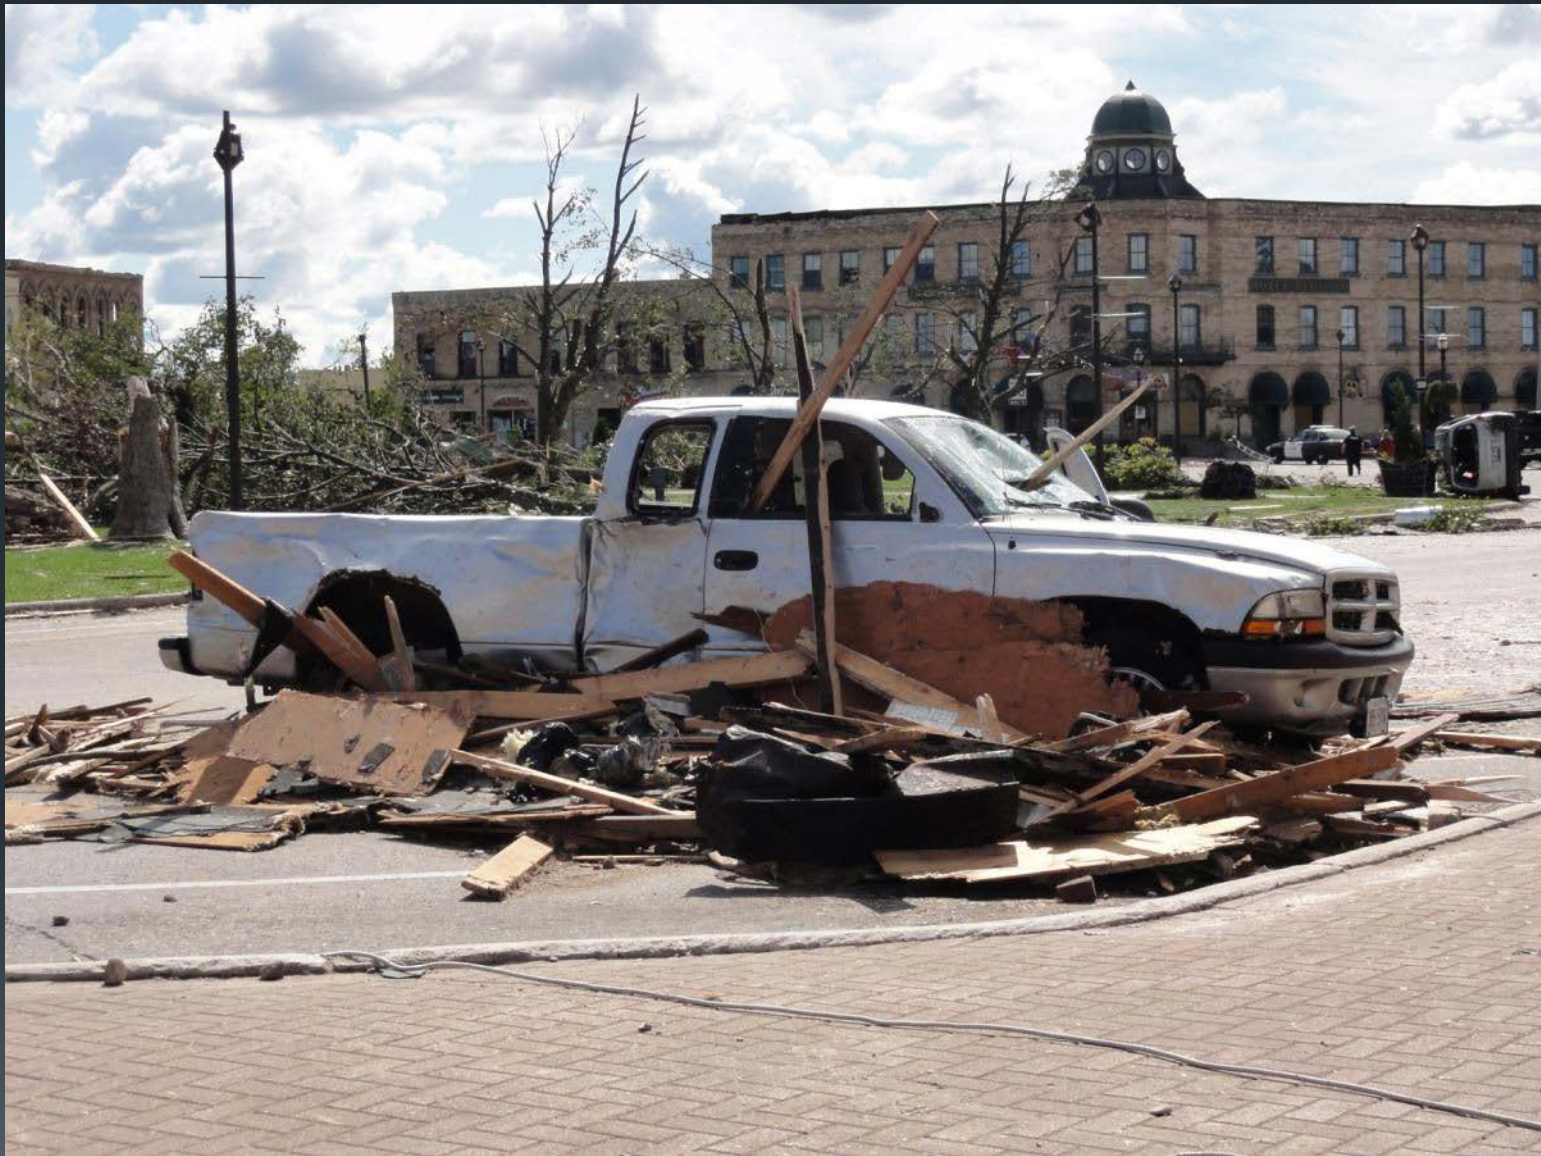
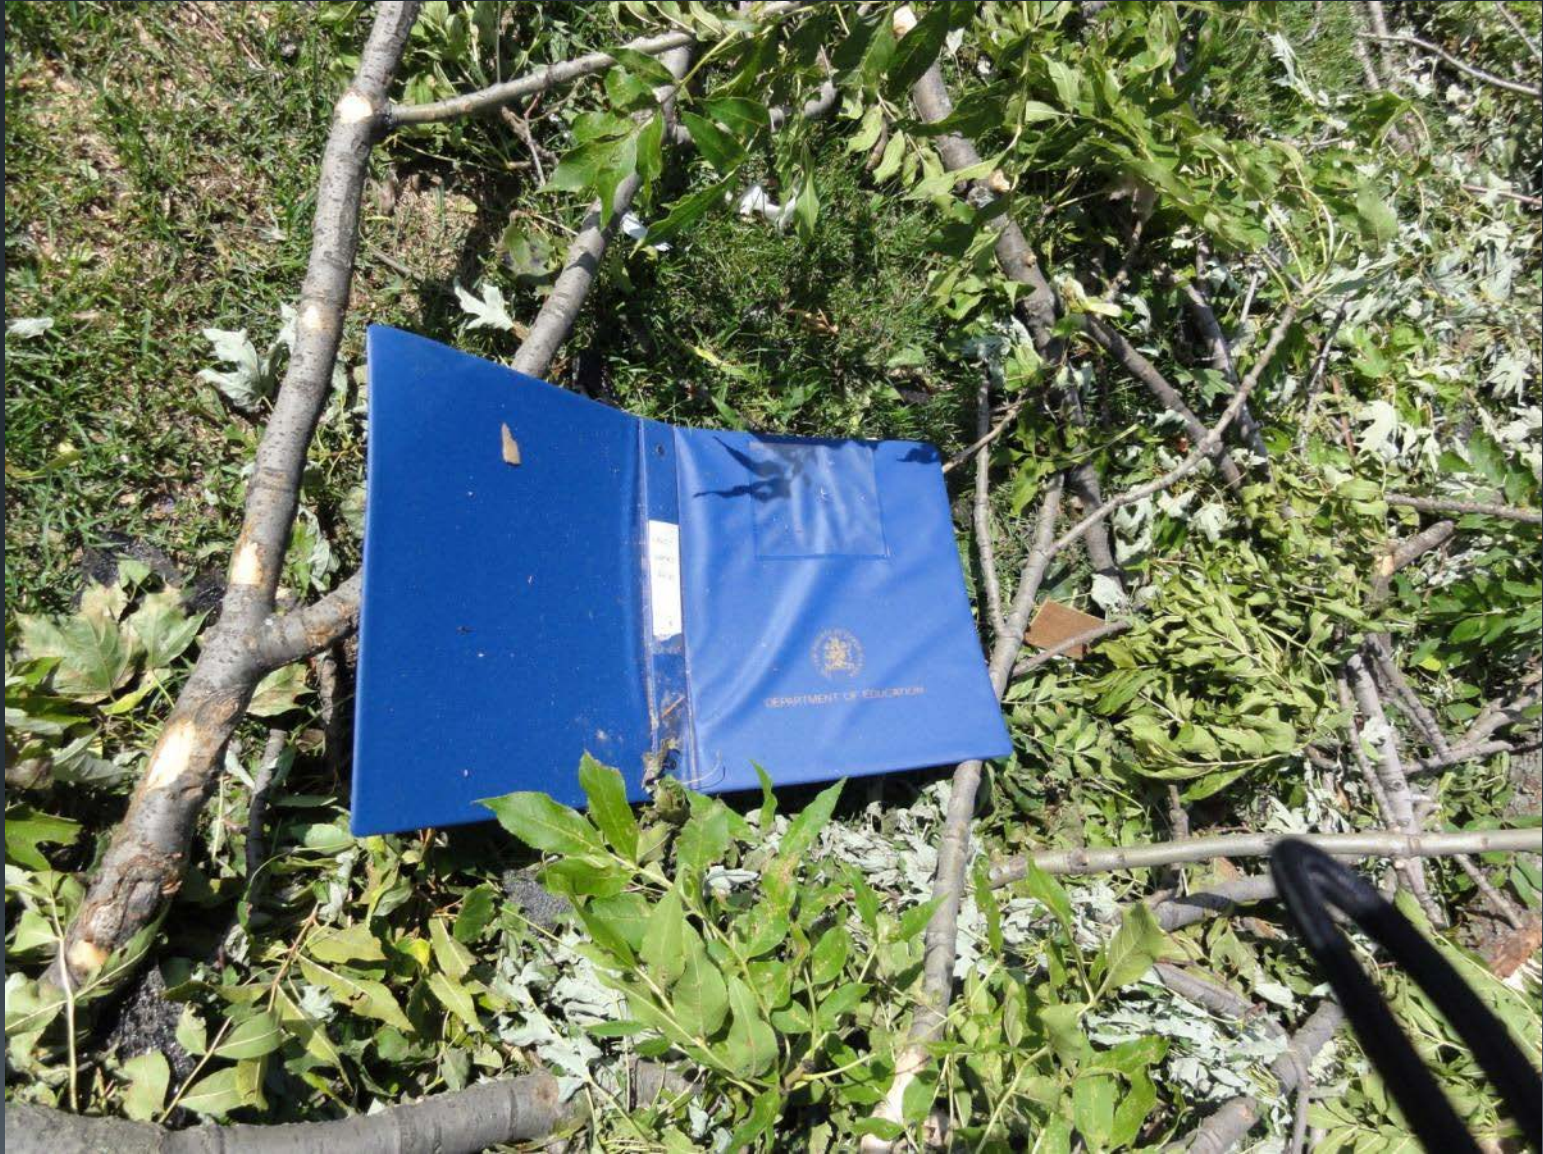
Debris field

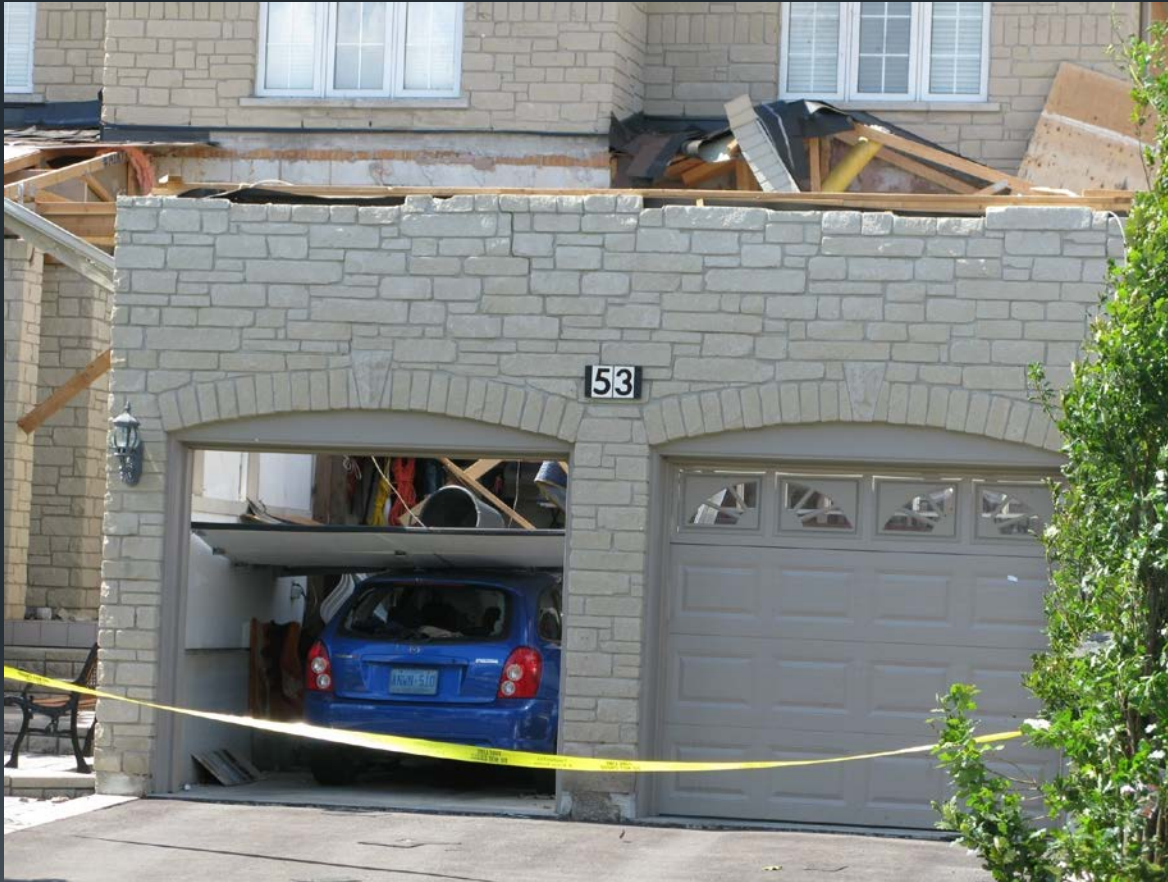
Global Roof Failures - Flight

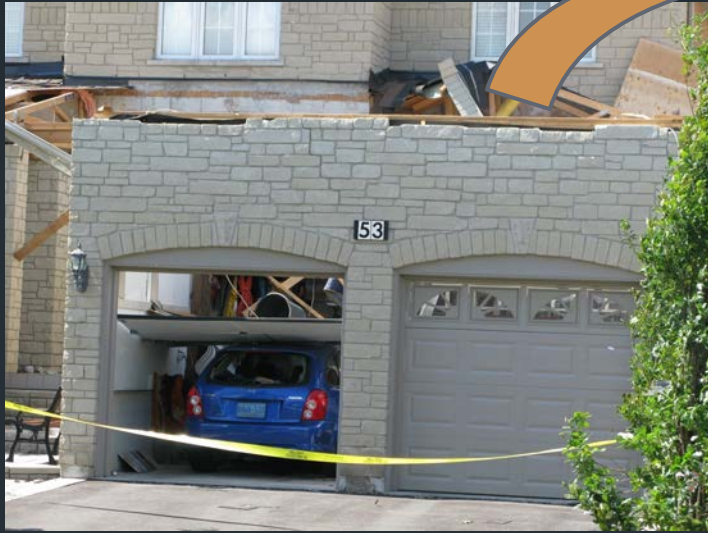
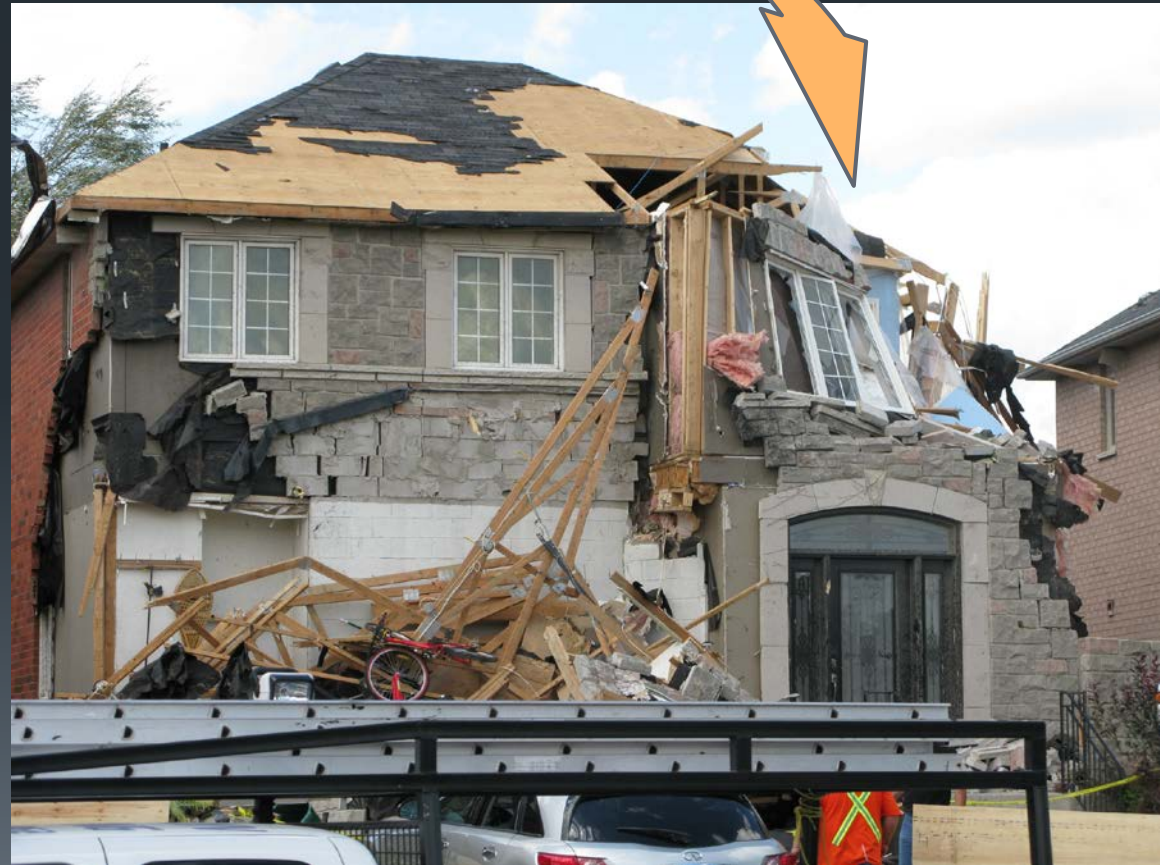
Global Roof Failures - Flight

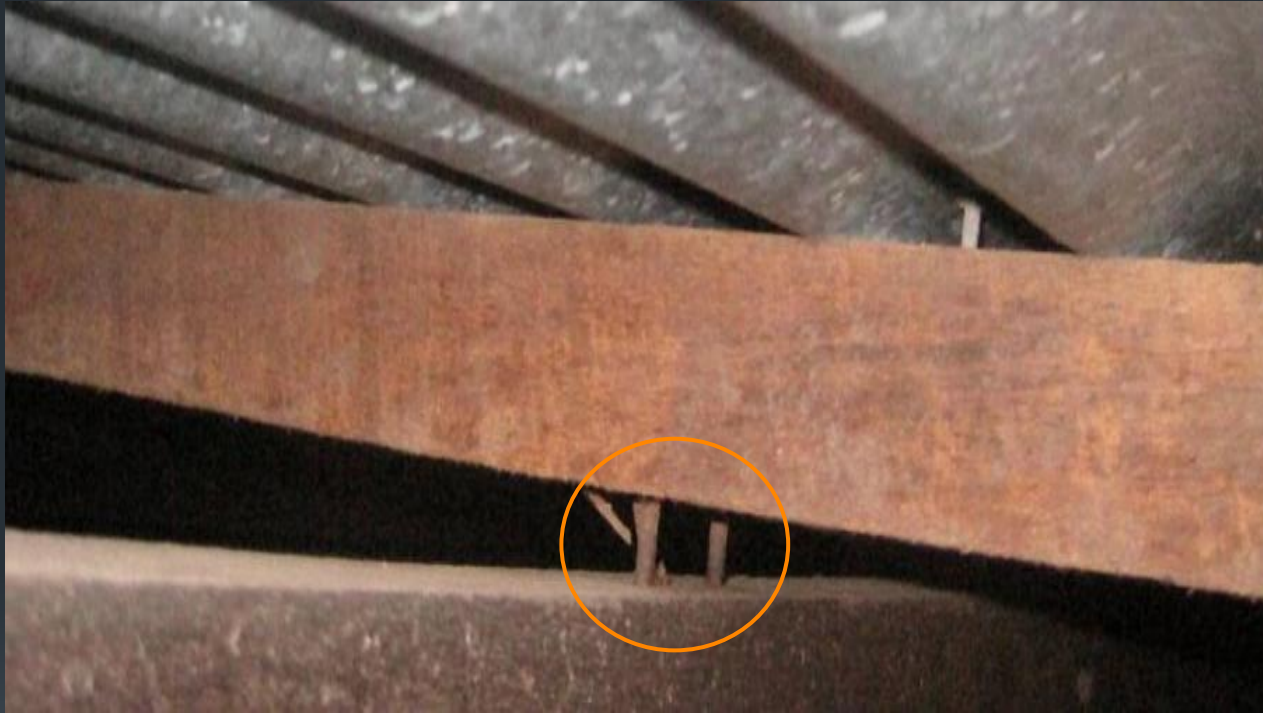
Global Roof Failures - Failure
