Observations from the Goderich Tornado

Sarah Stenabaugh

Goderich Damage Survey

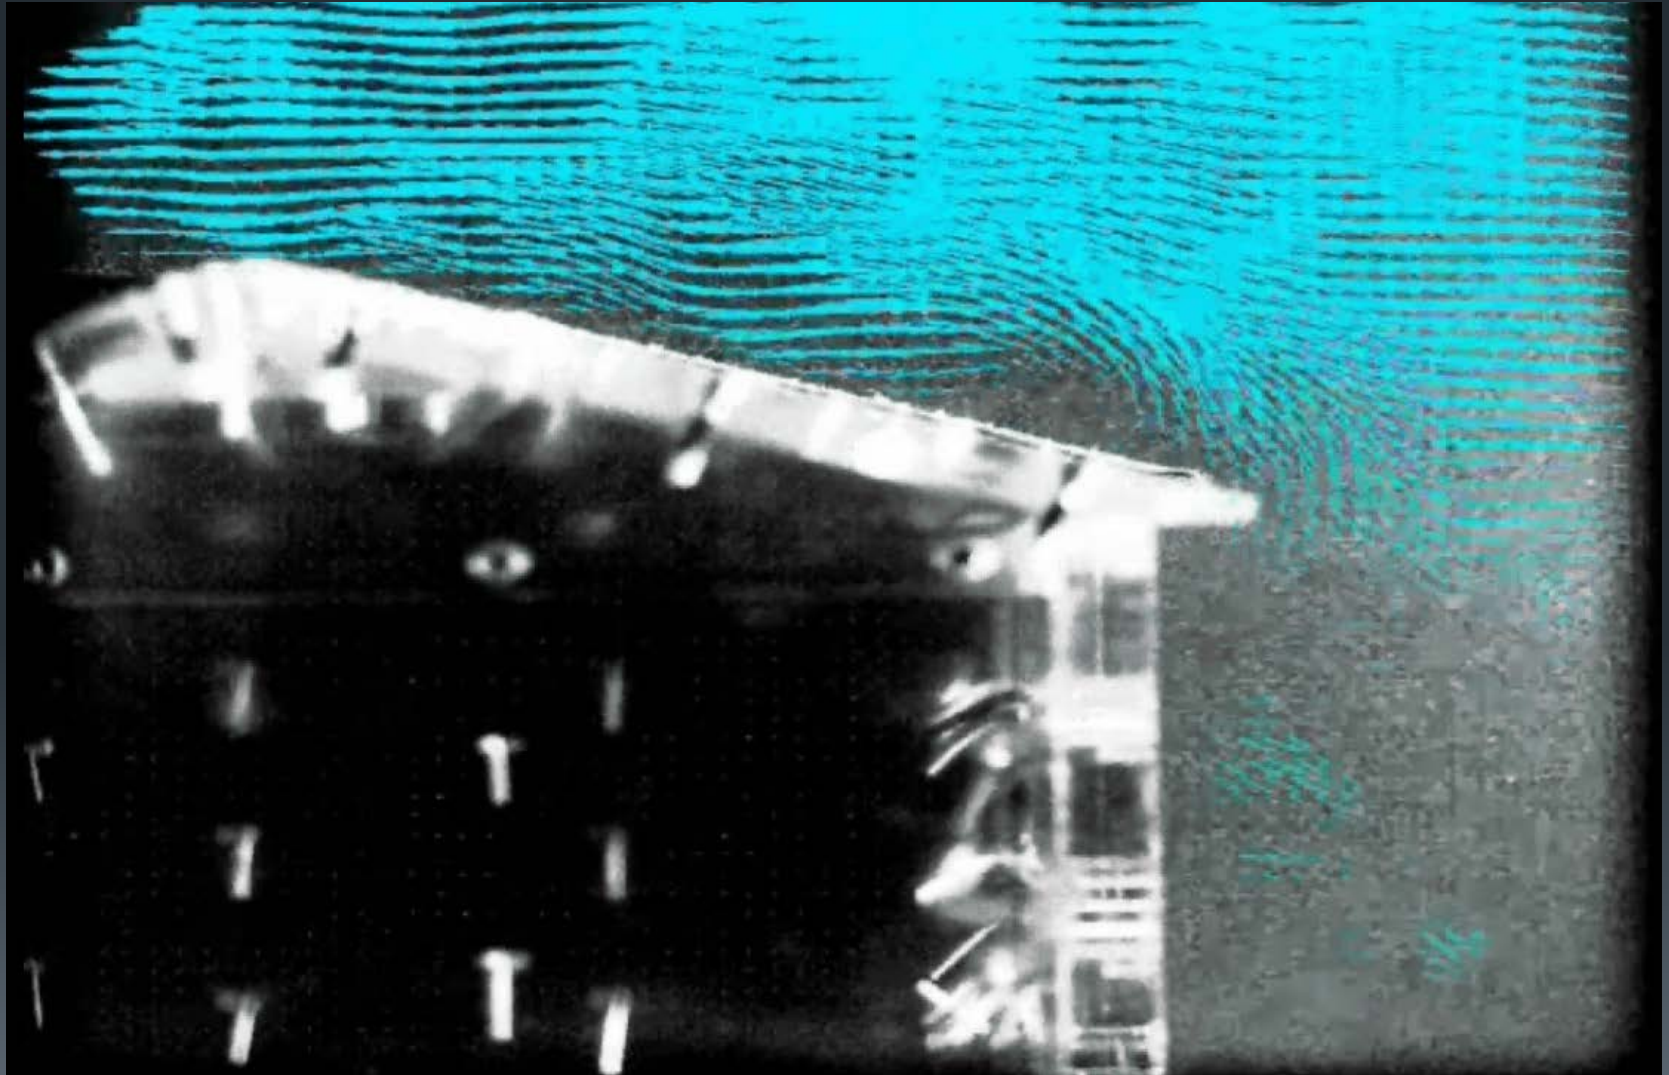
Failure wind speed

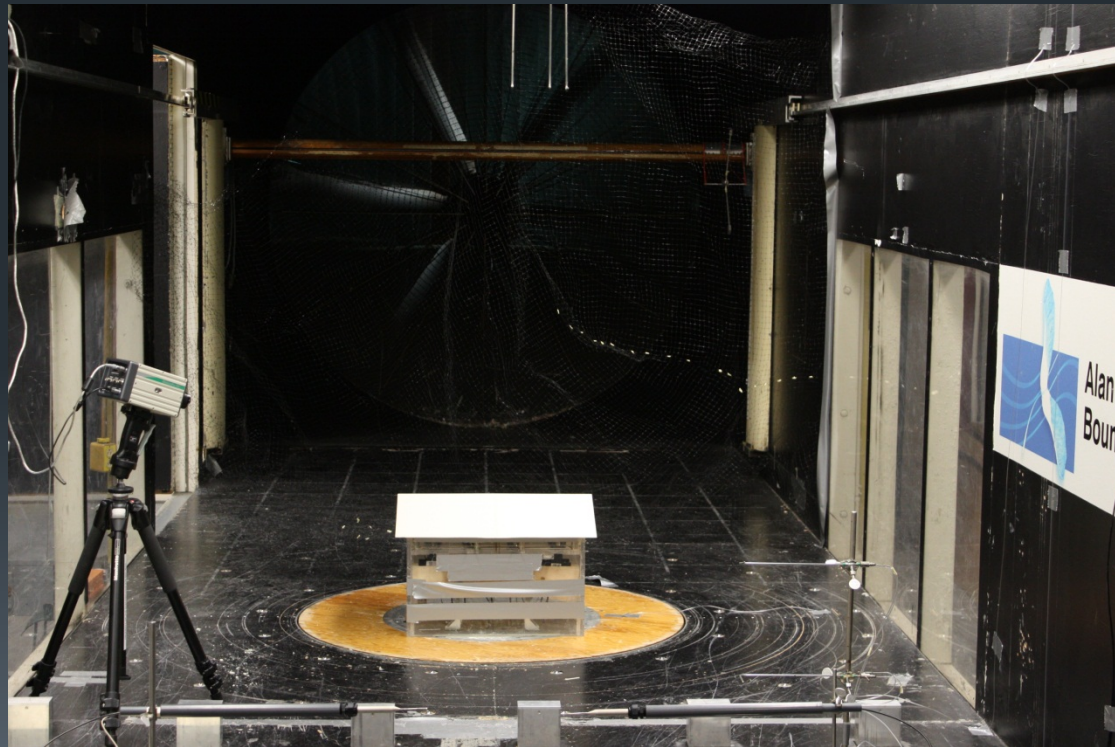
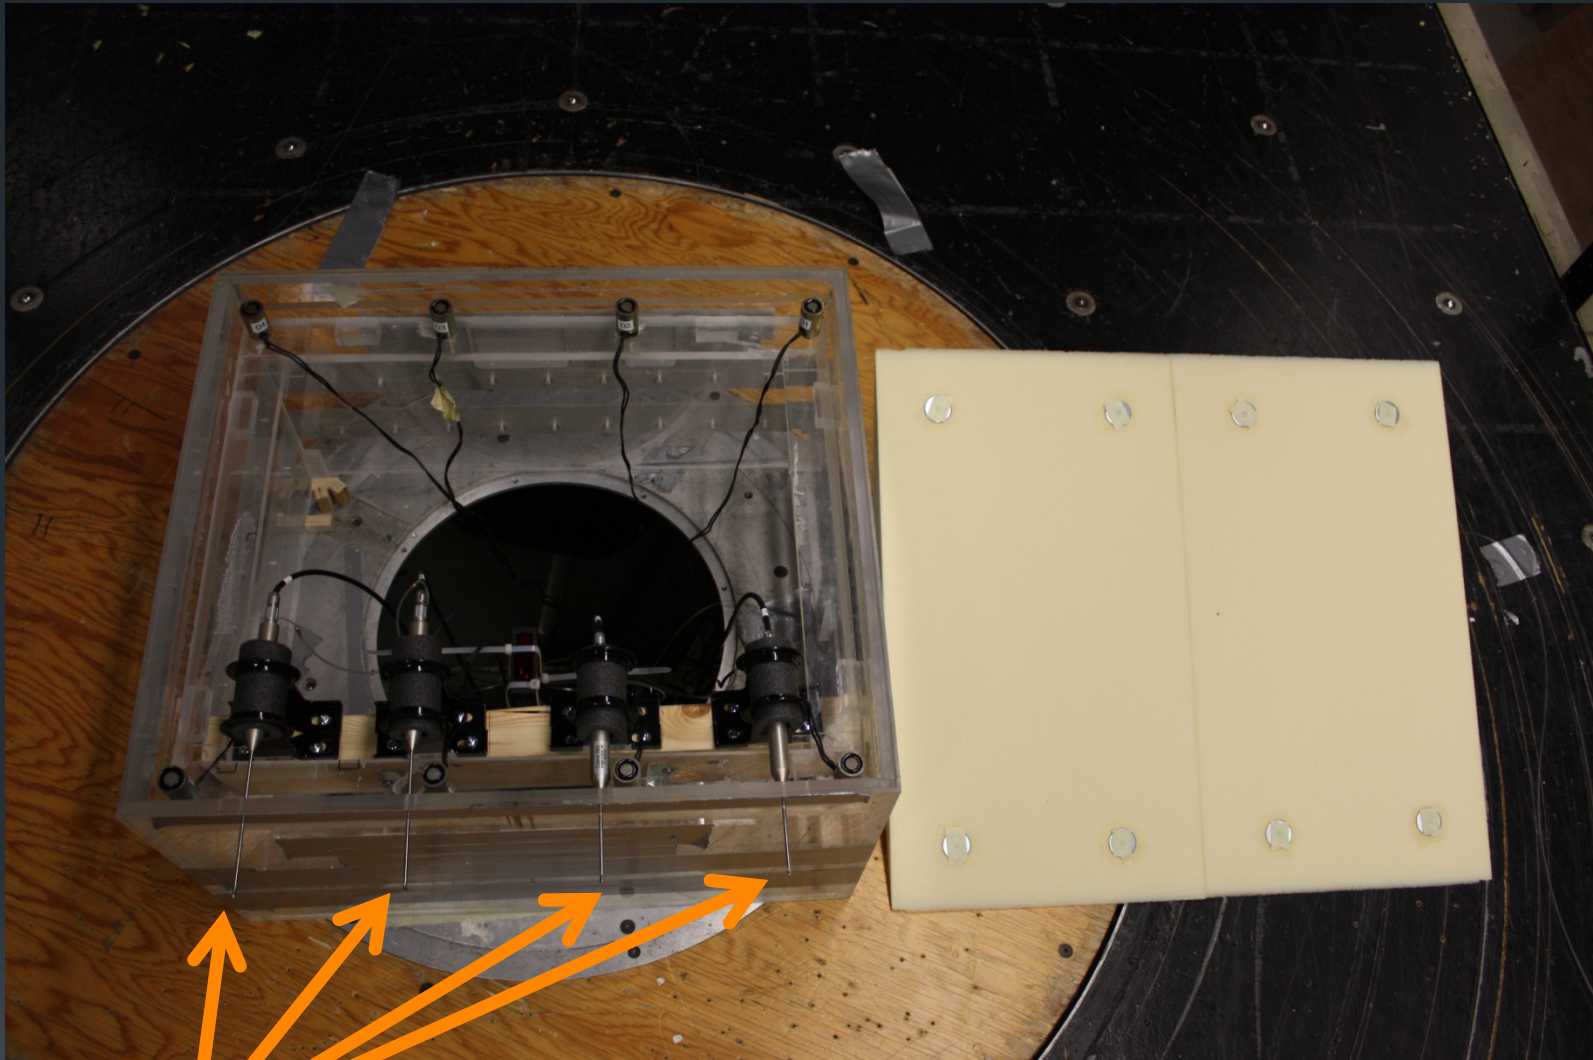
Testing set-up

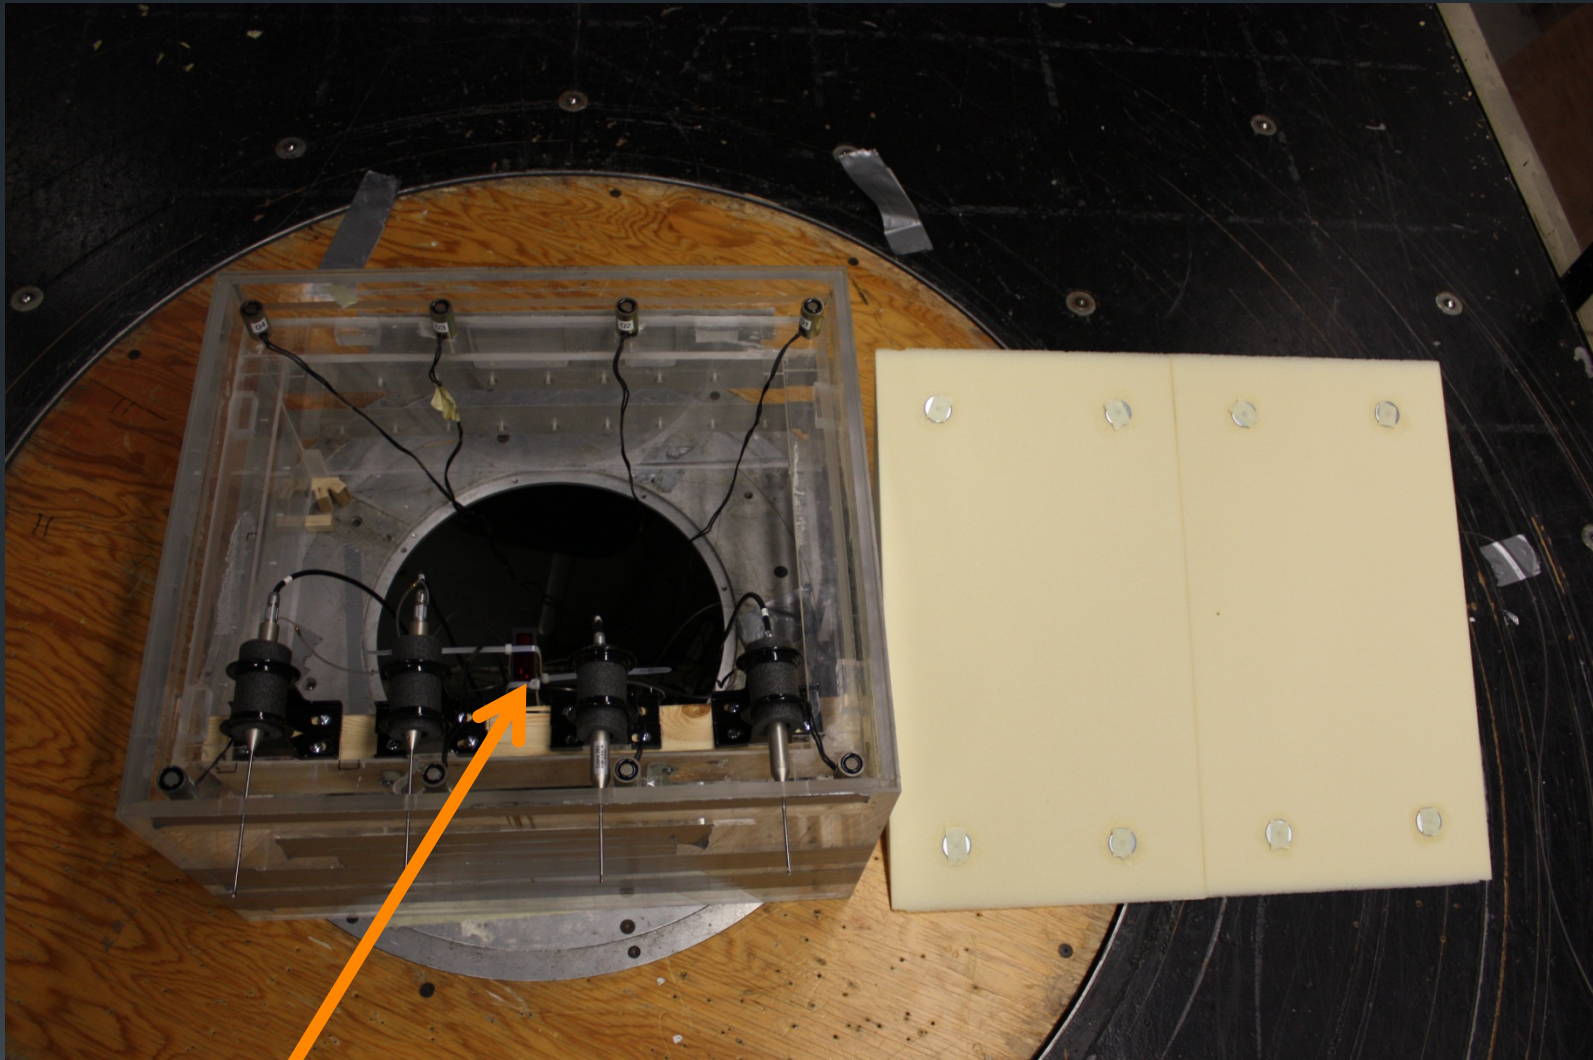
Electromagnets and contacts
