Earthquake Risk in Canada and the National Building Code

Tuna Onur, Ph.D.

*ICLR, Toronto, ON
20 January 2012*

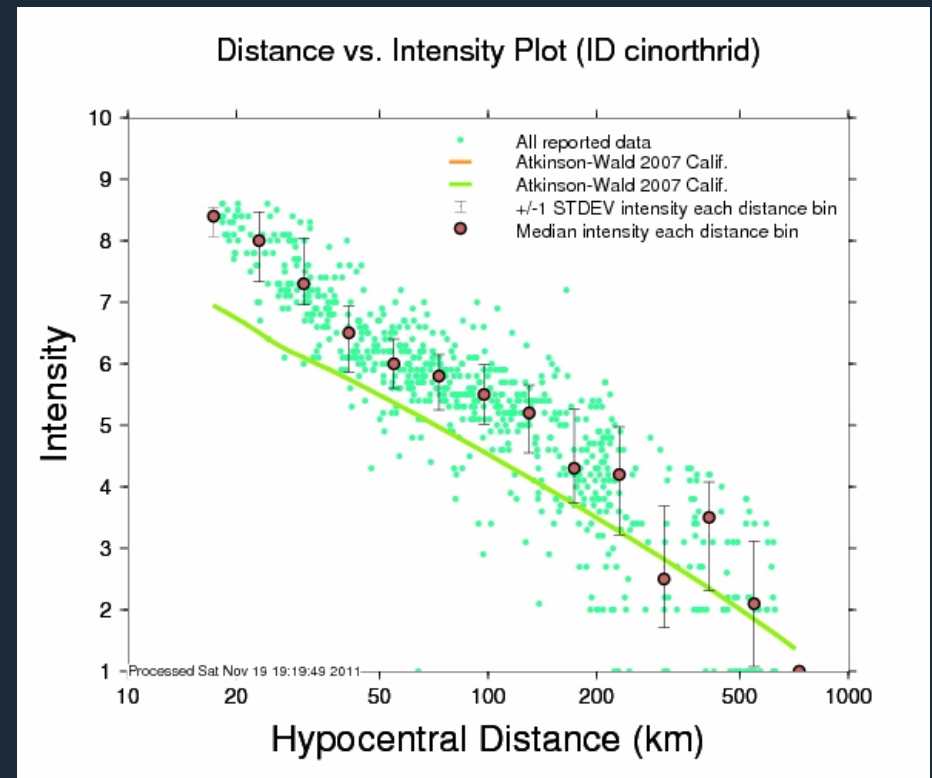
2. How seismic waves propagate to sites of interest (ground motion attenuation)

- Magnitude
- Distance
- Fault type
- Site conditions

Scatter in data

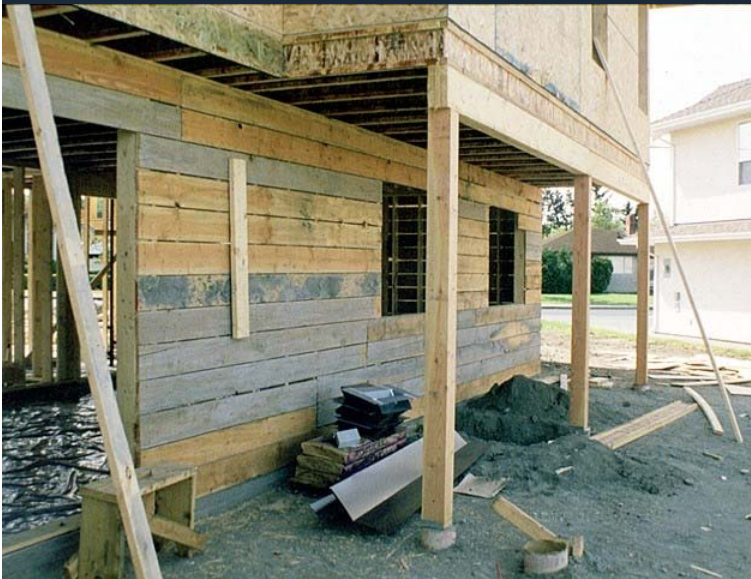
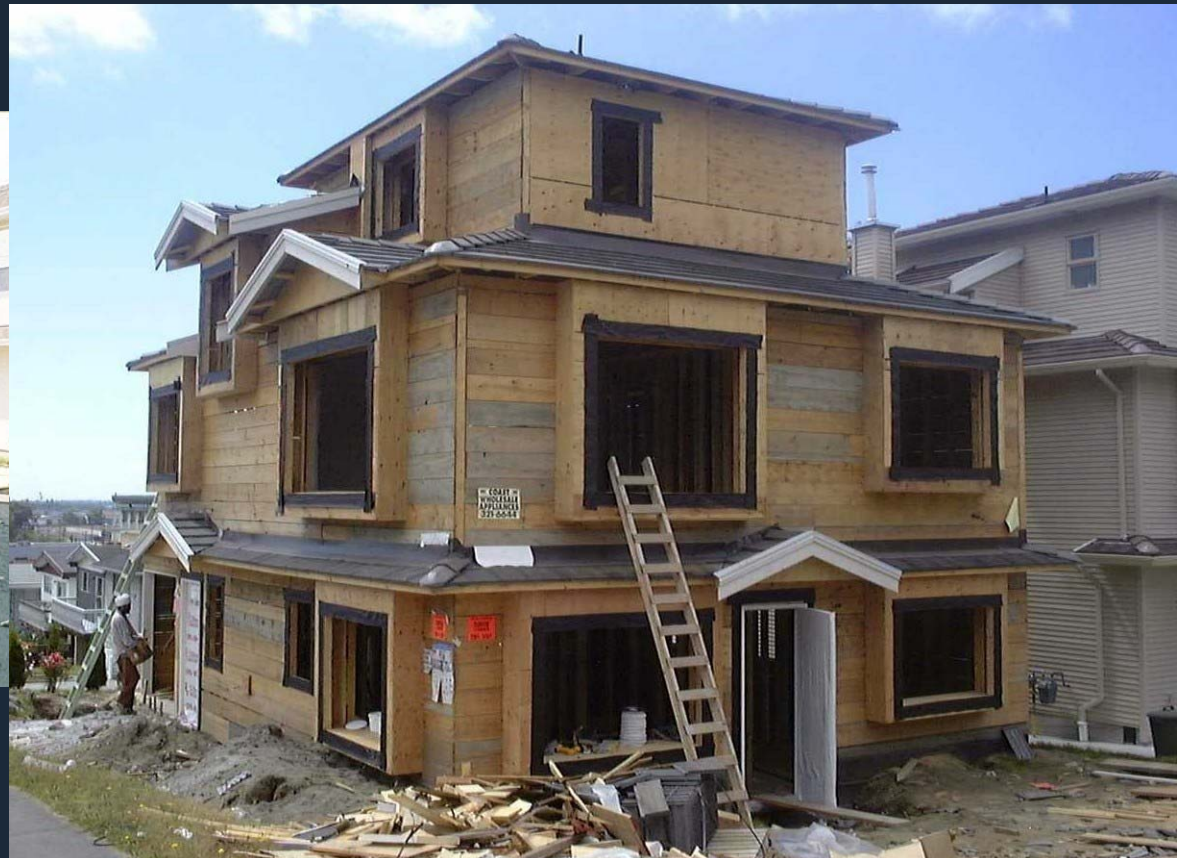
Single-family wood-frame

- Common practice: Use of horizontal boards from concrete foundation formwork as first-storey walls
- Many not anchored to their foundations

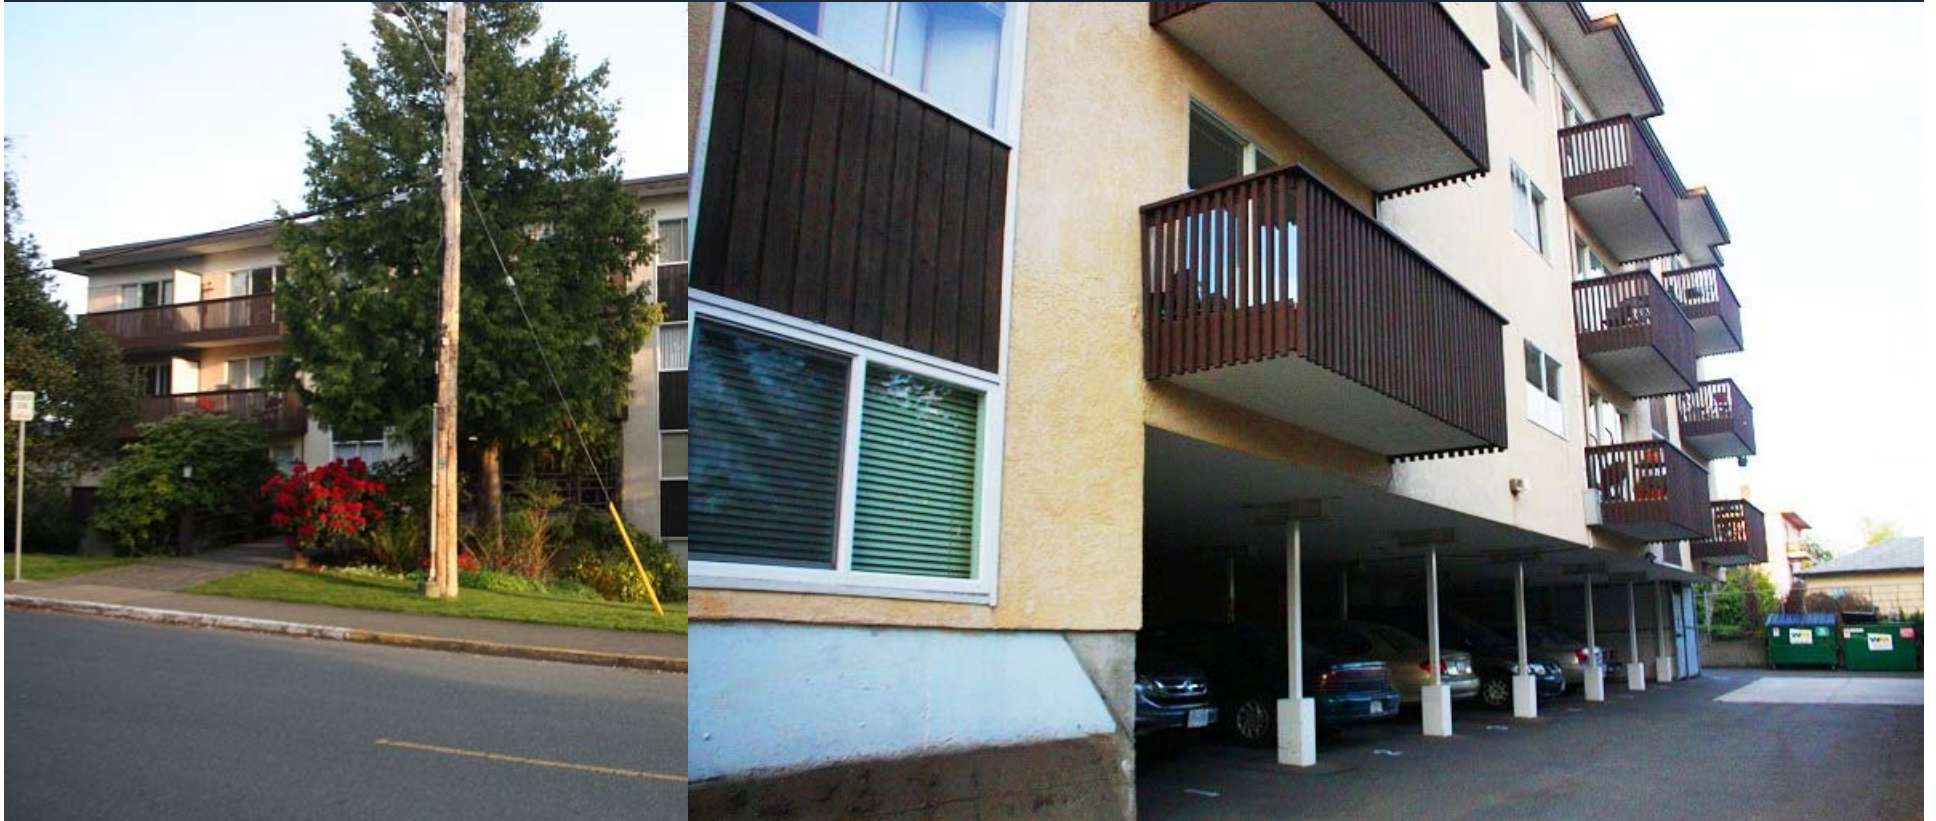
Multi-family wood-frame

- Multi-family apartment buildings that are 3 storeys or lower and have footprint area less than 600 m²
- “Tuck-under” parking on the ground floor

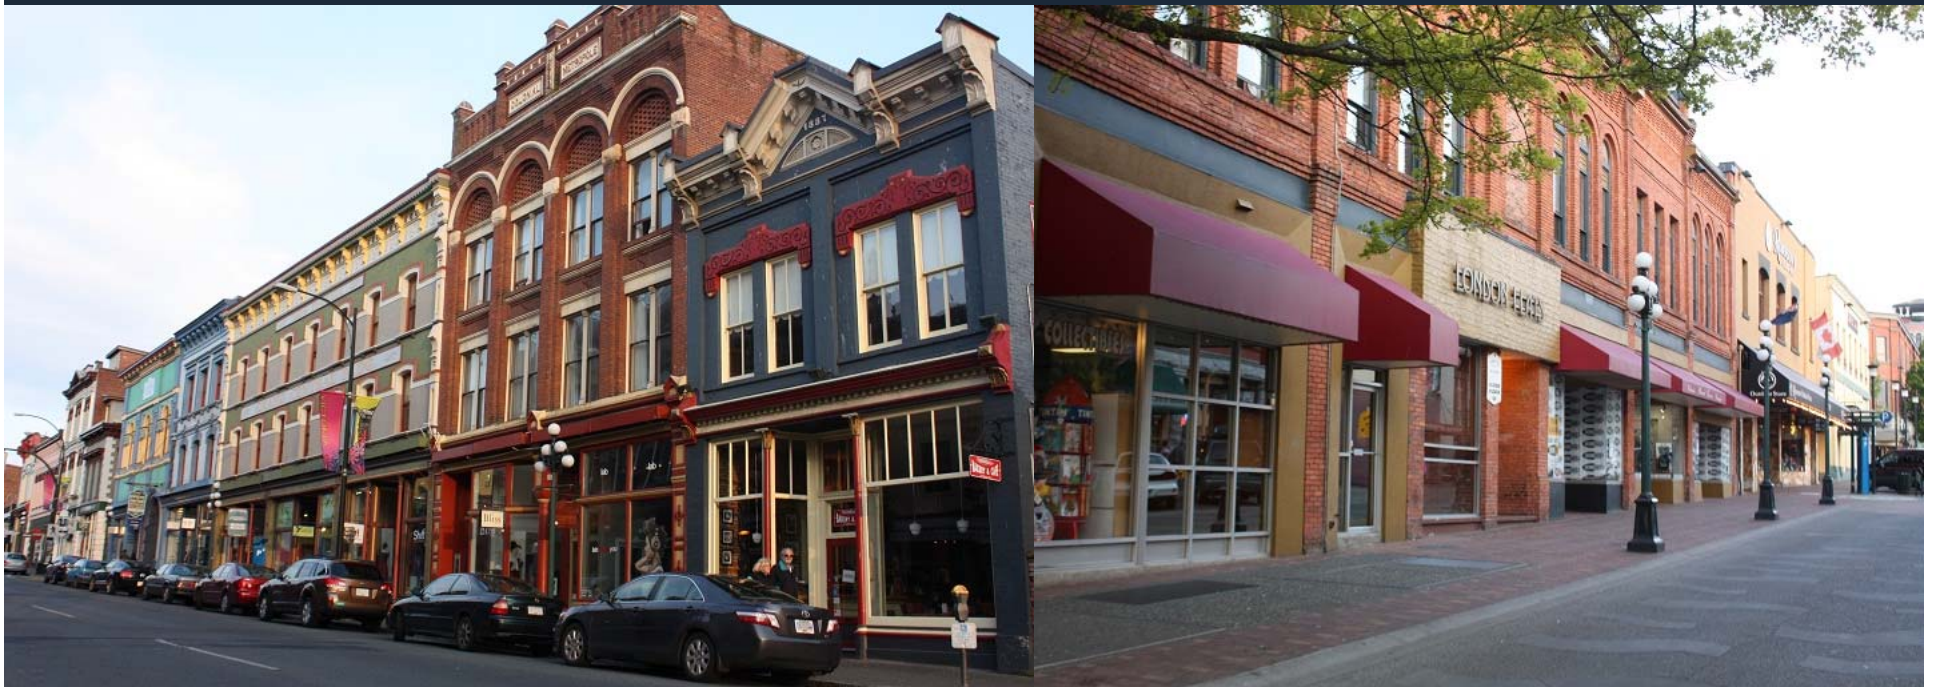
Unreinforced Masonry

- In the west, particularly prevalent in downtown Victoria, but also found in older parts of Vancouver
- Prevalent in most major cities in the east, particularly in Montreal, Quebec City, Ottawa

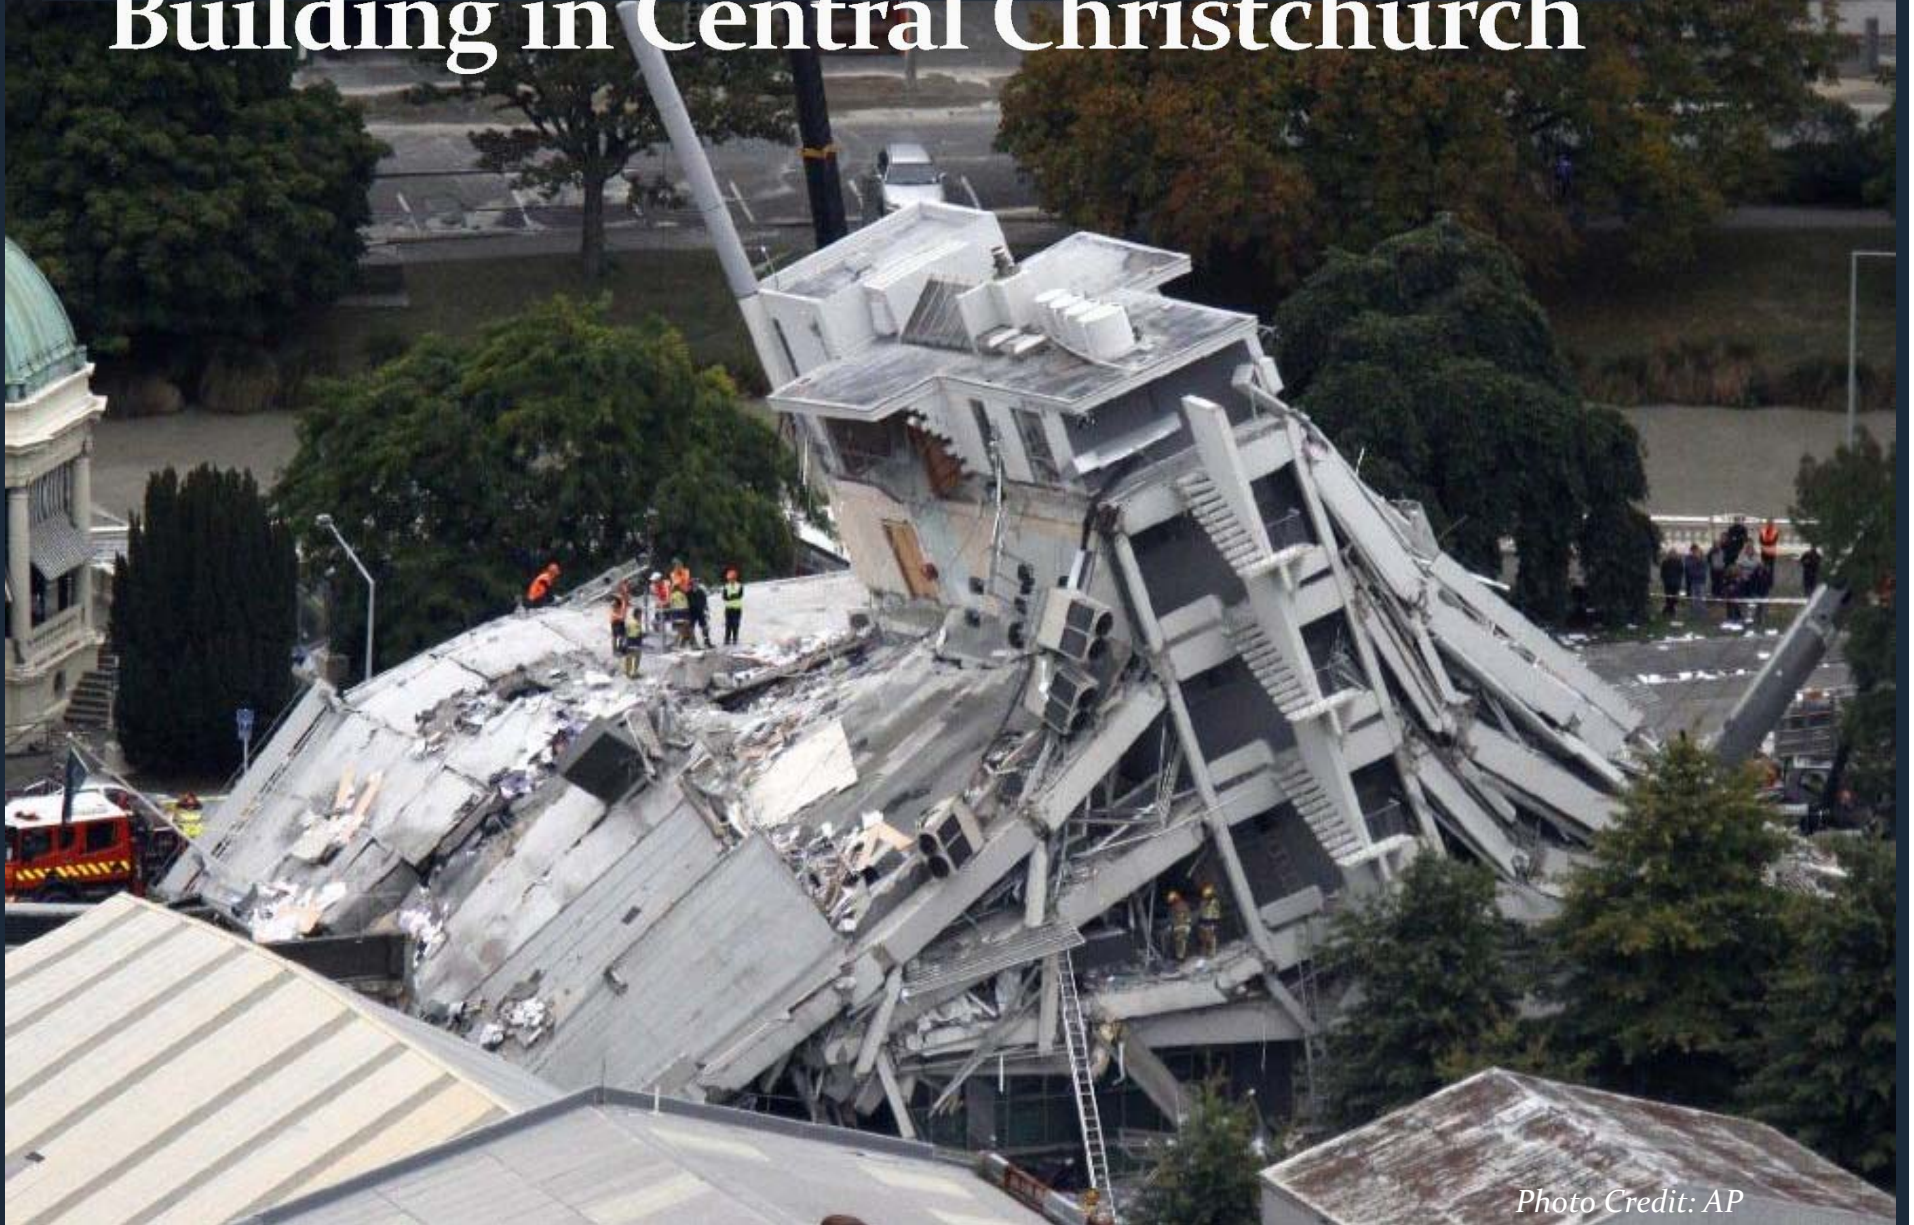
Collapsed Pyne Gould Guinness Building in Central Christchurch

- High stress-drop event
- Mainly URM damage
- Poor performance of a few reinforced concrete buildings (most of the casualties)
- Wide-spread liquefaction

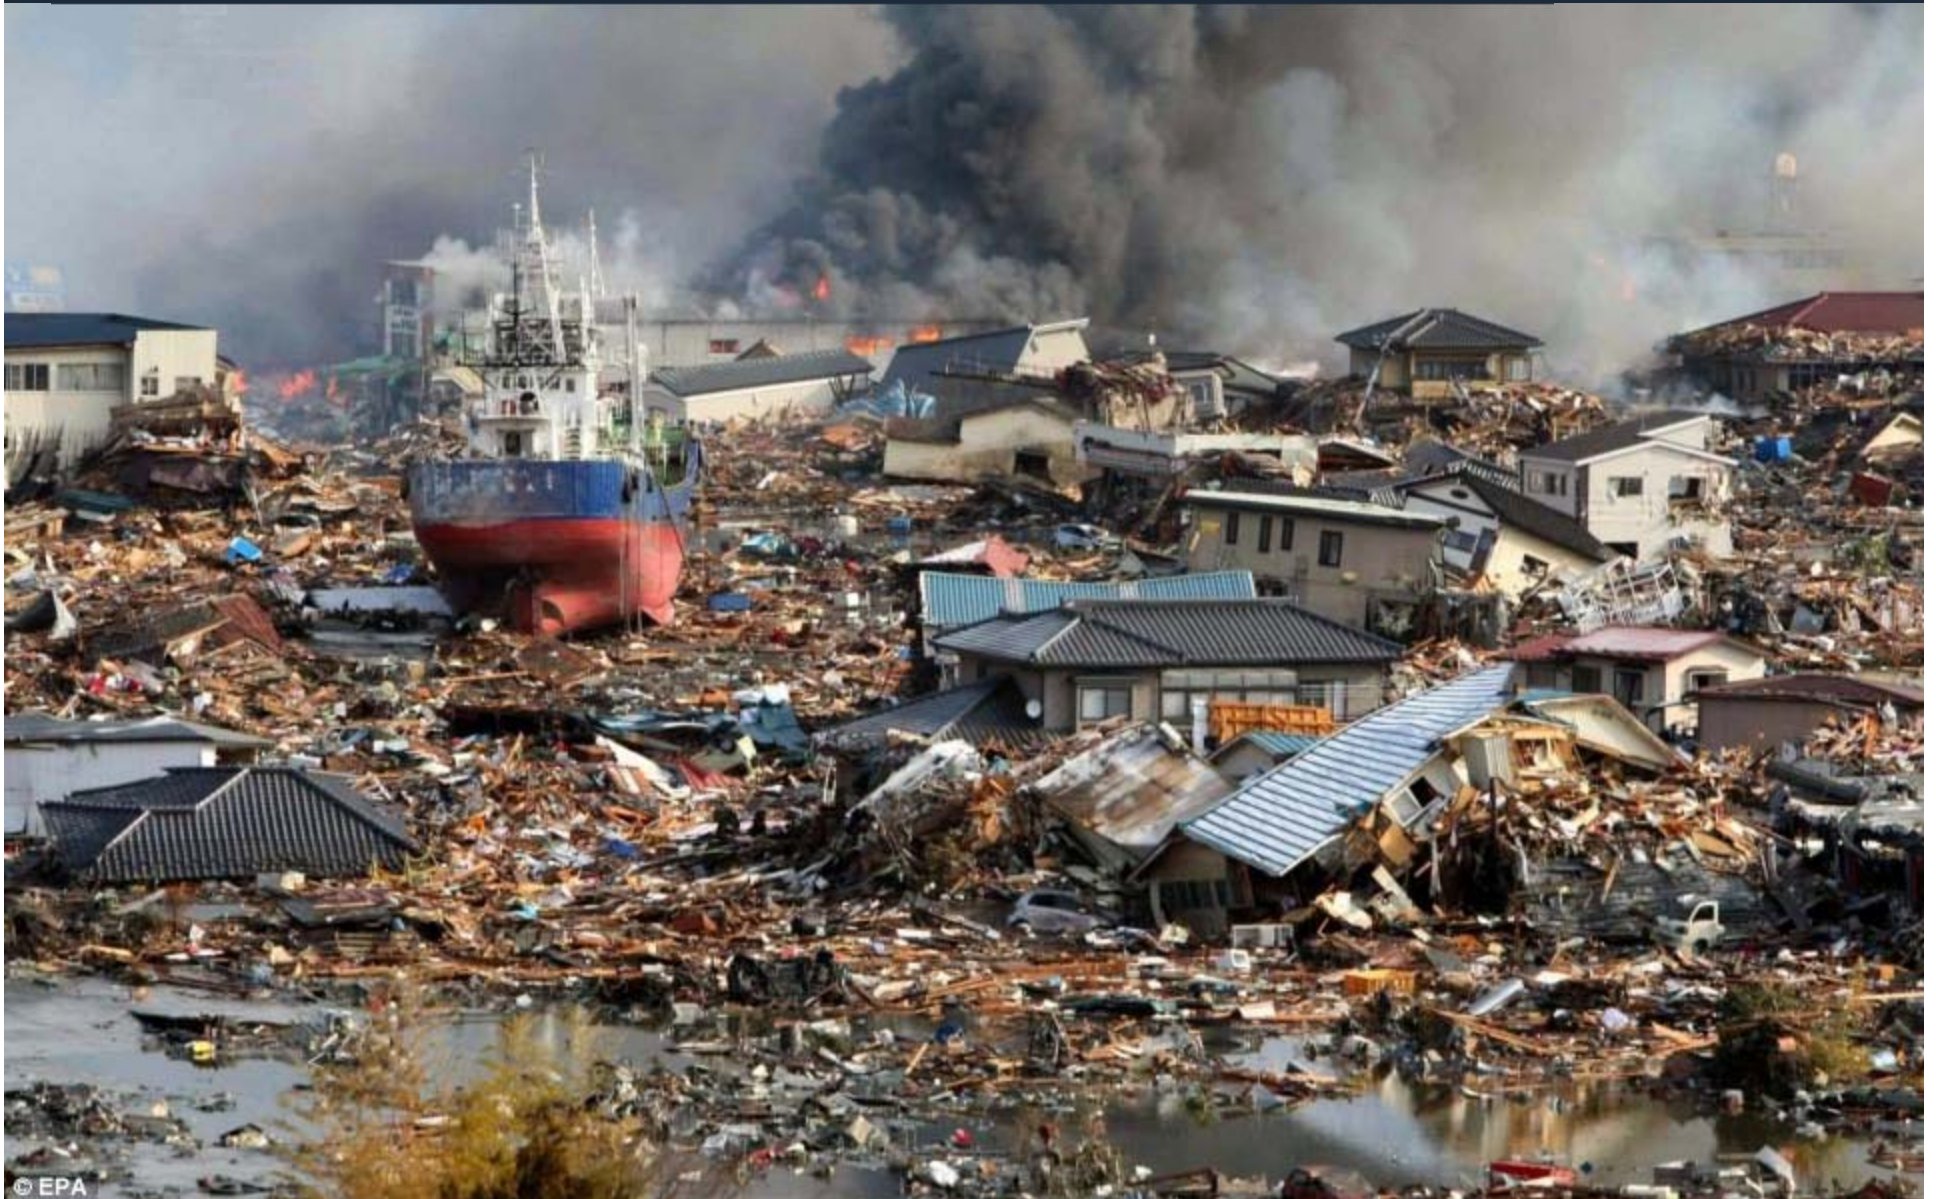
Tsunami Damage in Sendai

- Subduction earthquake
 - How does it compare to Cascadia?
- Extensive tsunami damage
- Long-duration strong shaking
- Foreshocks and aftershocks
