Retrofitting Homes to Reduce Basement Flood Risk Lessons Learned

Since 2009, ICLR has retrofitted three homes to reduce basement flood risk as part of this program. The experience with basement flood retrofits highlights the complicated nature of home drainage systems and the need to customize retrofits for each individual home.

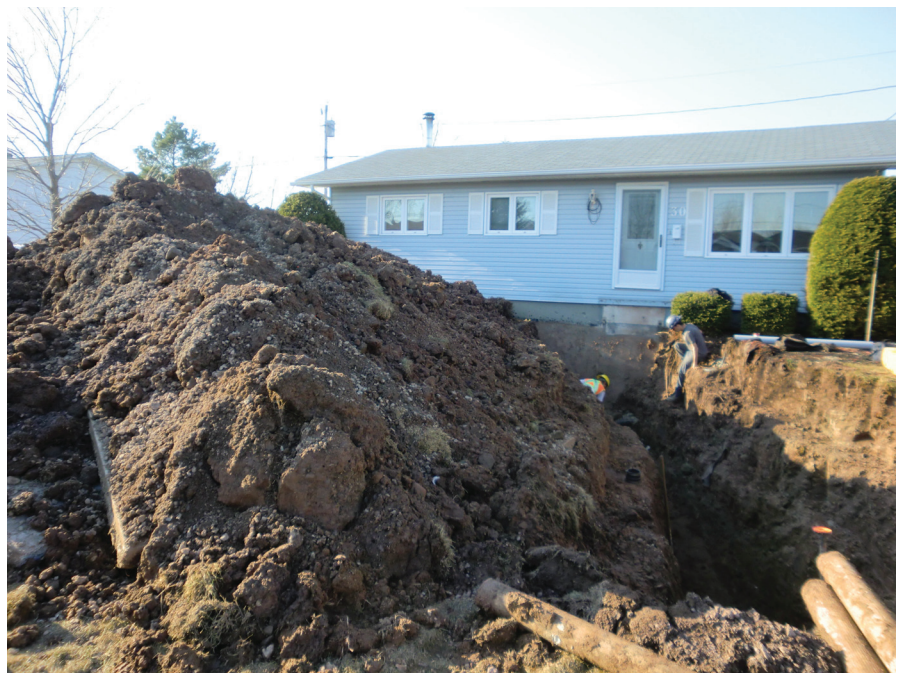
Investigation of sewer backup events sometimes leads to surprising discoveries – as well as extensive remedial work, as shown above.
