CATtales

e-newsletter of the Institute for Catastrophic Loss Reduction

Volume 8, Issue 4
July/August 2014

Building a more weather-resilient home

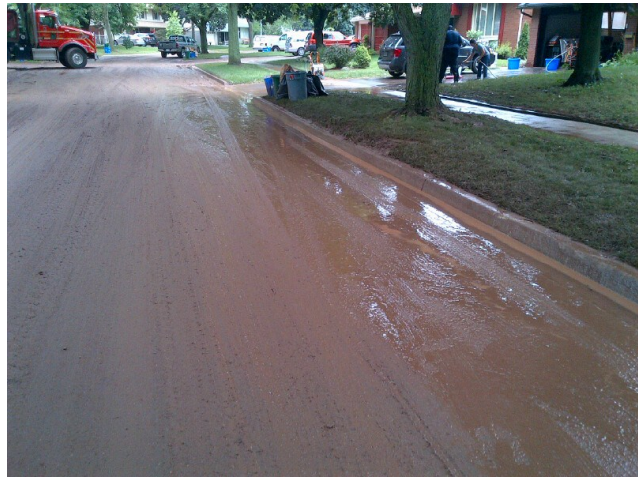
Residents of the lower section of Regal Road in Burlington not only had to contend with water, but also had to deal with a tsunamis of red clay.

One street, however, shocked me. In the middle of a seemingly untouched neighbourhood just south of New Street in the south-central part of the city, I came across Regal Road. On a small street leading to Regal, there were hints of muck on the roadway. However, when I turned the corner onto Regal, the road was covered from curb to curb in an inch of bright red clay. It was up driveways and into garages. Residents of the street also clearly had to deal with basement flooding. The mess was dramatic.

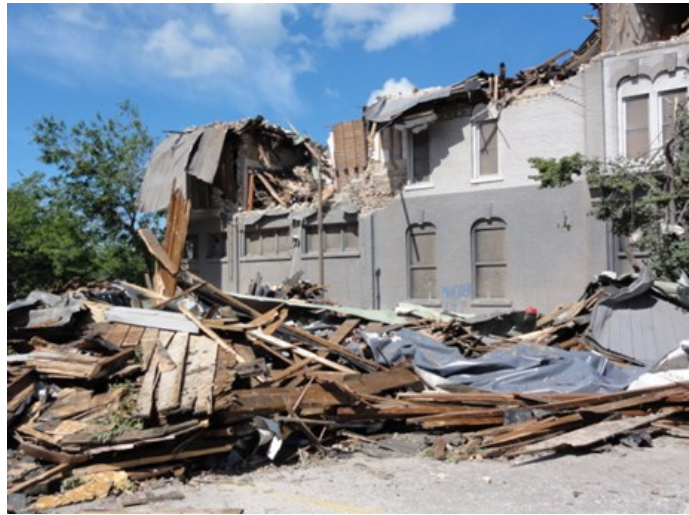
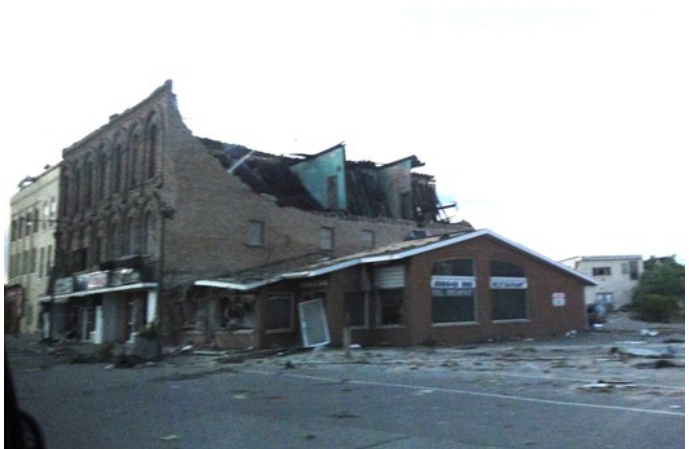
Damage from the Goderich tornado, August 2011.

consistent with failures observed in the field, particularly those in Goderich, (see photos on page 5), as well as others available to the authors.

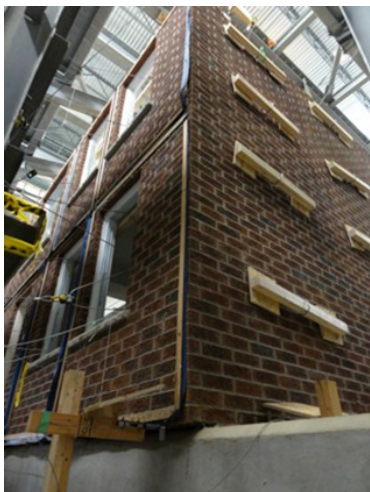
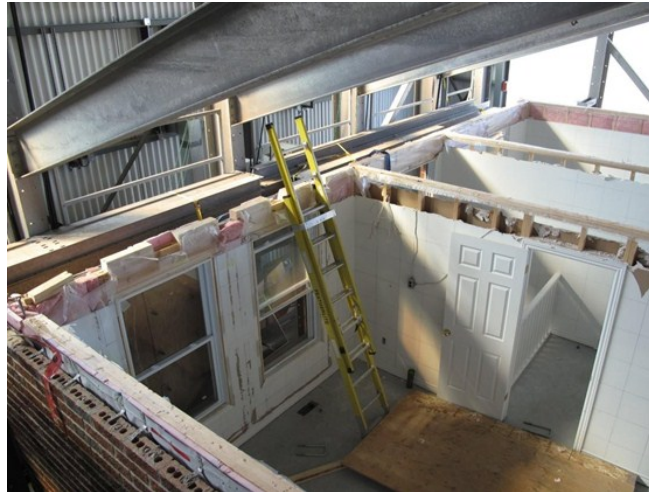
Test house at the Insurance Research Lab for Better Homes (IRLBH) without its roof.

With the completion of our research into the performance of roofs, we had a house in the lab that had no roof, as shown in the photographs below. This provided a unique opportunity to evaluate one particular aspect of the EF-Scale, namely the wind loads required to collapse the walls on a brick-clad house without a roof. For DI-2 (wood-frame houses), DOD-6 provides wind speeds which cause roof failure while “most walls

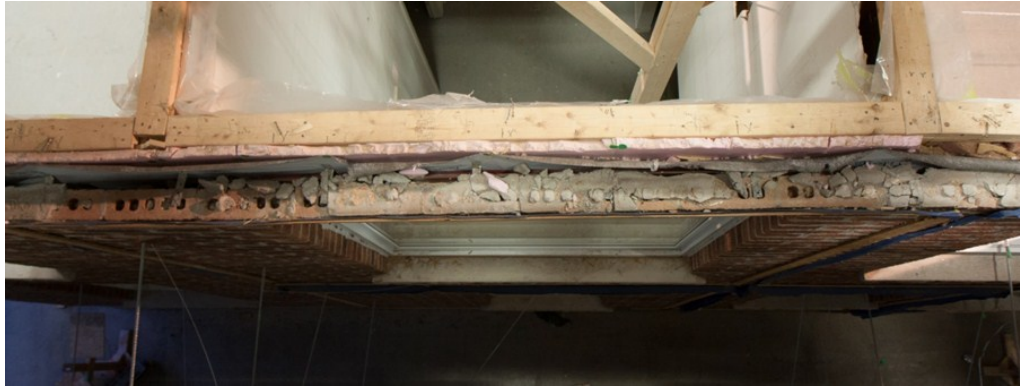
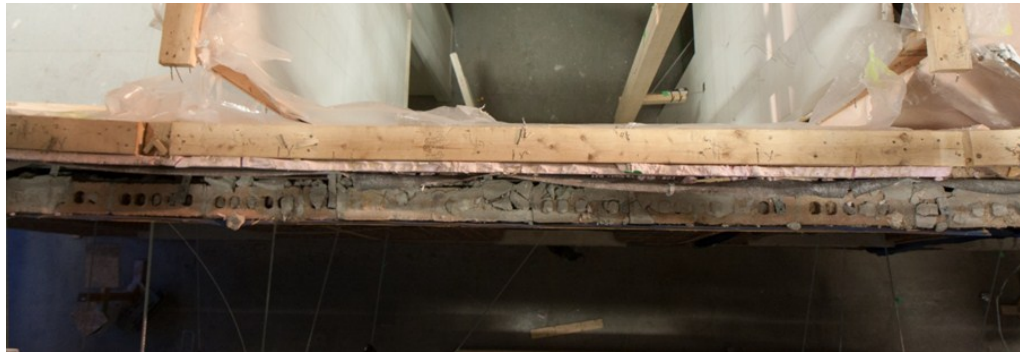
Photographs of the first failure in the brick-clad house, looking down on the wall from above: (upper) at the onset of failure, (lower) and just after failure when the exterior wall was disconnected from the interior walls.

The failure was at the connection between an interior wall and the exterior wall, as shown in the photographs (right). This failure mechanism is remarkably

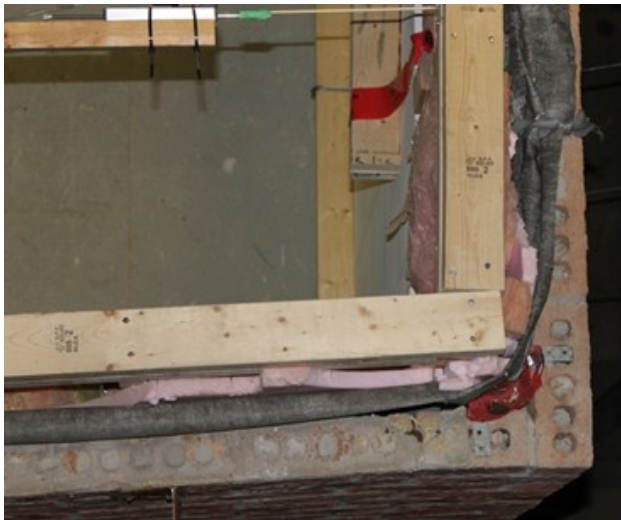
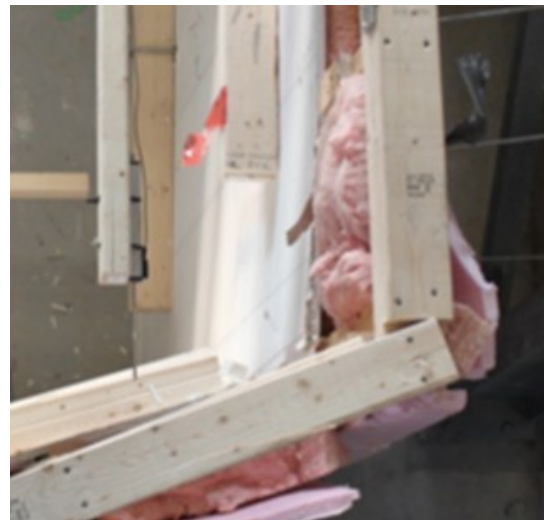
Photographs of corner displacements with brick cladding (left) and without bricks (right), at about the same load levels.

displacements along the span of the wall. Subsequent tests on undamaged portions of the walls, but with all of the bricks removed, showed this effect clearly, as do the photographs below. Thus, presuming that the bricks stay intact during the storm – and with the failure of the roof – brick-clad

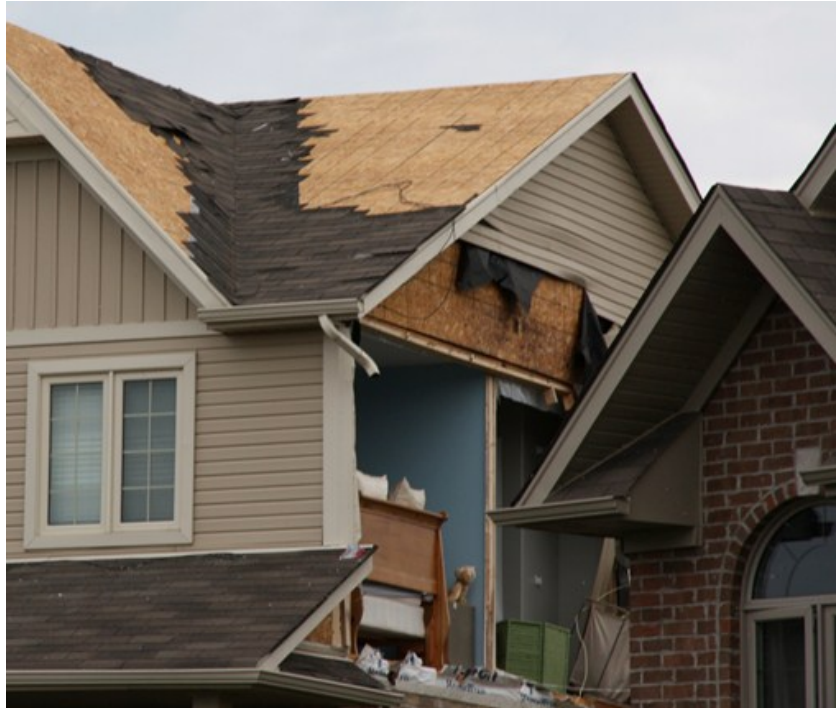
Damage from the Angus Tornado due to improper wall connections

As a final observation, wall failures that occur while the roof remains in place indicate serious construction deficiencies. An example is shown above from the Angus, Ontario Tornado, which

occurred in June 2014. Such failures are due to walls not being fastened into the structure in an adequate manner. **CT**
