DAMAGE IS IN THE DETAILS

Build better now....or BAIL later!

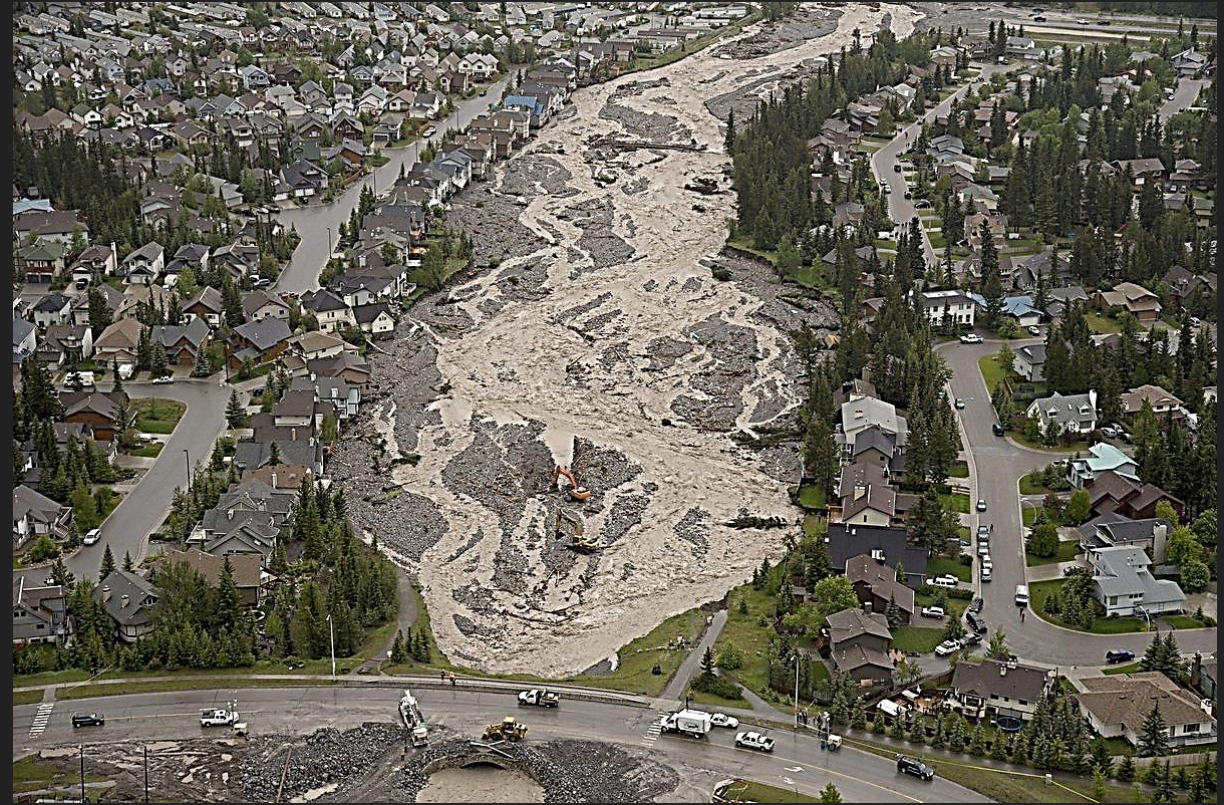
- Vancouver BC: Condo damages – inspection system failed + poor build methods
- Calgary & High River Alberta: 2-3 Billion \$ in damages – Urban Planning and water Management failed

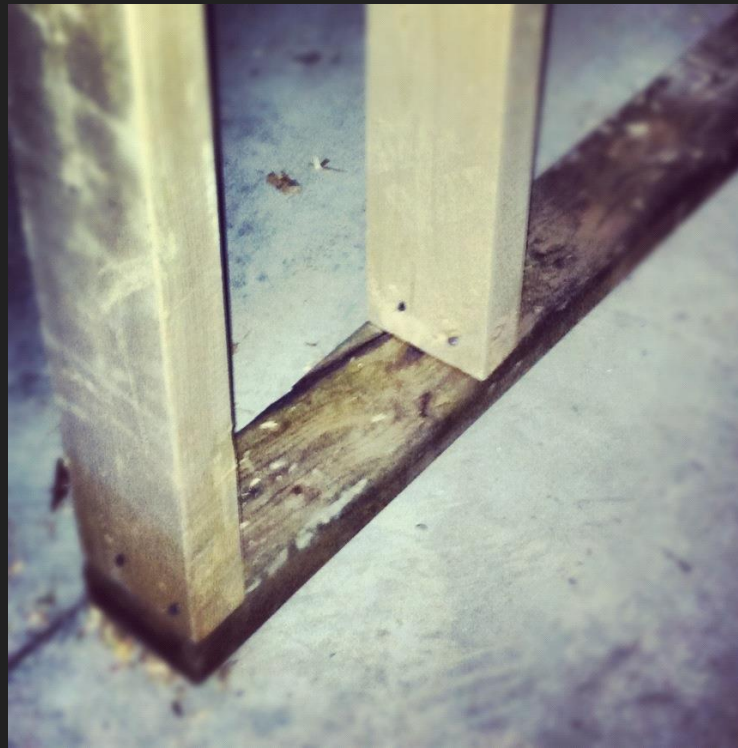
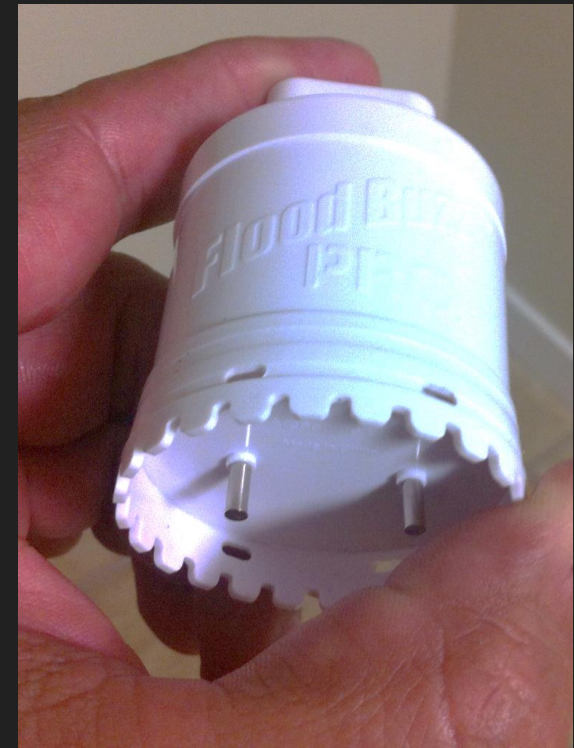
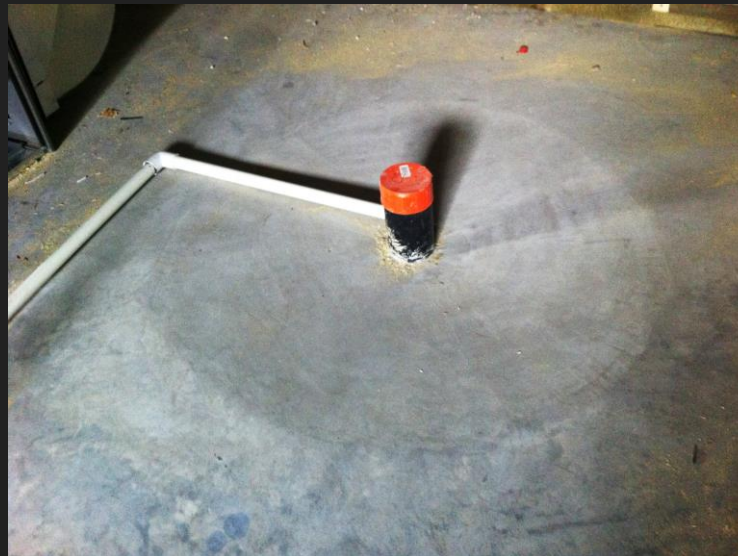
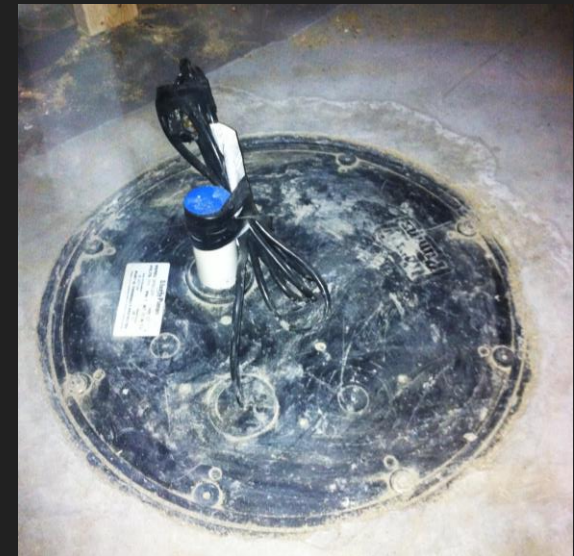
My Top 5 Inside

1. SEALED SUMP PIT WITH HIGH VOL PUMP
2. HARD LINE DISCHARGE
3. WATER ALARM
4. TREATED BASEMENT FRAMING
5. AGGRESSIVE SLOPE TO FLOOR DRAIN

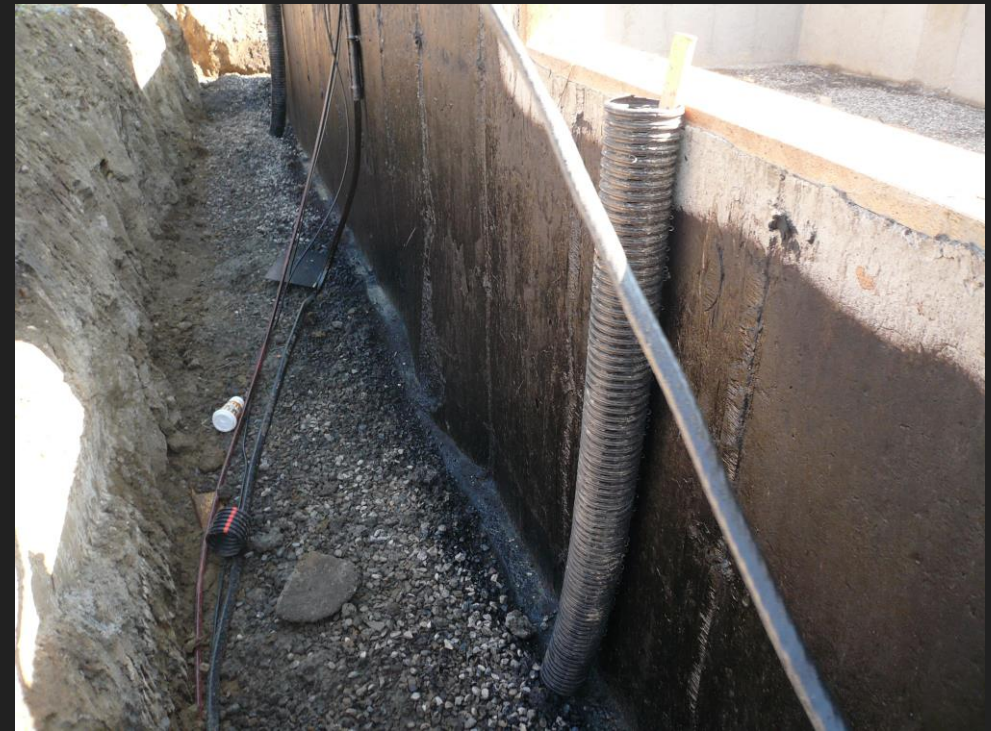
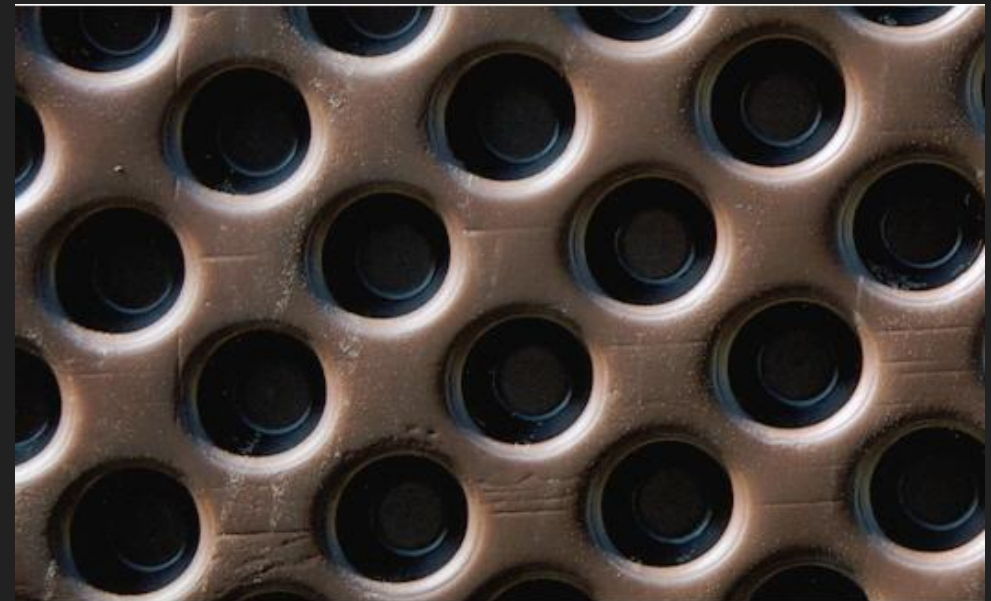
My top 10 outside

1. Overkill the washed rock over the weeping tile
2. Aggressive grade for 5' perimeter
3. Tar the footing wall intersection or:
4. Clad foundation with Delta MS
5. Inspect customer landscaping at 1 year warranty anniversary
6. Proper swales between homes
7. Proper orientation of downspouts
8. Balance the trough discharge around perimeter so that no one area receives large amounts of water
9. Discharge as much of the roof moisture to garage and driveway side of home (furthest from basement footings)
10. 5' perimeter sloped clay cap under finished soil
