Some Observations from Recent Chile Earthquake

H. P. Hong
Dept. of Civil & Environmental Eng.
University of Western Ontario
London, Ontario, Canada
Hongh@eng.uwo.ca

The Event: Chile earthquake

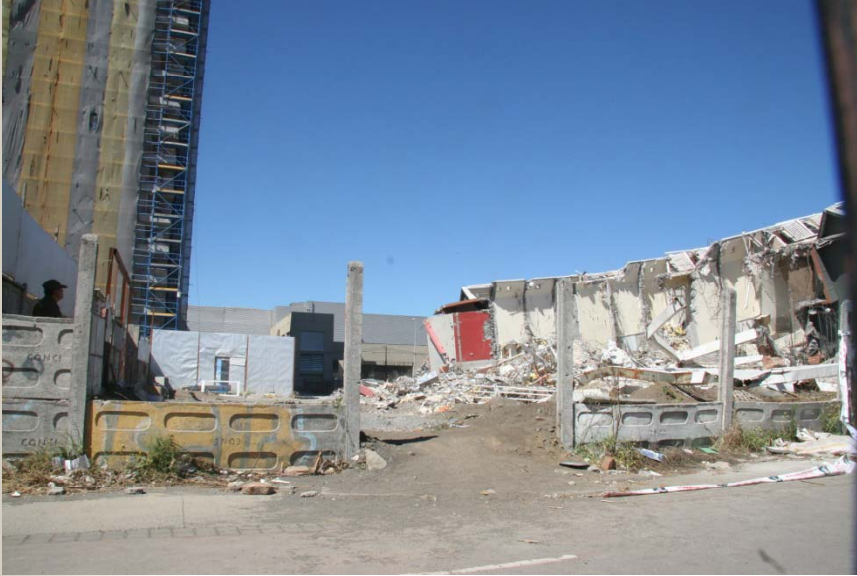
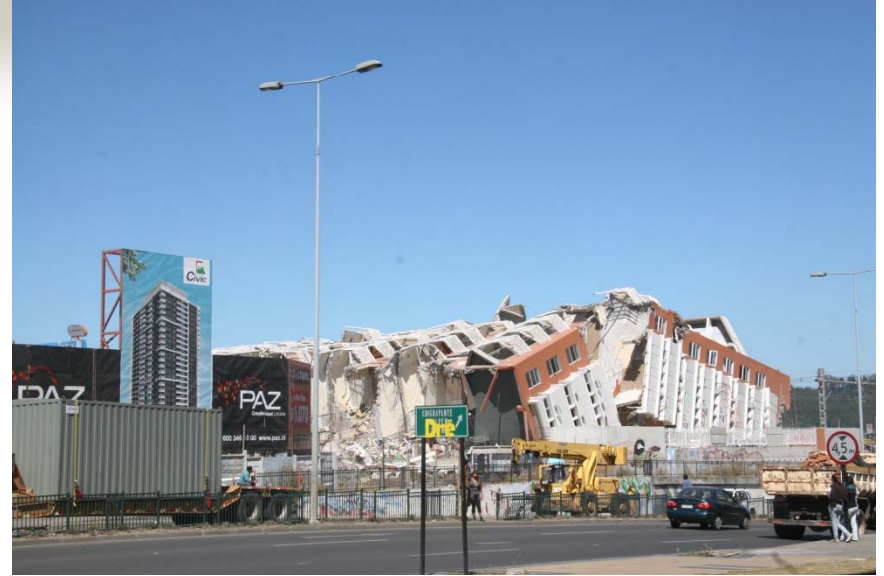
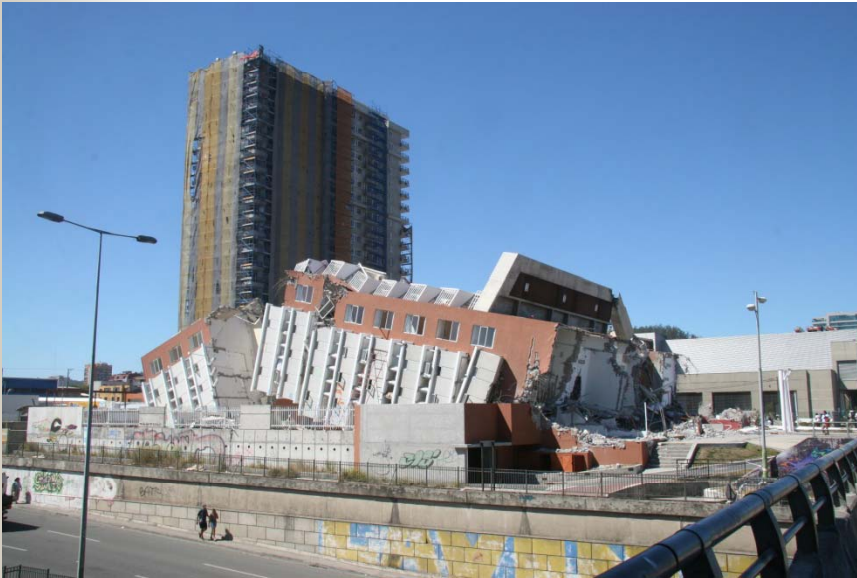
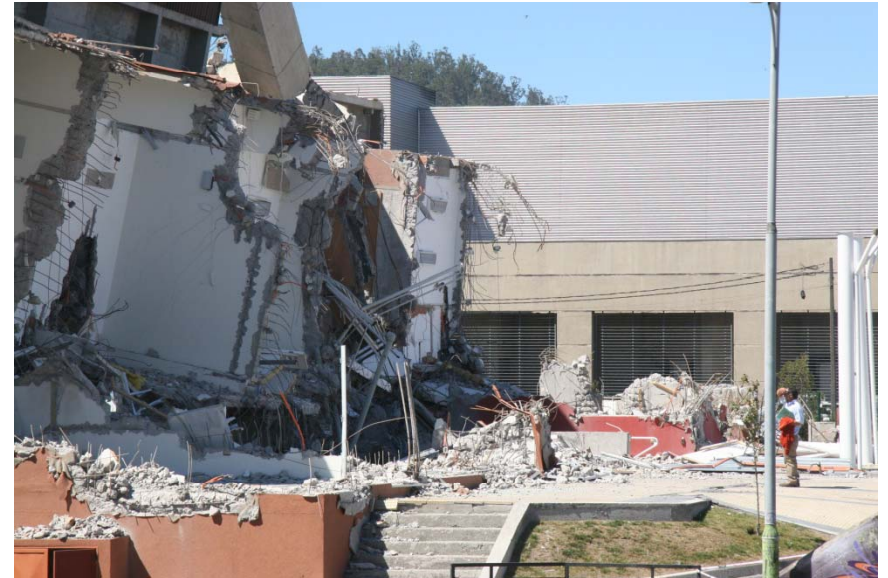
A building in Concepcion

A building in Concepcion: Interstory collapse and will be demolished.

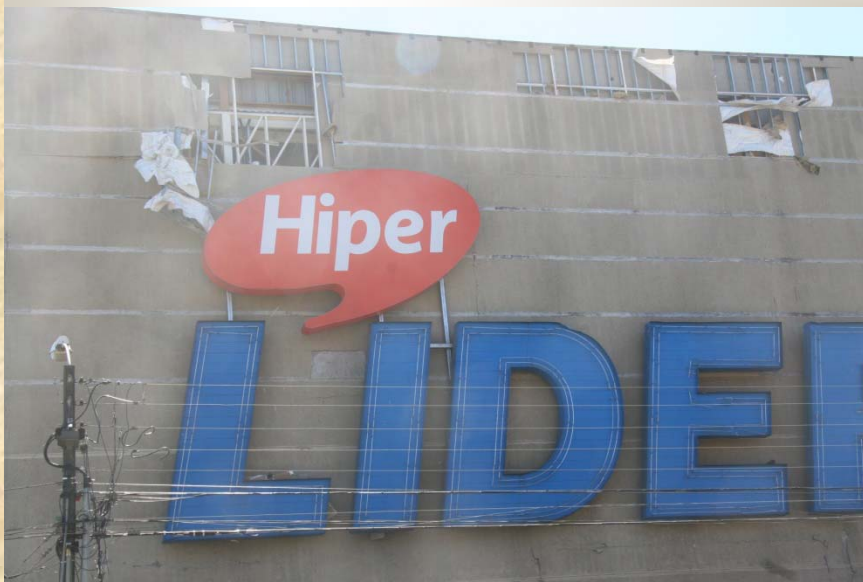
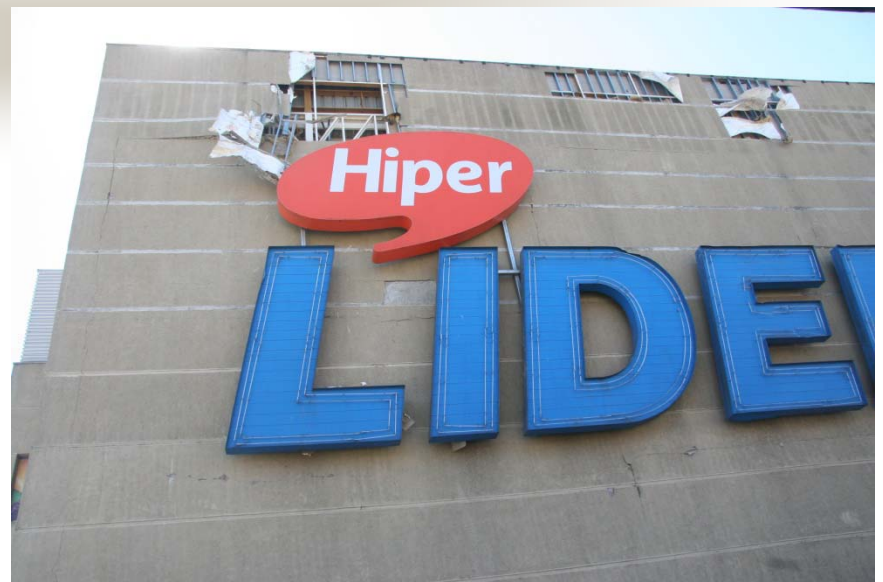
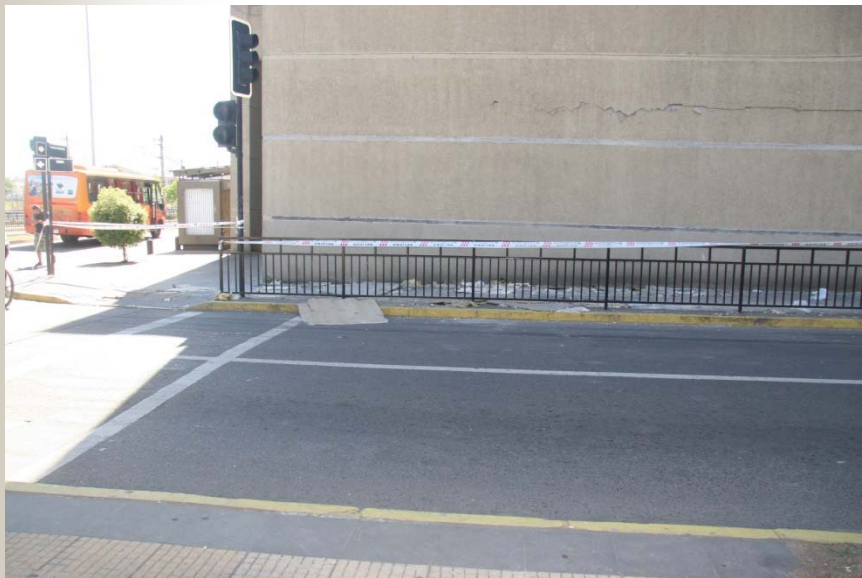
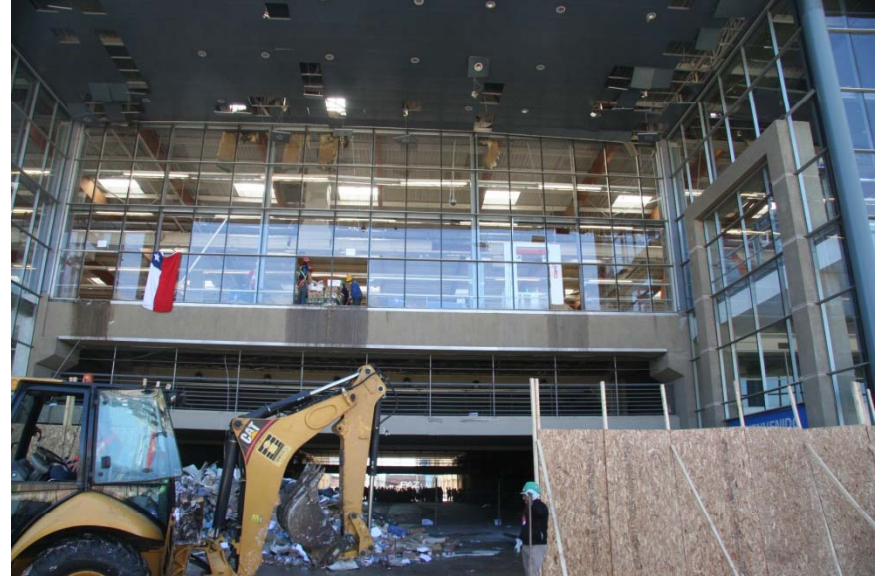
Examples of buildings that survived this earthquake

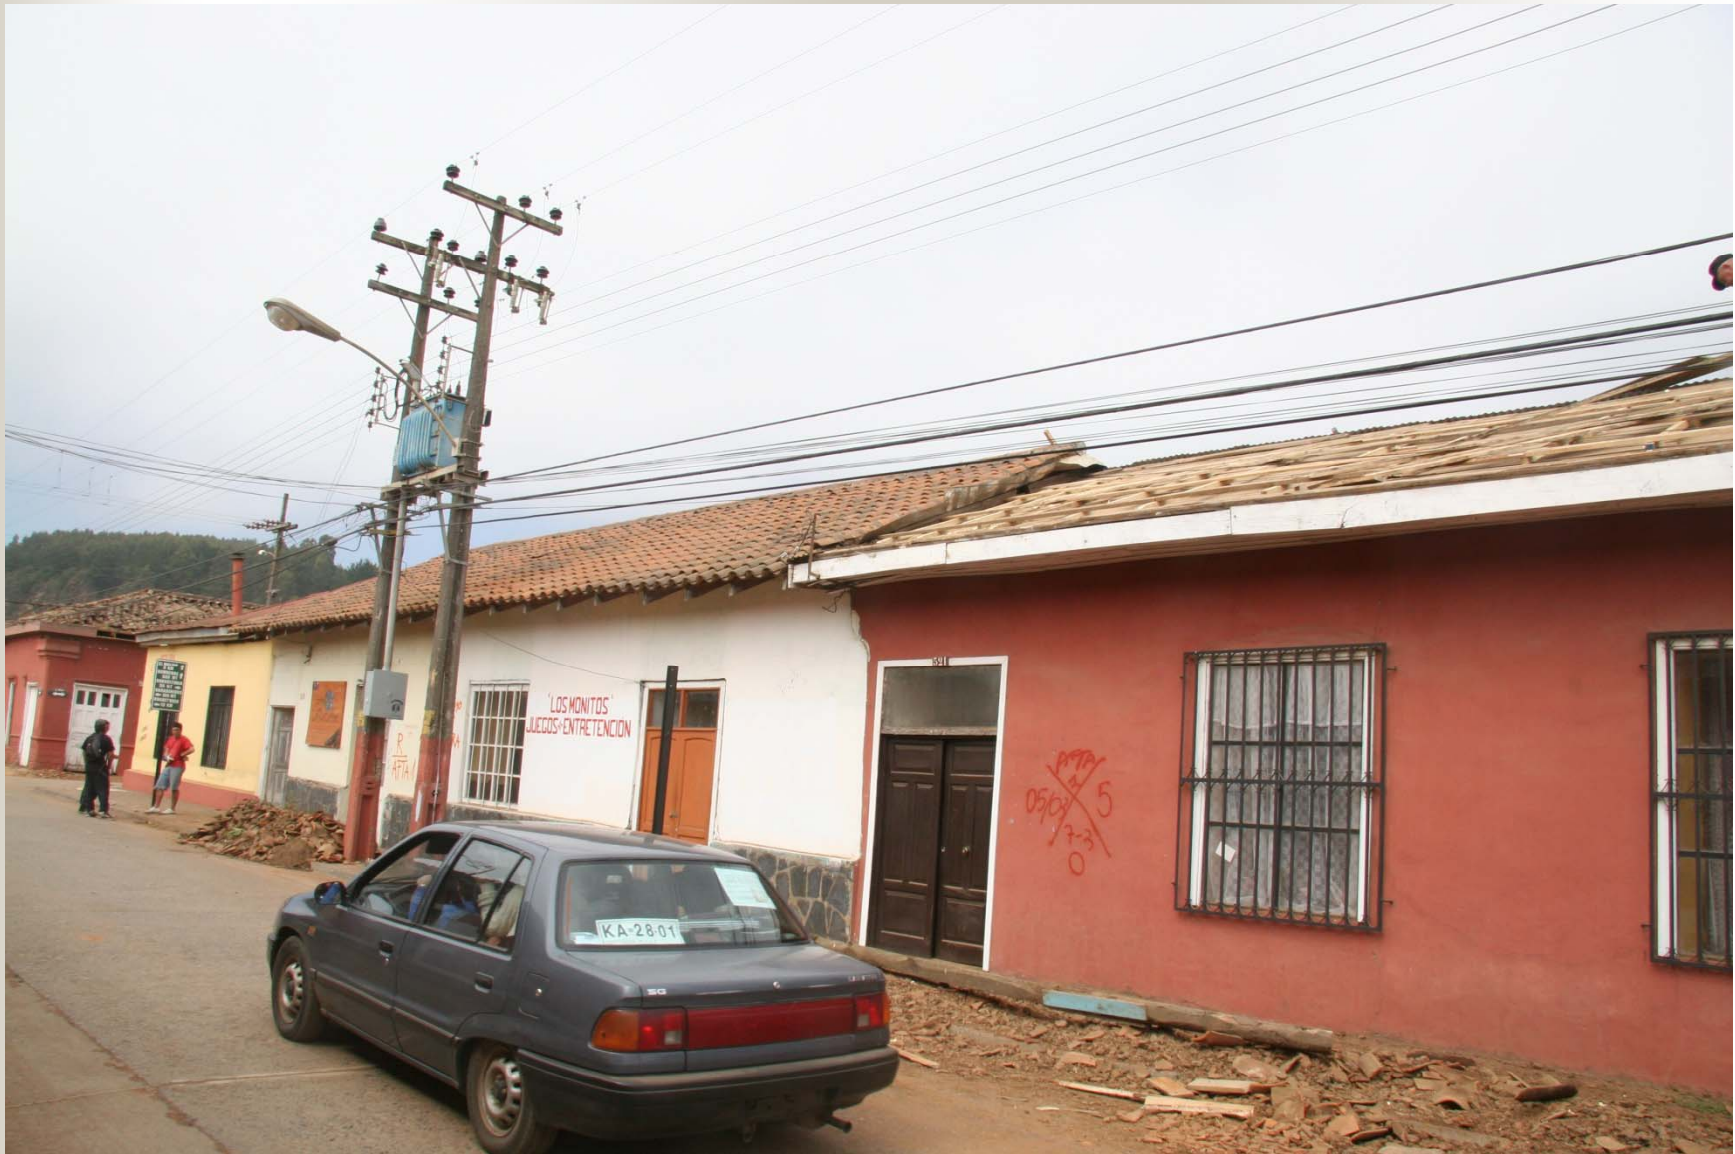
A street view in Talco

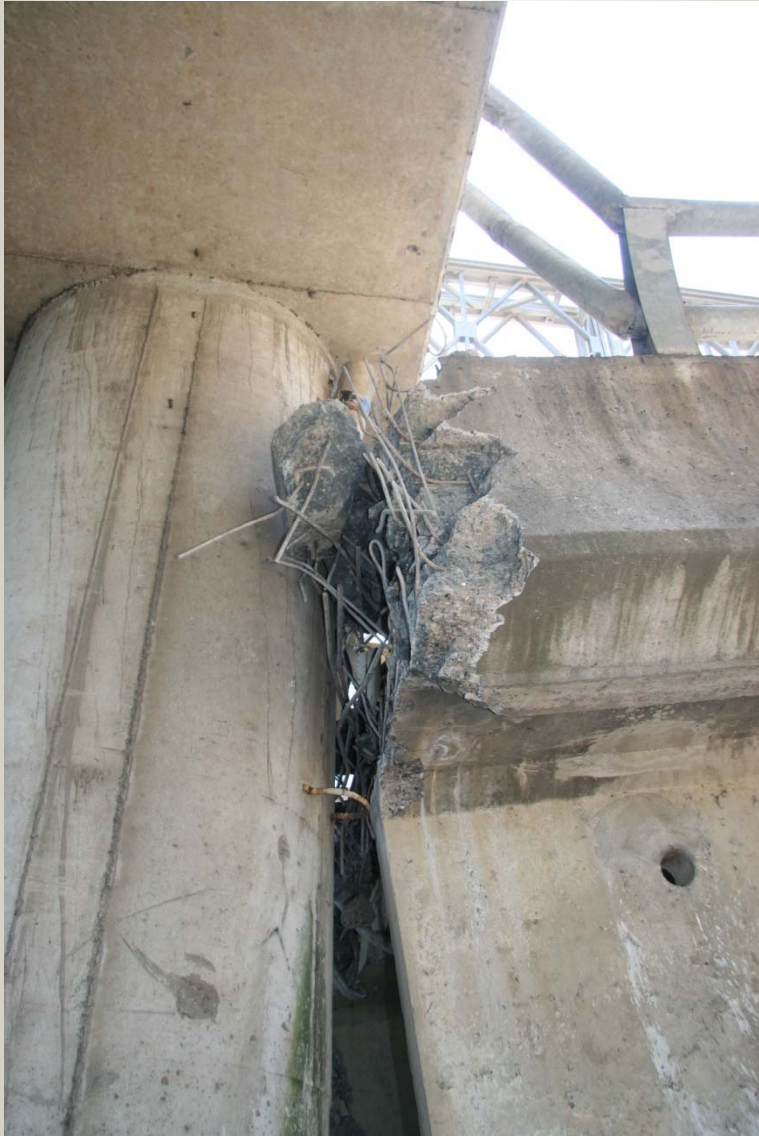
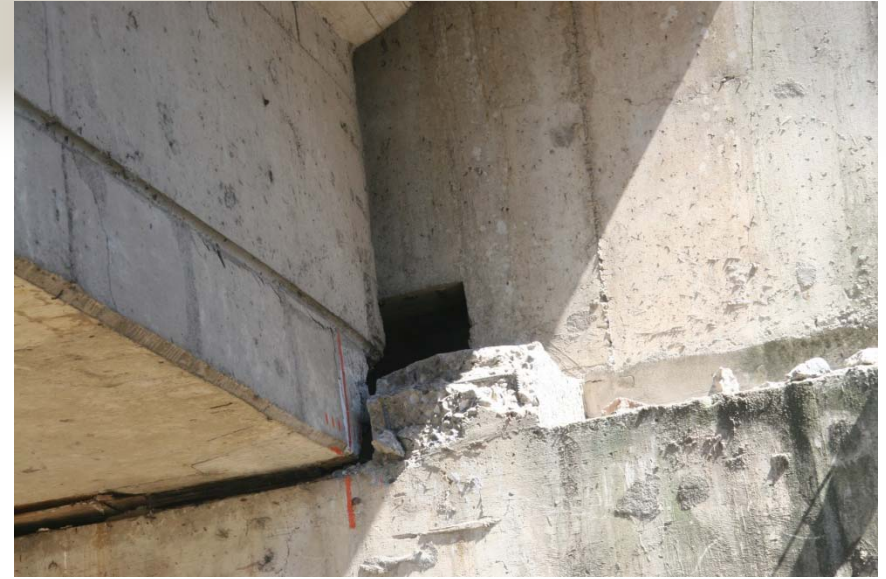
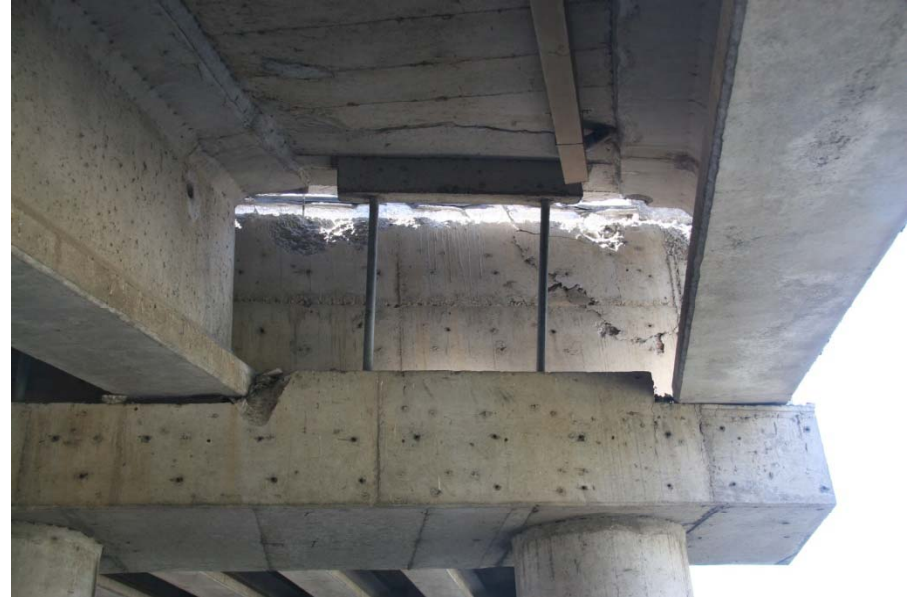
Deck unseating at Llacolén bridge

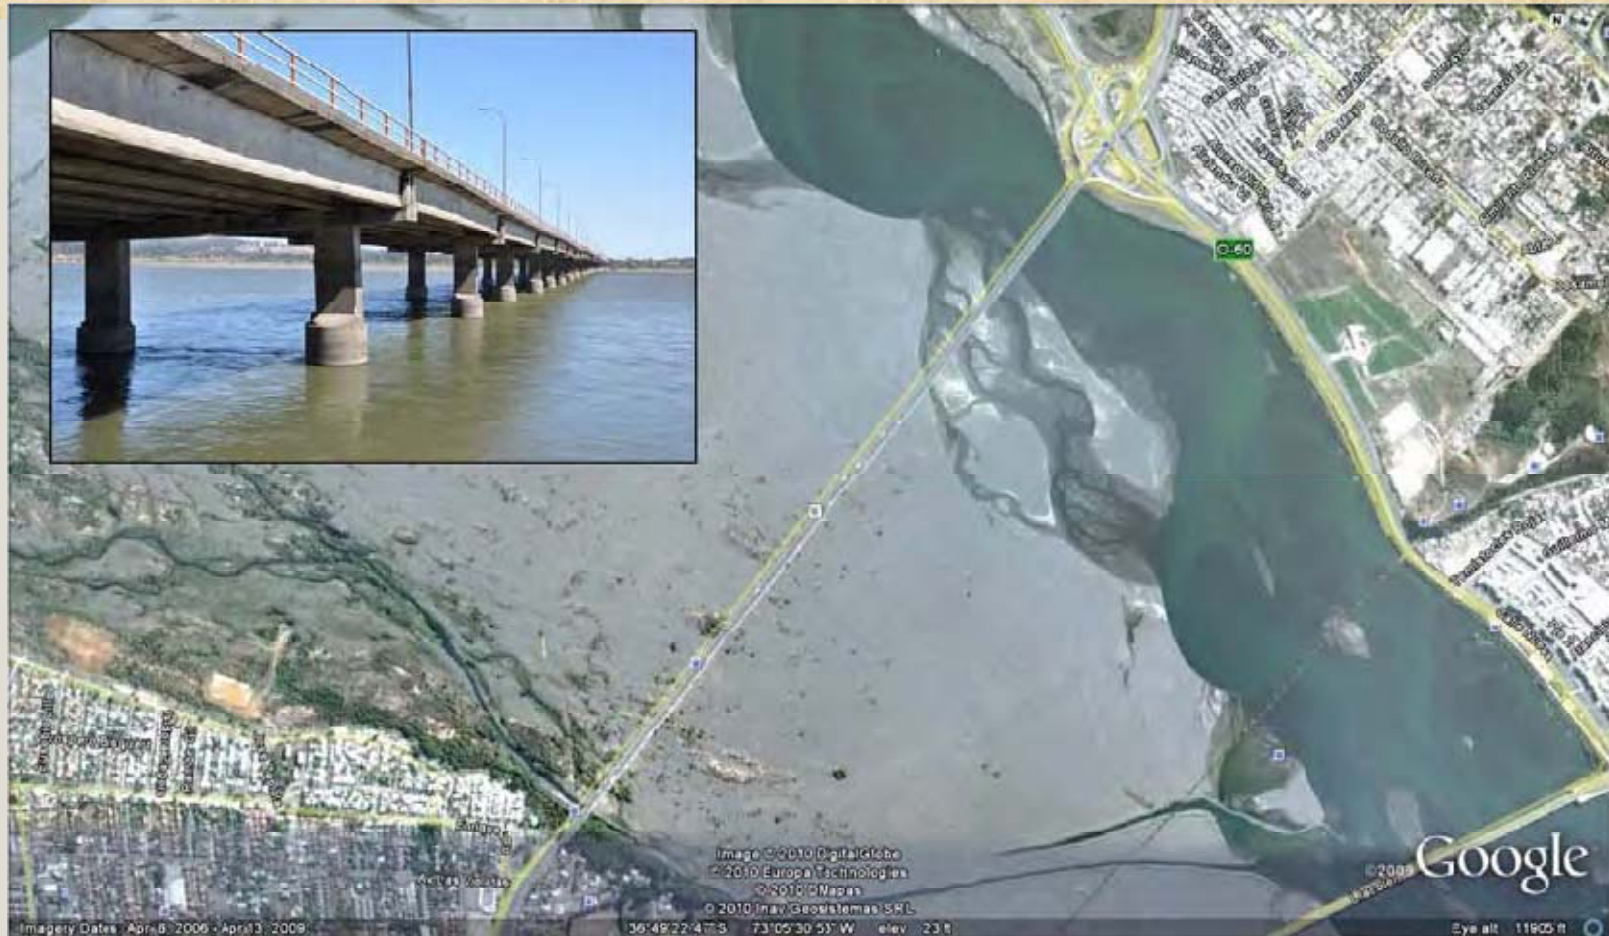
This is a old bridge and it was not in service for several years.

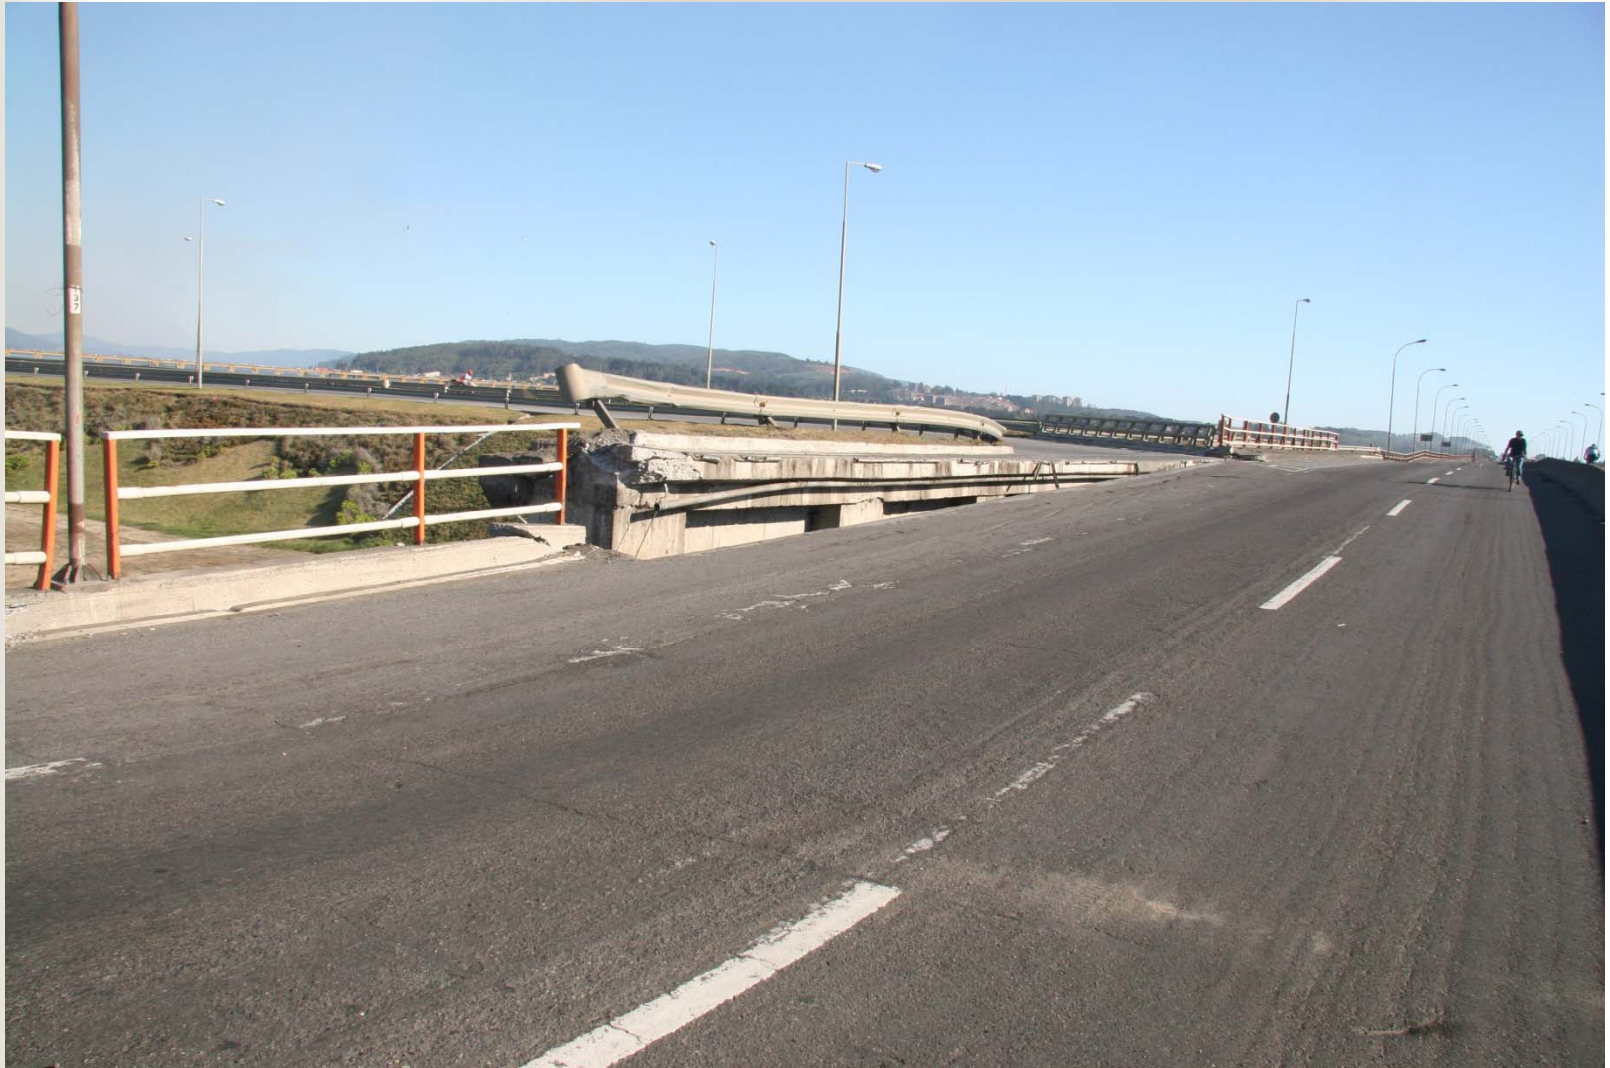
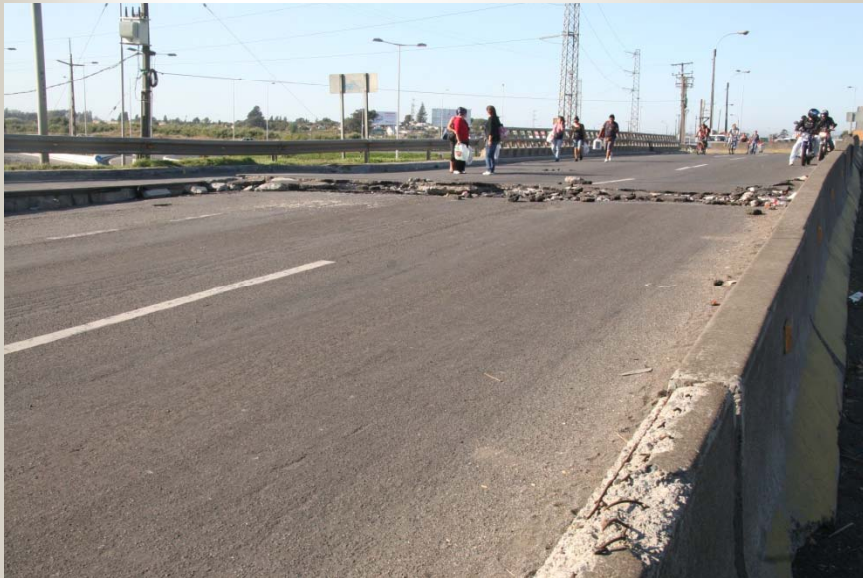
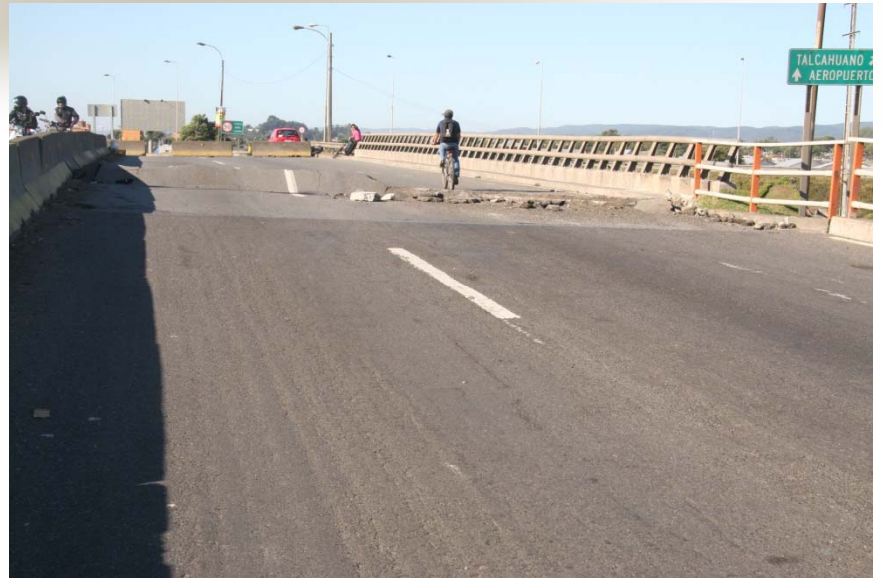
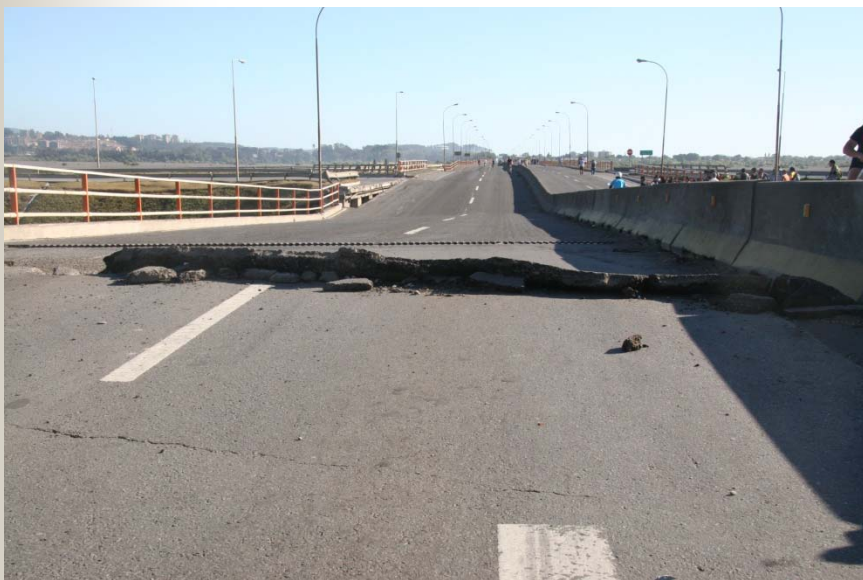
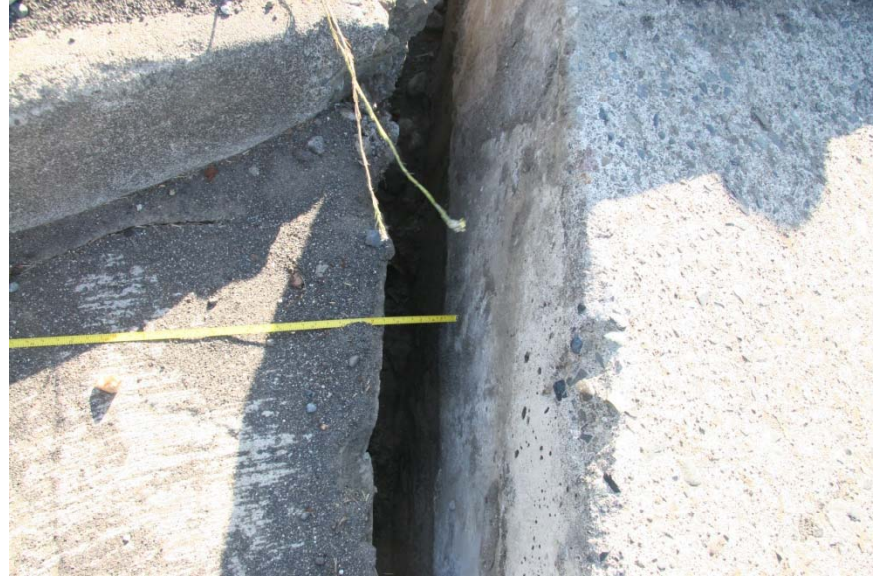
Juan Pablo II bridge connects the cities of Concepción and San Pedro de la Paz. It opened to the public in 1974. "The bridge consists of 70 spans ($L = 33$ m, $W = 21.9$ m) each one composed of 7 reinforced concrete girders and a concrete slab. The segments sit on reinforced concrete bents with drilled pier Supports." (Report of the NSF Sponsored GEER Association Team, Edited by J. Bray and D. Frost)

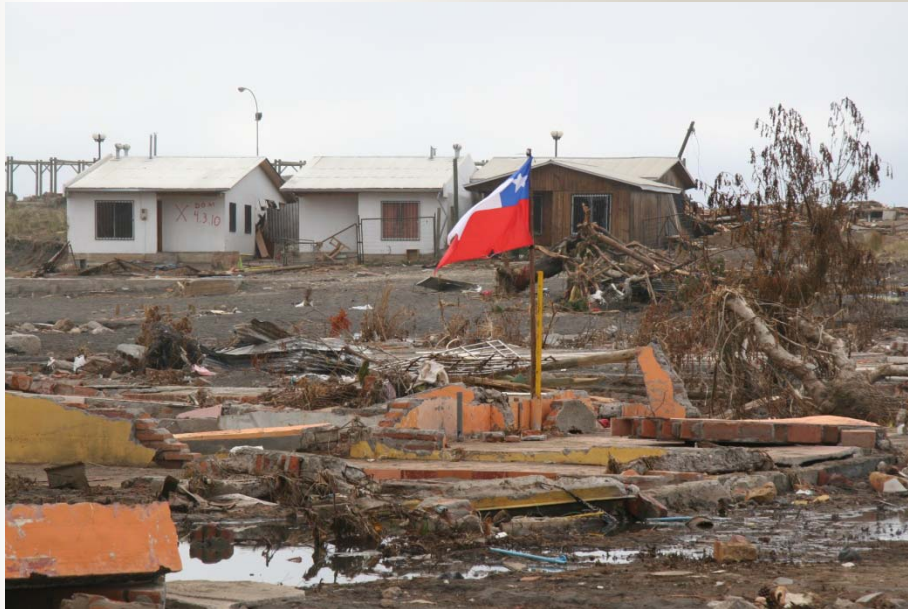
in Talcahuano

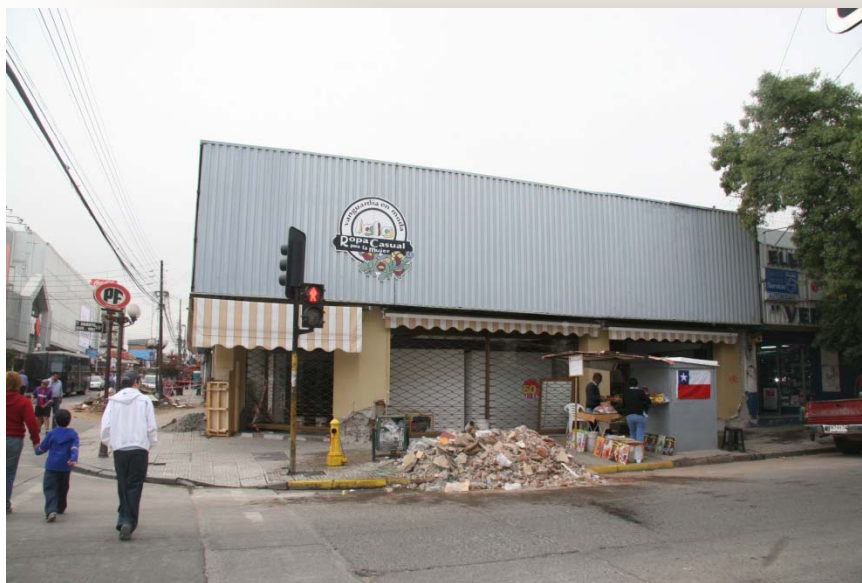
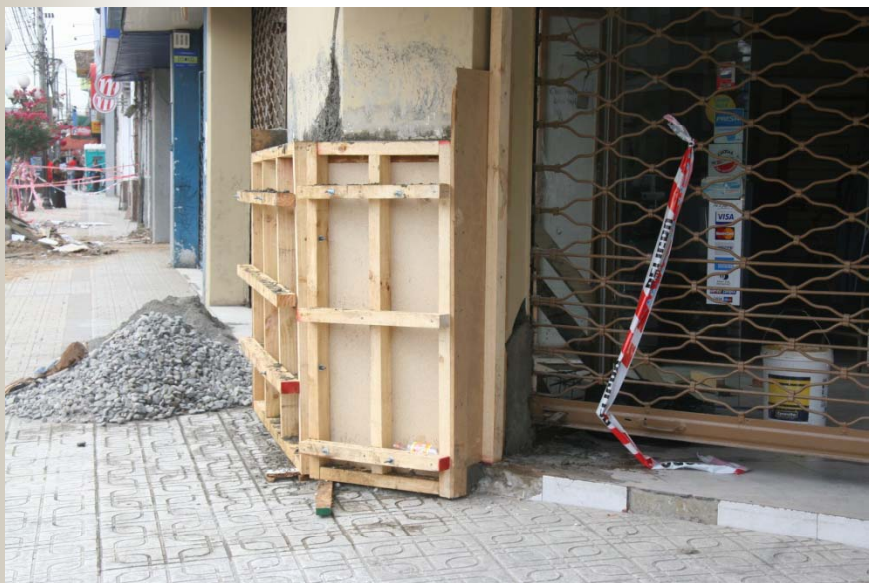
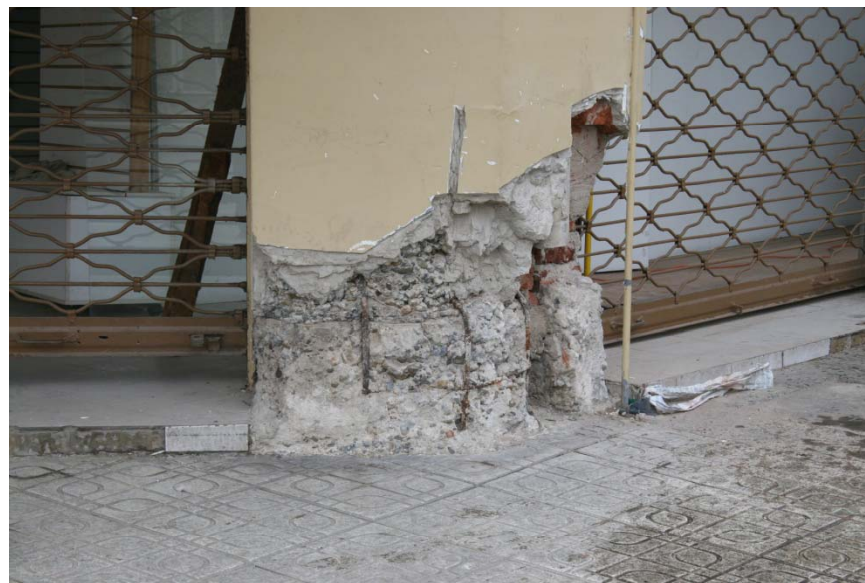
Some observed non-engineered repair
